## INTERSTATE COMMERCE COMMISSION

REPORT OF THE DIRECTOR OF THE BUREAU OF SAFETY CONCERNING AN ACCIDENT WHICH OCCURRED ON THE GRAND TRUNK WESTERN RAILROAD AT SOUTH BEND, IND., ON APRIL 28, 1932.

June 7, 1932.

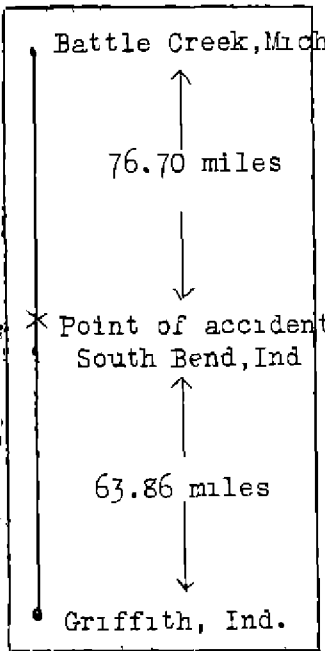
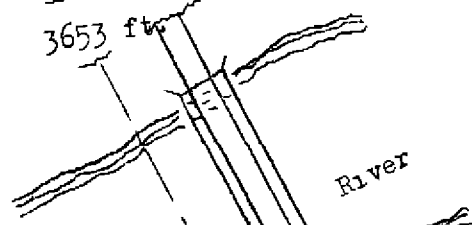
Inv. No. 1763  
Grand Trunk Western R.R.  
South Bend, Indiana  
April 28, 1932

Point of accident
