INTERSTATE COMMERCE COMMISSION

REPORT OF THE DIRECTOR OF THE BUREAU OF SAFETY
CONCERNING INVESTIGATION OF AN ACCIDENT WHICH
OCCURRED AT THE INTERSECTION OF THE TRACKS OF
THE GREAT NORTHERN RAILWAY AND THE CHICAGO,
MILWAUKEE, ST. PAUL & PACIFIC RAILROAD NEAR
WAHPETON, N. D., ON JANUARY 30, 1932.

March 29, 1932.

Inv. No. 1750
 Chicago, Milwaukee, St. Paul & Pacific
 Great Northern
 Wahpeton, N. D.
 Jan. 30, 1932

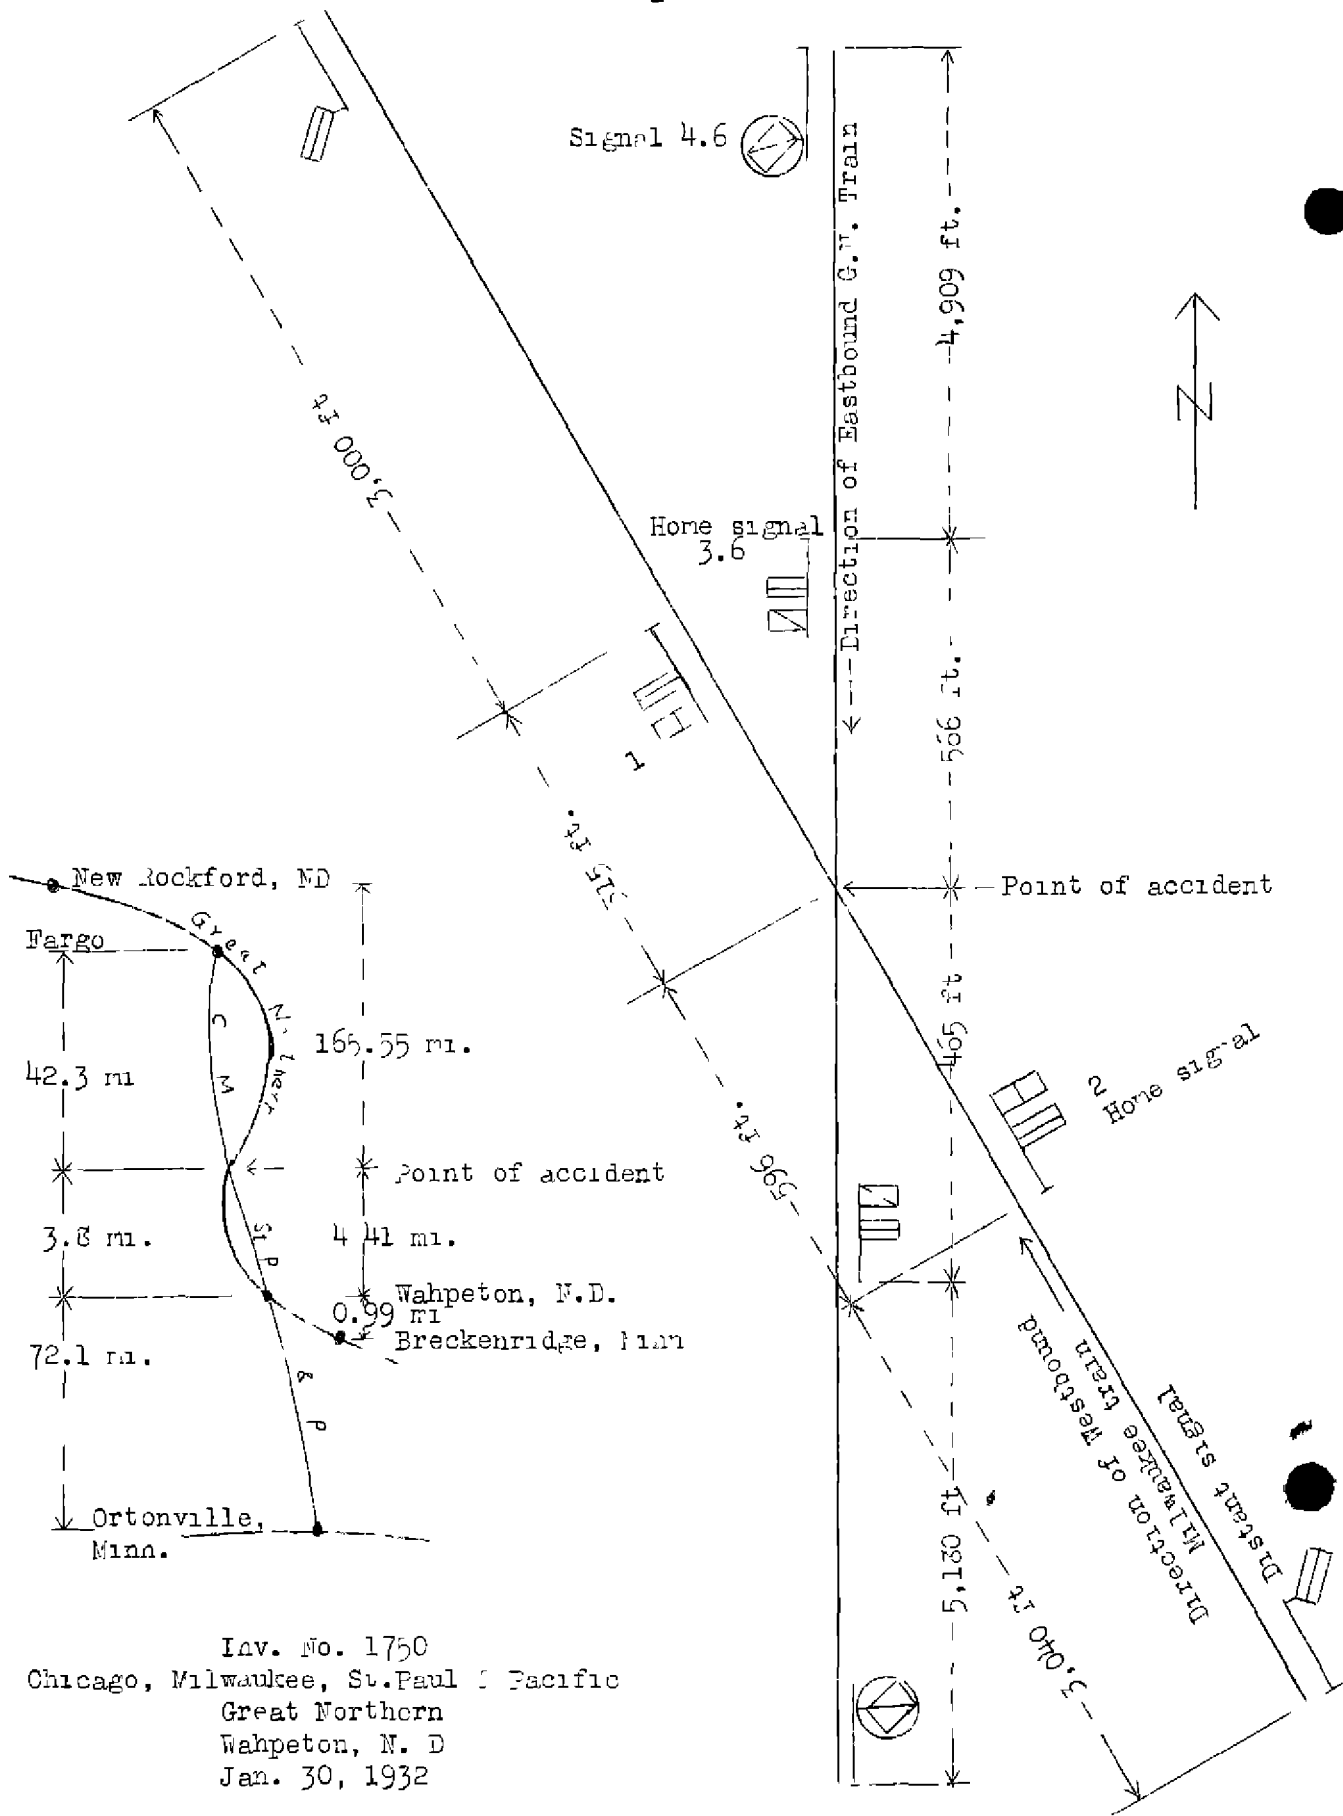
The interlocking system at this crossing, installed in 1923, consists of signals and electric circuits which function automatically upon the approach of trains, there are no switches or derails. On each line there are two home signals, of the semaphore type, governing movements over the crossing, approach indications for these home signals are given by distant signals, also of the semaphore type, on the Milwaukee, and by the automatic block signals, of the color-light type, on the Great Northern. The home signals are normally at stop, and approach lighting is used for all signals, on the Great Northern the colors used are red for stop, yellow for caution, and green for clear, and on the Milwaukee red for stop, green for caution, and white for clear. Trains approaching on the Milwaukee from the east are governed by a fixed distant signal, displaying caution, located 3636 feet east of the crossing, and by home signal 2, a two-position, two-arm, upper-quadrant signal, displaying either stop or proceed on the upper arm while the bottom arm is fixed in horizontal position, this signal is located 696 feet east of the crossing. Trains approaching on the Great Northern from the west are governed by signal 4.6, located 5475 feet west of the crossing, and by home signal 3.6, of the two-position two-arm, upper-quadrant type, with the bottom arm fixed in horizontal position, this signal is located 566 feet west of the crossing. Both of these signals display either stop or approach indications. The automatic interlocking is so arranged that the train which first arrives on its approach circuit selects the route and operates the signals to permit its movement over the crossing, all other operative signals being held at stop. The approach circuit on the Milwaukee extends 2065 feet east of the distant signal or 6601 feet from the crossing, on the Great Northern, signal 4.6 is lighted when a train approaches within approximately 3000 feet of it, and the circuits controlling the lighting and operation of signal 3.6 extend to signal 4.6, a distance of 5475 feet from the crossing.
