✓  
RAILROAD ACCIDENT INVESTIGATION  
✓  
REPORT NO 4152

GREAT NORTHERN RAILWAY COMPANY  
(BURLINGTON NORTHERN, INC.)

MARYSVILLE, WASHINGTON LIBRARY

JUNE 6, 1969

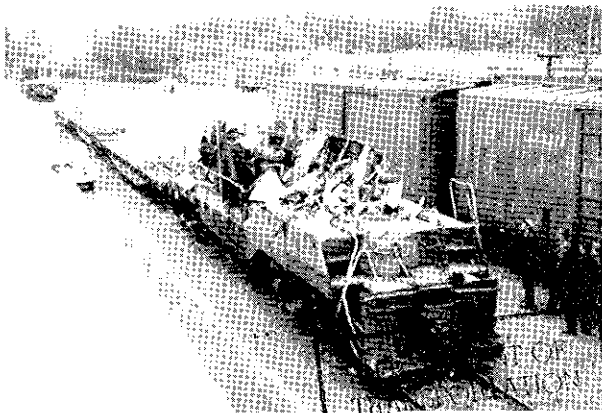
COVER PHOTO: Locomotive of Extra 675 South

south of the crossing. The engine hood was torn off and the engine was somewhat damaged. The control compartment was crushed, as a result of a derailed gondola car stopping on top of it. The photo on the cover page shows the extent of damage to the locomotive.

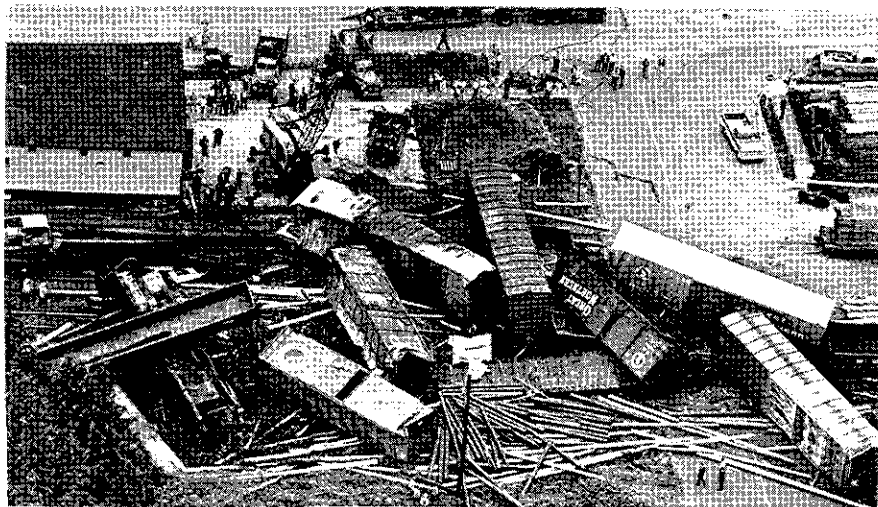
PLATE NO. 3

The locomotive and first 20 cars of this train were derailed. The locomotive overturned onto its left side. It stopped at a 40-degree angle to, and with one end across, the main track about 450 feet south of the collision point. The derailed cars stopped in various positions on or near the structures of the main track, siding and team track, as shown in Plates No. 2 and No. 3.

Extra 725 South approached from right. Locomotive of that train is under gondola car at left. Locomotive of Extra 675 South is under wreckage at center.
