INVESTIGATION NO. 3722
THE GREAT NORTHERN RAILWAY COMPANY
REPORT IN RE ACCIDENT
AT GRAND RAPIDS, MINN., ON
AUGUST 17, 1945

Railroad: Great Northern
Date: August 17, 1943
Location: Grand Rapids, Minn.
Kind of accident: Rear-end collision
Trains involved: Passenger : Freight
Train numbers: 35 : Extra 2109 West
Engine numbers: 5402 : 2109
Consist: 4 cars : 77 cars, caboose
Speed: 8 m. p. h. : 20 n. p. h.
Operation: Timetable and train orders;
yard limits
Track: Single; 1° curve; practically level
Weather: Clear
Time: 1:15 a. m.
Casualties: 20 injured
Cause: Failure properly to control
speed of following train
moving within yard limits

Accident at Grand Rapids, Minn., on August 17, 1943, caused
by failure properly to control speed of following
train moving within yard limits.

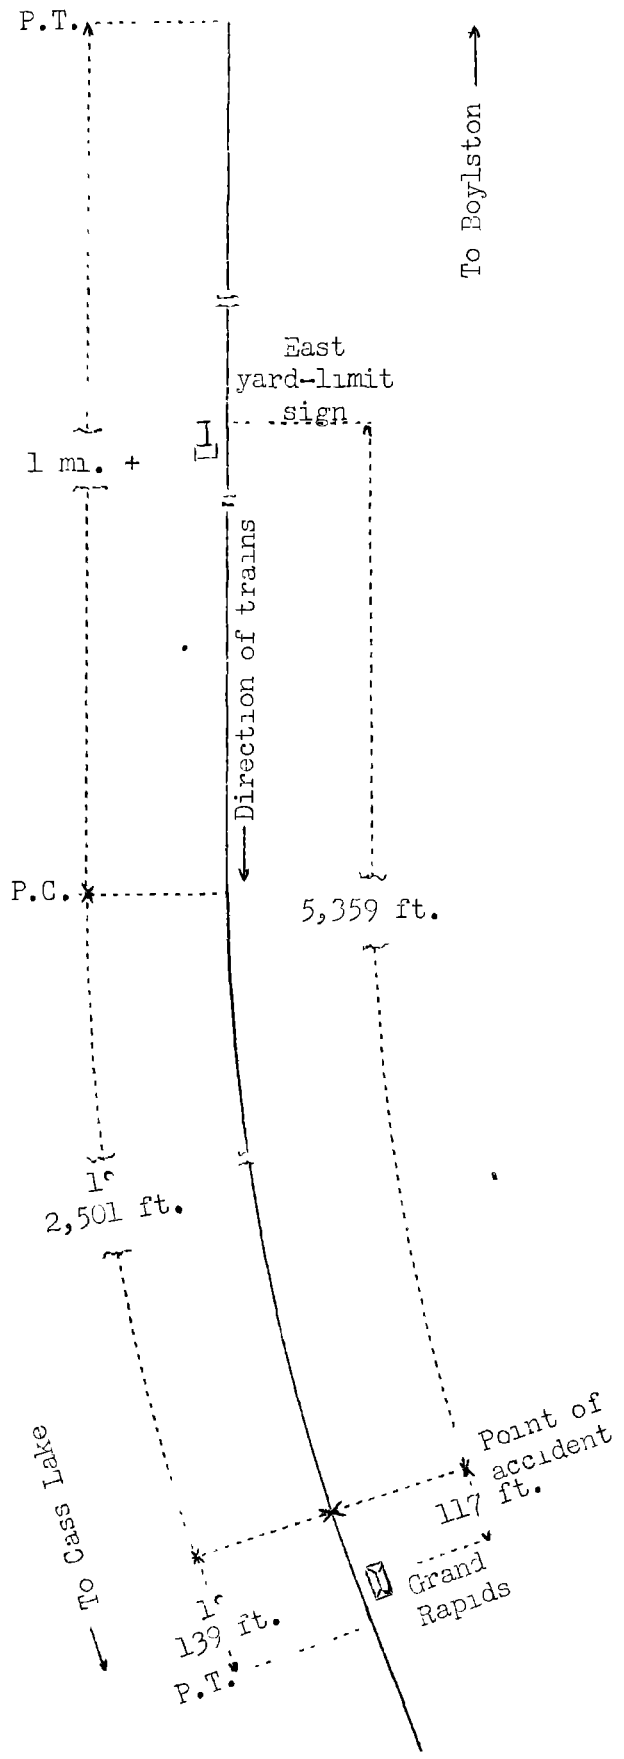
Inv. No. 2722
 Great Northern Railway
 Grand Rapids, Minn.
 August 17, 1933

Location of Accident and Method of Operation

This accident occurred on that part of the Mesabi Division designated as the Third Subdivision and extending between Boylston, Wis., and Cass Lake, Minn., 149.41 miles. In the vicinity of the point of accident this was a single-track line, within yard limits, over which trains were operated by timetable and train orders. There was no block system in use. The accident occurred on the main track at a point 117 feet east of the station at Grand Rapids and 5,359 feet west of the east yard-limit sign. From the east the track was tangent more than 1 mile, then there was a 1° curve to the left 2,501 feet to the point of accident and 139 feet beyond. At the point of accident the grade was practically level.
