## INTERSTATE COMMERCE COMMISSION

REPORT OF THE DIRECTOR OF THE BUREAU OF SAFETY CONCERNING AN  
ACCIDENT ON THE GREAT NORTHERN RAILWAY NEAR MILAN,  
WASH., ON DECEMBER 3, 1933.

February 14, 1934.

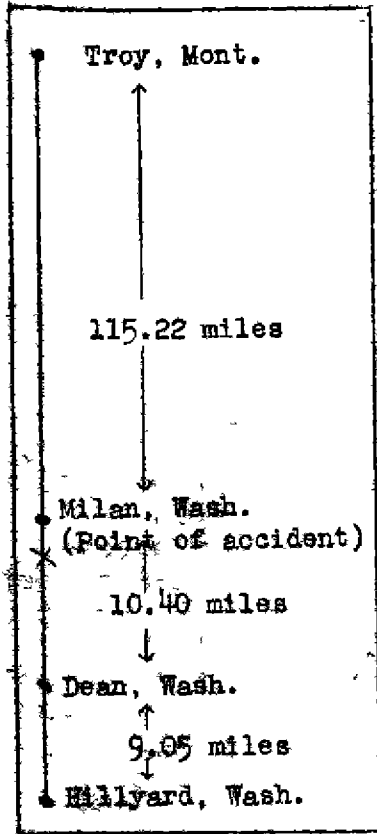
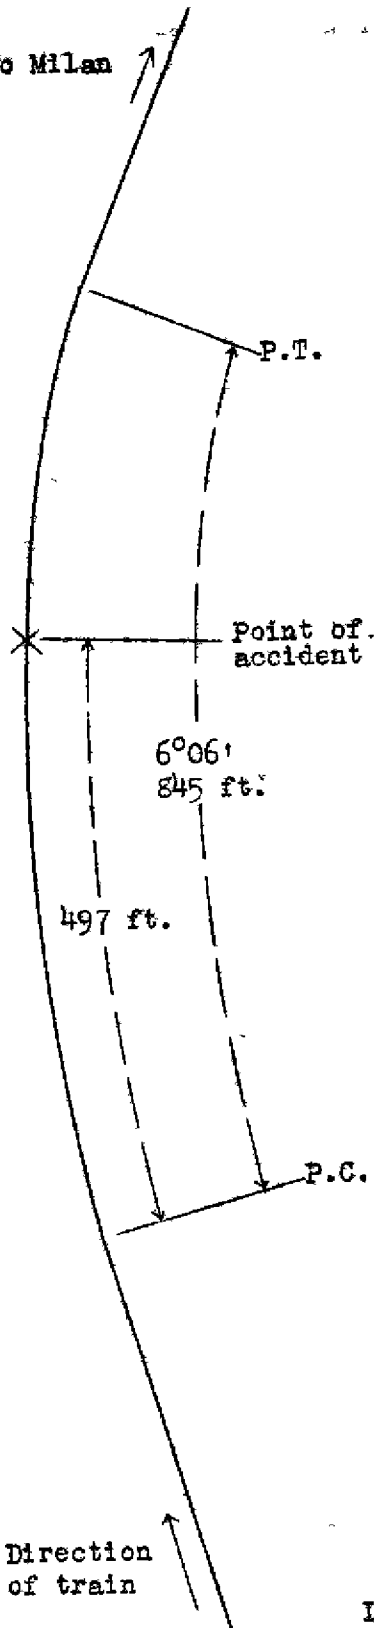
Inv. No. 1872  
 Great Northern Ry.,  
 Milan, Wash.  
 Dec. 3, 1933.

Area of displaced granite

Profile of cut

The slide consisted of about 50 cubic yards of granite which was displaced from the south face of the cut. It became dislodged from a point starting about 11 feet above the track and extending upward to a point about 25 feet above the track. Seepage of surface water into the various faults in the rock formation, with alternate periods of freezing and thawing, undoubtedly resulted in loosening the rock, and possibly coupled with the vibration of passing trains, caused the rock finally to become dislodged. The slide took place less than 20 minutes prior to the accident, as an east-bound helper engine passed through the cut about 9 40 p.m. at which time members of the crew of the helper engine noticed nothing wrong. It appeared probable that the track circuit controlling the automatic block signals was not disturbed as a result of the slide and therefore that the engine crew of the freight train received no warning of danger when passing the last east-bound signal assuming that the slide had come down before that time.

There had been a slide in this cut in the spring of 1932, somewhat smaller than the one here involved, and this previous experience with rock in which there are faults extending in all directions should have led to precautions to guard against a repetition. Such measures were not taken, however, and a second slide has been attended with disastrous consequences. Immediate consideration should be given to the necessity of preventive measures, such as installing a slide-detector fence, widening the cut, or adoption of such other steps as may be desired in order to provide safety at this point in future.
