## INTERSTATE COMMERCE COMMISSION

REPORT OF THE DIRECTOR OF THE BUREAU OF SAFETY CONCERN-  
ING AN ACCIDENT WHICH OCCURRED ON THE GREAT NORTHERN  
RAILWAY NEAR SCENIC, WASH., ON FEBRUARY 15, 1932.

April 27, 1932.

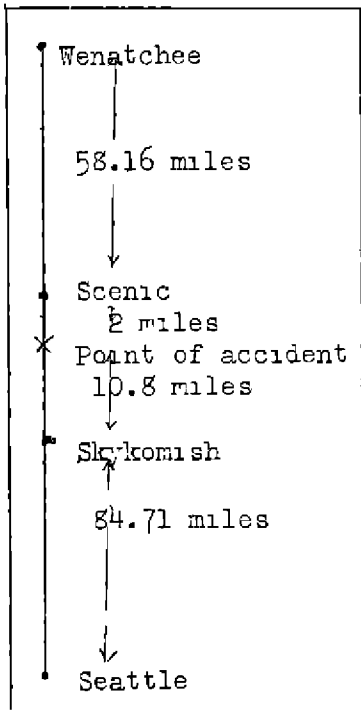
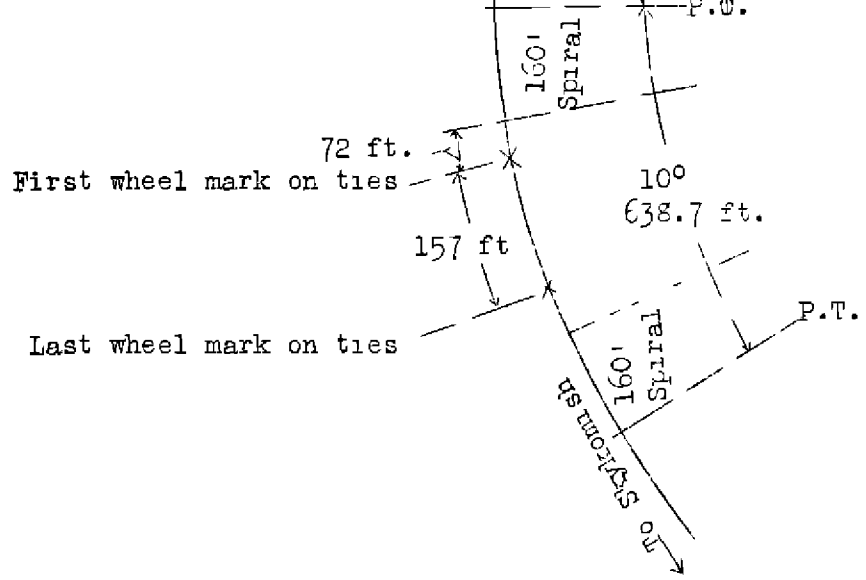
Inv. No. 1752  
Great Northern Ry.,  
Scenic, Wash.  
Feb. 15, 1932

Examination of the track by the Commission's inspectors disclosed that the first wheel mark on the ties was on the gauge side of the north or outside rail of the curve at a point 72 feet west of the east spiral. The indications were that the wheels of the front tender truck were derailed at this point, marking the ties, the spike heads were also marked or broken off for a distance of several feet on the gauge side of the outside rail and this rail was kinked near its leaving end. The ties and spikes were marked on the gauge side of the north rail for a distance of 157 feet west of the first mark on the ties, and then marks appeared on the outside of the north rail. Faint marks were found in the snow in two different places on the outside of the south rail, apparently flange marks, indicating that the south side of the tender was held in suspension until the tender reached the location of a wooden pole, which is on the north side of the track at a point 92 feet west of the first mark and supports the overhead electric catenary wires, the tender struck this pole a glancing blow at a point 10 feet above the ground, indicating that the tender was leaning considerably to the right or north. Apparently the tender then tipped over, at a point 47 feet west of the pole, causing the engine to be pulled off the track from the rear, the last wheel mark on the ties appearing at a point 18 feet beyond where the tender tipped over. In starting its slide down the mountain side, the engine apparently broke off the first catenary pole west of the pole that was struck by the tender, the snow dozer then being pulled from the track by the engine and stopping on the west spiral of the curve, opposite the second catenary pole beyond the one struck by the tender. The rear end of the dozer was 285 feet west of the first wheel mark on the ties, and 128 feet west of the last wheel mark on the ties.

This accident occurred on a curve of 10° on which a superelevation of 3 inches is maintained in accordance with the usual practice of this carrier in this particular territory and it also appeared that the speed for a distance of 10 miles is restricted to 30 miles per hour by a sign located about a quarter of a mile east of the point of accident, and that there is a further restriction of 20 miles per hour for freight trains between Scenic and Skykomish, within which territory this accident occurred. There is no evidence that the speed exceeded 30 miles per hour, and while there is no question but that it did exceed 20 miles per hour, there was evidence to the effect that it was customary and often necessary to operate a snow dozer at a higher rate of speed in order to enable it to perform its work properly. A careful examination of the equipment failed to disclose anything which it was thought could have contributed to the accident, there was a broken arch bar on the forward tender truck and the surface of the fracture indicated the presence of an old flaw, but it was thought that this arch bar broke after the tender had been derailed. The evidence indicated, however, that the tender was the first to be derailed and it is possible that the speed was higher than estimated by the employees involved and that with this type of equipment the superelevation did not provide a sufficient margin of safety for this higher rate of speed.
