INVESTIGATION NO. 2816
THE GREAT NORTHERN RAILWAY COMPANY
REPORT IN RE ACCIDENT
AT TOWNER, N. DAK., ON
AUGUST 15, 1944

Accident at Towner, N. Dak., on August 15, 1944, caused
by a motor-truck being driven upon a street grade
crossing immediately in front of an approaching train.

Inv. No. 2816
 Great Northern Railway
 Towner, N. Dak.
 August 15, 1944

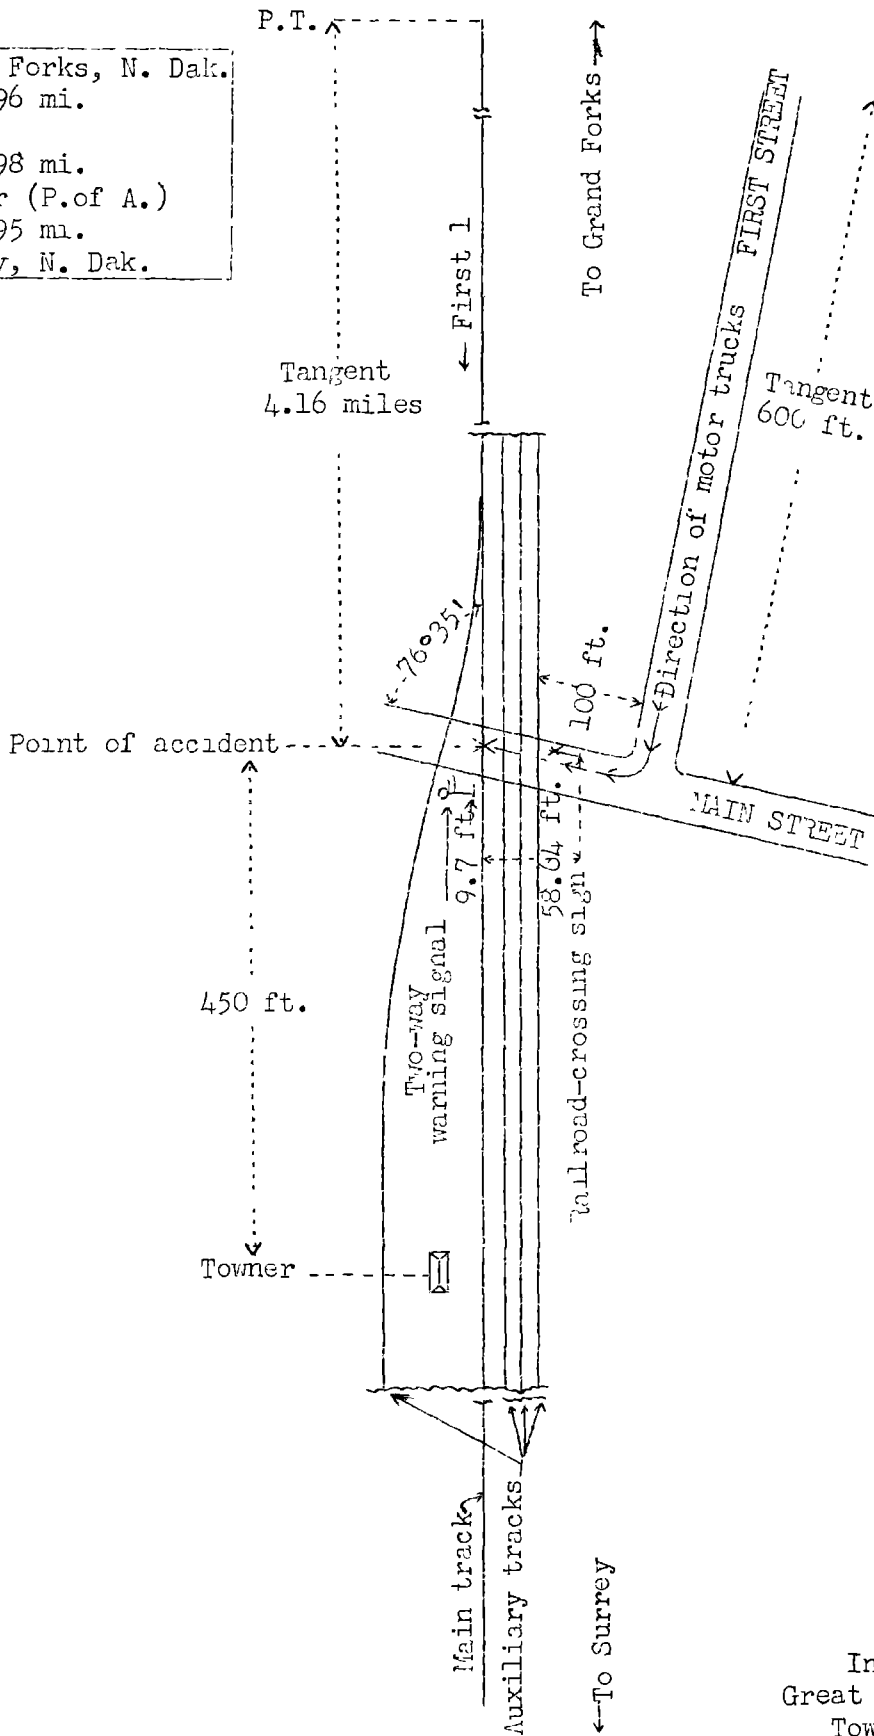
In the vicinity of the point of accident First Street was practically parallel to the railroad on the south, and at a point about 100 feet south of the grade crossing it intersected Main Street, which crossed the railroad at an angle of $76^{\circ}35'$. From the east on First Street and thence northward on Main Street, there were, in succession, a tangent about 600 feet to Main Street, a sharp curve to the right, and a tangent 100 feet to the crossing and some distance beyond. From the intersection to the crossing the grade for north-bound vehicles was slightly ascending. At the crossing there were three auxiliary tracks south and one auxiliary track north of the main track. South of the crossing, Main Street was surfaced with gravel to a width of about 60 feet. The crossing was 32 feet wide, and the distance from the most southerly rail to the most northerly was about 70 feet, and the distance from the most southerly rail to the south rail of the main track was about 40 feet. The area between the rails of each track was surfaced with planks, and there was one 12-inch plank outside each rail. The remainder of the surface of the crossing was surfaced with gravel.

A standard cross-buck railroad-crossing sign was located to the right of the direction of north-bound traffic, 58.64 feet south of the center-line of the main track and 22.5 feet east of the center-line of Main Street. This sign was mounted on a mast and bore the words "RAILROAD CROSSING" in black letters on a white background. An automatic two-way warning signal was located to the left of the direction of north-bound traffic, 9.7 feet north of the center-line of the main track and 41.5 feet west of the center-line of Main Street. On the mast of this signal an electrically-lighted sign 8 inches by 31 inches was mounted 11.5 feet above the level of the street, and bore the word "DANGER" in red letters. A bell 12 inches in diameter was mounted on top of the mast 13.2 feet above the level of the street. The letters of the sign were illuminated and the bell sounded when a west-bound train occupied any portion of the track throughout a distance of 2,500 feet immediately east of the crossing.

Because of buildings adjacent to the track and cars standing on the auxiliary tracks at the time of the accident, a west-bound train approaching on the railroad could not be seen by the driver of a north-bound vehicle until the vehicle was within 24 feet of the south rail of the main track, then an unobstructed view could be had a distance of about 2 miles.
