INTERSTATE COMMERCE COMMISSION

REPORT OF THE DIRECTOR

ACCIDENT ON THE
GREAT NORTHERN RAILWAY

INVESTIGATION NO. 2363

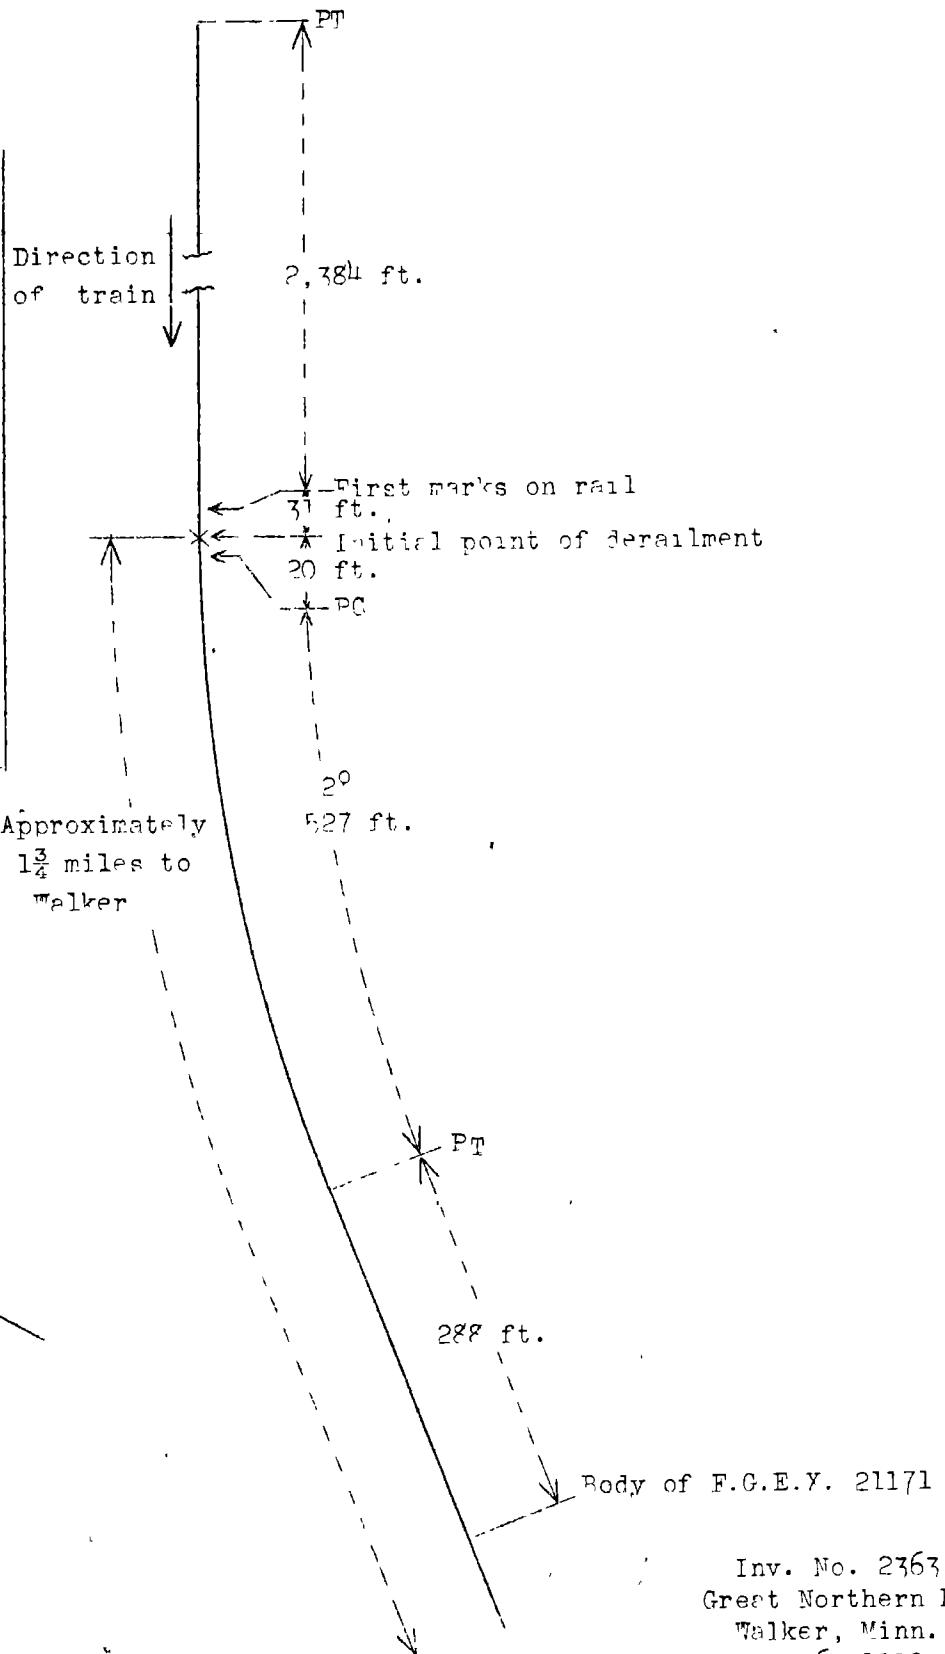
Inv. No. 2363
 Great Northern Ry.
 Walker, Minn.
 June 6, 1939

Car Foreman Fonfara, located at Superior, Wis., stated that on June 9 he examined the lead truck of F.G.E.X. 21171, which was a Bettendorf type of truck with cast-steel bolster. He found that the bolster had been welded on top of the right end at four places between the center-plate and the side-bearing; this bolster had failed at three of these welds. As there was no indication that the bolster had been annealed after having been welded it was his opinion that the welding had not been done properly. He found no marks or stampings on the bolster, as required by the rules when such material is welded, but he thought that this welding had been done recently. He said that the center-plate appeared to be the wrong type for this car as four new rivet holes had been burned in it to match the holes in the bolster. There were eight holes in the center-plate but there were only four rivets. The rivets, which were sheared off, appeared to be new.

Superintendent Kelsey stated that on June 9, he, the car foreman, and the master mechanic inspected the lead truck of F.G.E.X. 21171. He said that several of the welds in the right end of the bolster had given way permitting the bolster to sag, and throwing the weight on the right side-bearing and on the left edge of the center-plate. The side-bearing and the left side of the center-plate showed signs of heavy wear. There was no evidence of any pressure on the left side-bearing. It was his opinion that this pressure caused the truck to bind, resulting in the wheels being thrown out of alignment, and this in turn caused the leading wheel to mount the left rail.

F.G.E.X. 21171 was a refrigerator car, built in April 1903 and rebuilt in October 1924. The truck under the forward or "B" end was a Bettendorf type, A.A.R. type 29, marked "F.G.E. S-155, 30 ton," and was equipped with 4-1/8 by 3-inch journals. The bolster was of cast steel, cast January 1905, and was an L. & N. pattern No. G-5422. The center-plates were marked "S-32." This bolster showed that four fractures located on top of the right end and at the four corners of the hole between the center-plate and the side-bearing had been welded recently. Three of the welds were 3/8 by 3 inches and the other one was 3/8 by 5 inches. Because of the thin layer of metal apparently the welds did not penetrate the body of the bolster. The center-plate was of a design different from the original, and, to apply the new plate, four additional rivet holes had been burned in it to match the holes in the bolster. This work, which appeared to be crude workmanship, had been done recently as the rivets were new and not corroded. This car was in the W.F.E.X. shops at St. Paul, Minn., on March 26, 1939, and according to the shop superintendent's records, in addition to other repairs, truck center-plates were riveted on the "A" and the "B" ends of the car.

The evidence was to the effect that the first car in the train, F.G.E.X. 21171, a refrigerator car loaded with merchandise, was the first car to become derailed. The leading left wheel mounted the ball of the left rail and ran a distance of 10 feet before it dropped off, after which it ran on the ties a distance of 51 feet. The truck then turned sidewise and skidded along the rail and the ties a distance of 510 feet. The condition of the track had no bearing on the accident and the train was not exceeding the authorized speed. An examination of the bolster of the truck under the forward or "B" end disclosed that four fractures located on the top of the right end and at the four corners of the hole between the center-plate and the side-bearing had been welded recently. These welds consisted of only a thin layer of metal which did not penetrate the body of the bolster, and it was evident that the bolster had not been annealed after having been welded. Three of these welds gave way, which permitted the bolster to sag, and threw the weight on the right side-bearing and on the left edge of the center-plate. These parts showed indications of heavy wear, and there was no evidence of any pressure on the left side-bearing. Apparently the fracture caused the truck to bind on the right side-bearing which in turn threw the wheels out of alignment and caused the lead wheel to mount the left rail. An examination of the center-plate on this bolster disclosed that it was of design different from the original application.

This accident was caused by the failure of a truck bolster, because of improper welding.
