REPORT NO. 3611
GREAT NORTHERN RAILWAY COMPANY
IN RE ACCIDENT
NEAR WEST UNION, MINN., ON
FEBRUARY 11, 1955

Accident near West Union, Minn., on February 11, 1955,
caused by broken joint bars and a broken rail.

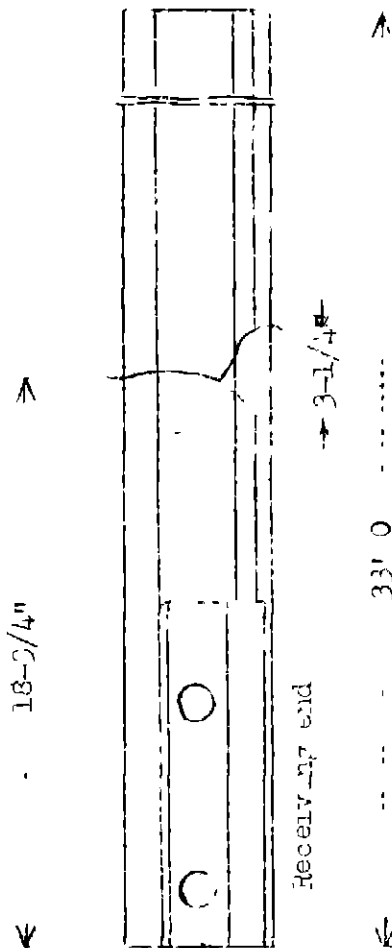
Sketch also in - broken half-north side of track

After the accident occurred both joint bars in a joint in the north rail of the track were found to be broken. Each joint bar was broken between the ends of the rails and at right angles to the base of the rail, and the half sections remained bolted to the ends of the two rails. These joint bars were manufactured by the Lackawanna Steel Company in 1912. Examination of these joint bars disclosed a progressive fracture in the bar on the gage side of the rail which extended downward from a point under the head of the rail and covered approximately 15 percent of the cross-sectional area of the vertical portion of the bar. A progressive fracture in the top of the bar on the field side of the rail covered approximately 3 percent of the cross-sectional area of the vertical portion. The remainder of the breaks appeared to be new. The adjacent ties on each side of the joint were in good condition.

The rail east of the broken joint bars was broken at a point 18-3/4 inches east of the receiving end. The break extended vertically through the head and web to a point near the base. Below this point a triangular section of the web and base 3-1/4 inches in length was broken out. The 18-3/4-inch section of rail had been dislodged from the track, and the remaining portion of this rail had been forced from its normal position. The head of the end of the rail east of the break had been struck near the center, and a 2-inch section of the field side of the head was sheared and broken off. The west end of the head of the rail at the joint was somewhat battered, but there was no batter on the top surface of the head at the broken ends. This rail was manufactured by the Lackawanna Steel Company in 1910 and bore heat number 8519.

It had been in this location in the track since some time prior to the year 1936. According to the report of the chief engineer of the carrier a compound fracture existed in the head approximately 1/2 inch below the top and 5/8 inch from the gage side of the rail at the point of failure. This fracture originated internally from a horizontal split head and covered approximately 2 percent of the cross-sectional area of the head. The chemical composition of the rail was normal.

During the investigation there was some question as to whether the initial failure occurred in the joint bars or in the rail. From the absence of batter on the tops of the broken ends, it appears that the rail was broken as a result of wheels striking the end of the rail after the failure of the joint bars and that the 18-3/4-inch section of rail was dislodged and the derailment occurred immediately after the rail was broken.

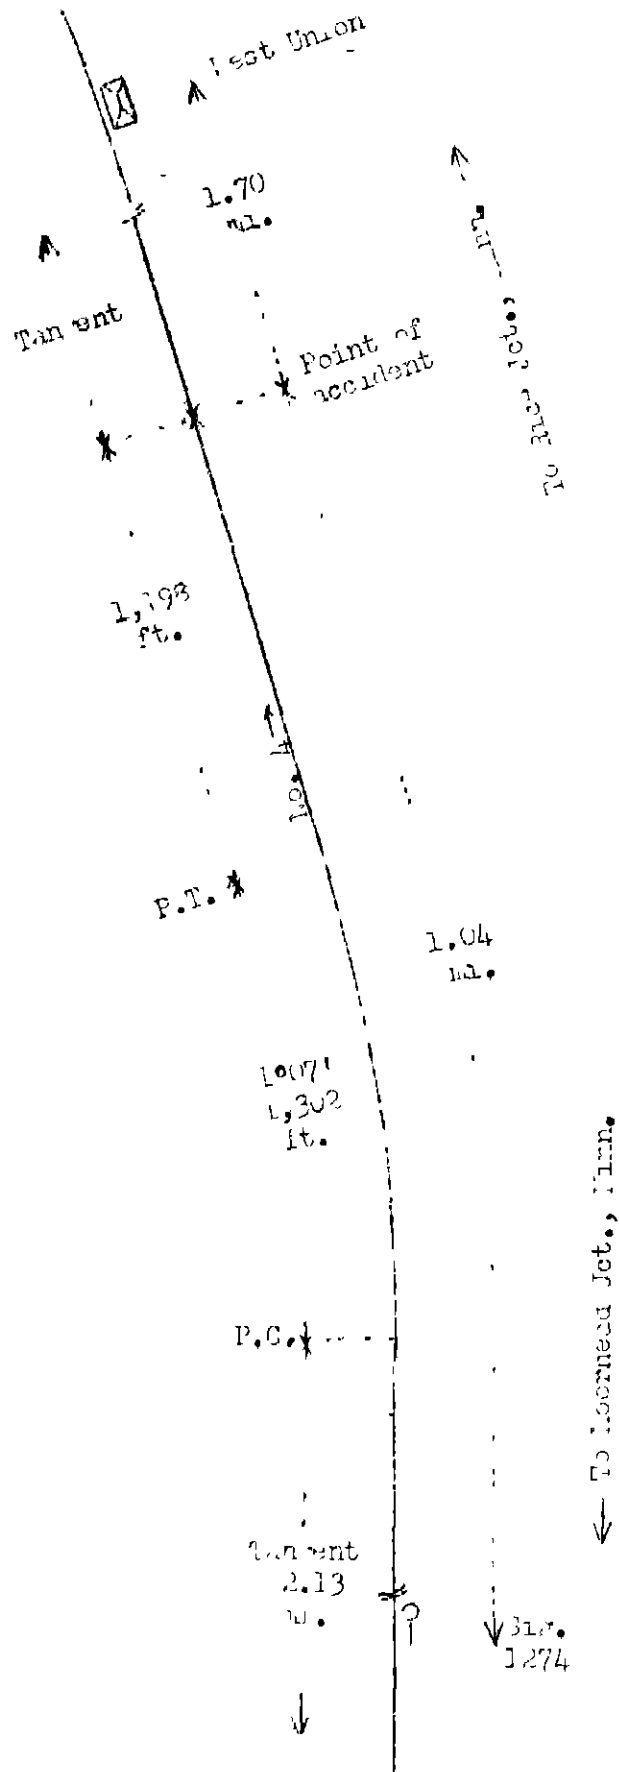
Separations occurred at each end of each of the first seven cars. The Diesel-electric units stopped with the front end of the first unit 1,510 feet east of the point of accident. The second unit stopped approximately in line with the track, and the third unit stopped with the rear end 17 feet north of the track. Each of the first five cars overturned and stopped on its left side. The front end of the first car was 37 feet north of the track, and the rear end was 109 feet north of the track. The rear end of the car was about 50 feet east of the front end and 785 feet east of the point of derailment. The front end of the second car was against the rear end of the first car, and the rear end was 130 feet north of the track. The front end of the third car was near the front end of the first car, and the rear end was 40 feet north of the track. The front end of the fourth car was against the rear end of the third car, and the rear end was 114 feet north of the track. The front end of the fifth car was about 25 feet west of the rear end of the fourth car, and the rear end was 51 feet north of the track. None of the other cars overturned. The sixth car stopped parallel to the track, with the front end near the rear end of the fifth car. The seventh car stopped with the front end about 40 feet east of the rear end of the sixth car and 82 feet north of the track, and the rear end 43 feet north of the track. The other cars stopped approximately in line, with the front end of the eighth car 41 feet north of the track. The rear truck of the twelfth car was not derailed. The first five cars were considerably damaged, and the second and third Diesel-electric units and the sixth to the ninth cars, inclusive, were slightly damaged.
