NATIONAL TRANSPORTATION SAFETY BOARD

REAR-END COLLISION OF TWO
GREATER CLEVELAND
REGIONAL TRANSIT AUTHORITY
RED LINE RAPID TRANSIT TRAINS
NEAR THE 98TH STREET STATION
CLEVELAND, OHIO
JULY 10, 1985

NTSB/RAR-87/01

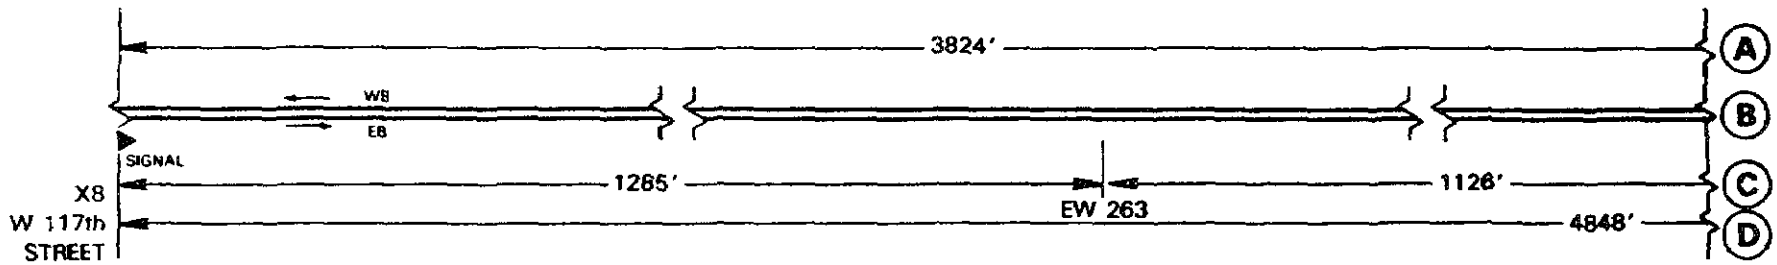
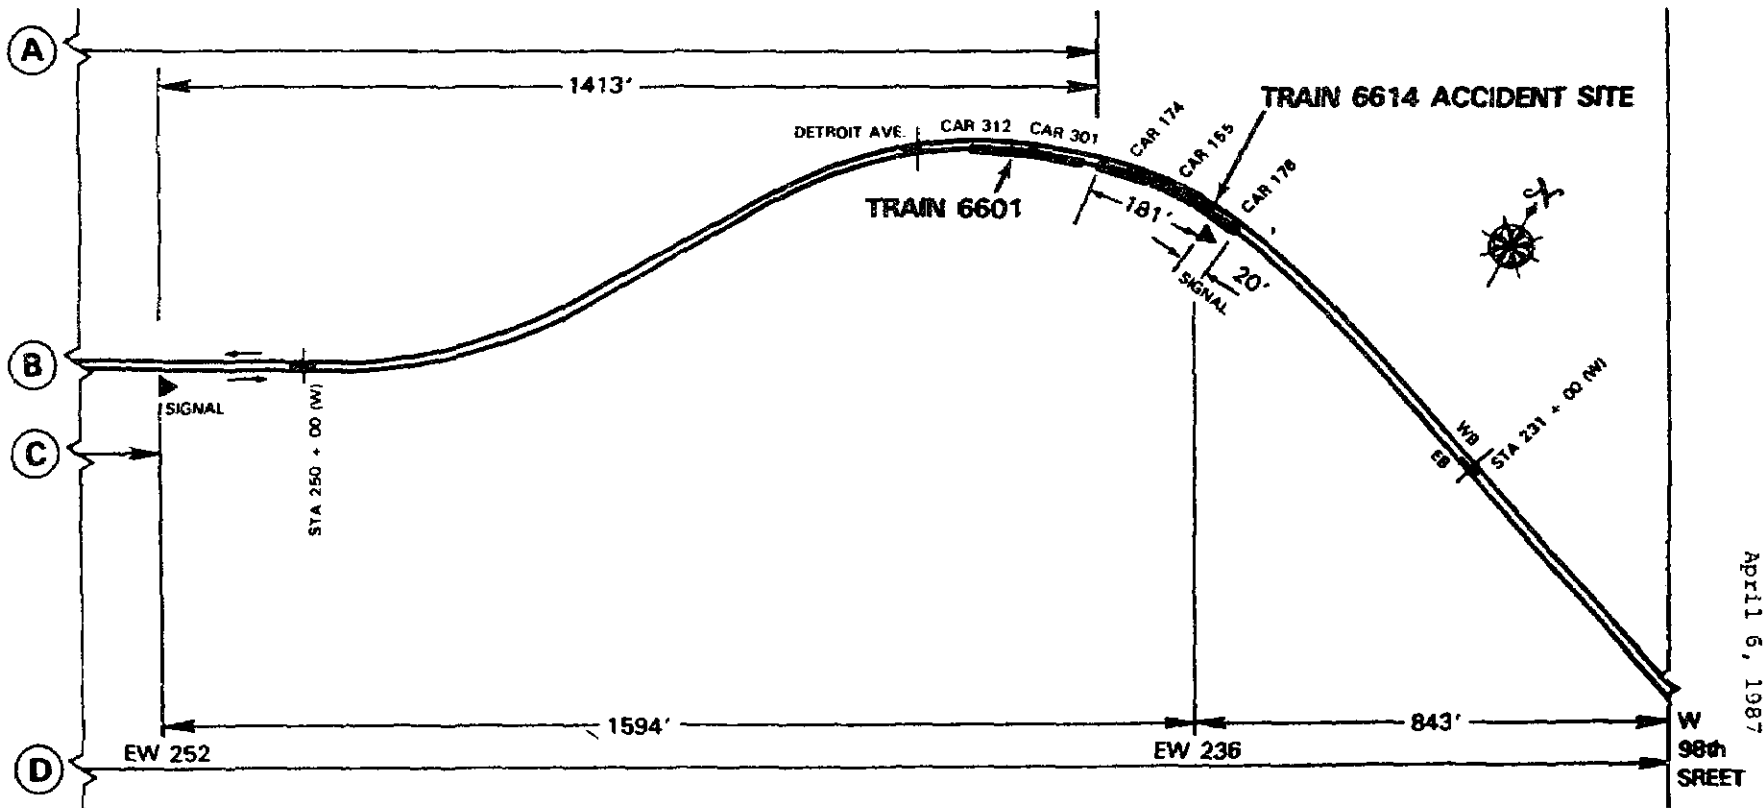
Figure 2.--Track and signal locations from the West 117th Street Station to the West 98th Street Station.

Train No. 6614 left West 117th Street, the first station west of West 98th Street, at about 8:05 a.m. The operator of train No. 6614 stated that before reaching West 98th Street Station, he noticed that the train's braking system air pressure had dropped from the normal 110 psig to 70 psig and he stopped the train to permit the air pressure to restore to the proper level. (When the supply air pressure reduces to the train brake pipe pressure, the train's brakes will automatically apply.) After this occurred, the operator was able to get the train to resume briefly its movement eastward. The air pressure then again reduced, causing the train's brakes to apply and stop the train. When the train stopped, it was standing in a right-hand curve, eastbound, with the rear end at a point about 3,824 feet east of the West 117th Street Station and 1,413 feet east of eastbound intermediate block signal EW 252. (See figure 2.) The

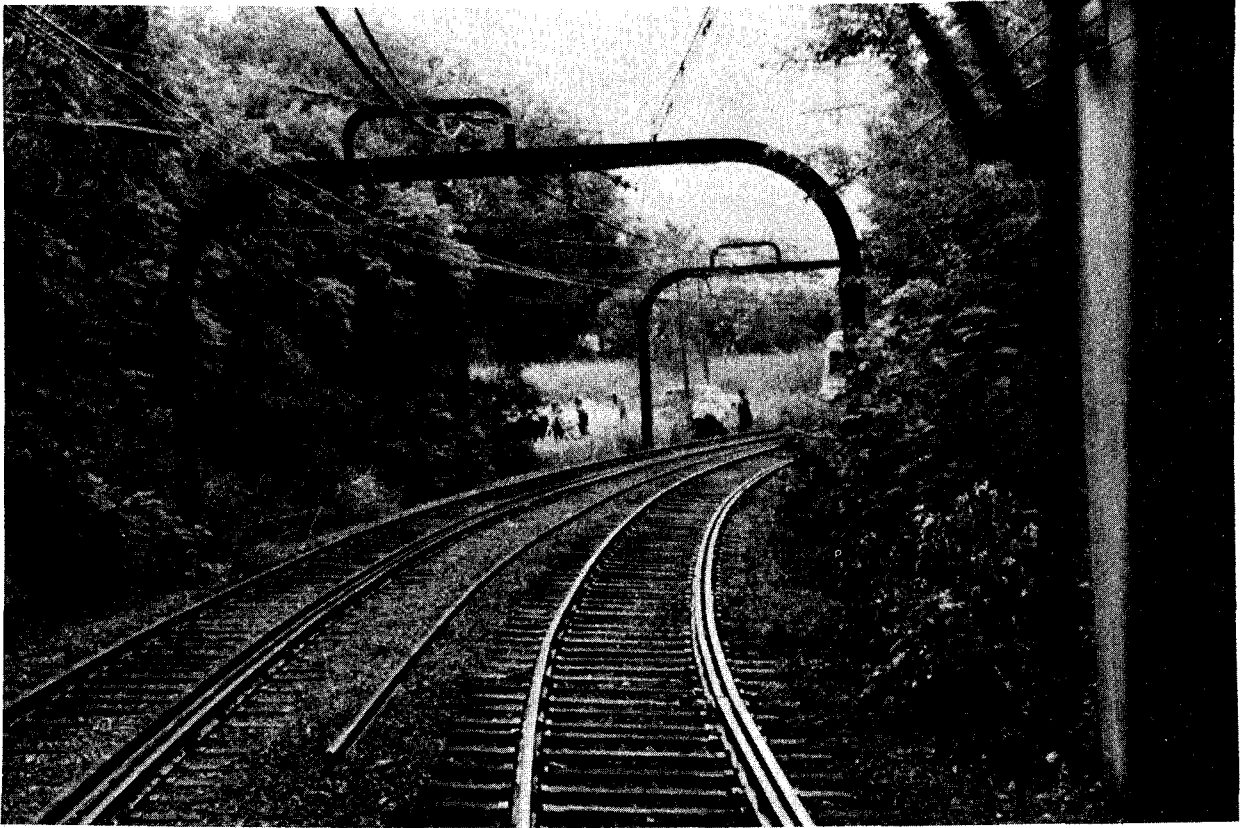
Figure 3.--Train appears at a distance of 266 feet.

Stopping distance tests established that, at a point 266 feet from the impact point, a two-car test train of 300-class cars required 126 feet to stop from 22 mph; at a point 140 feet from the impact point, the two-car test train required 131 feet to stop from 22 mph. Two tests made in the rain indicated that stopping distances were similar to those made when it was not raining.

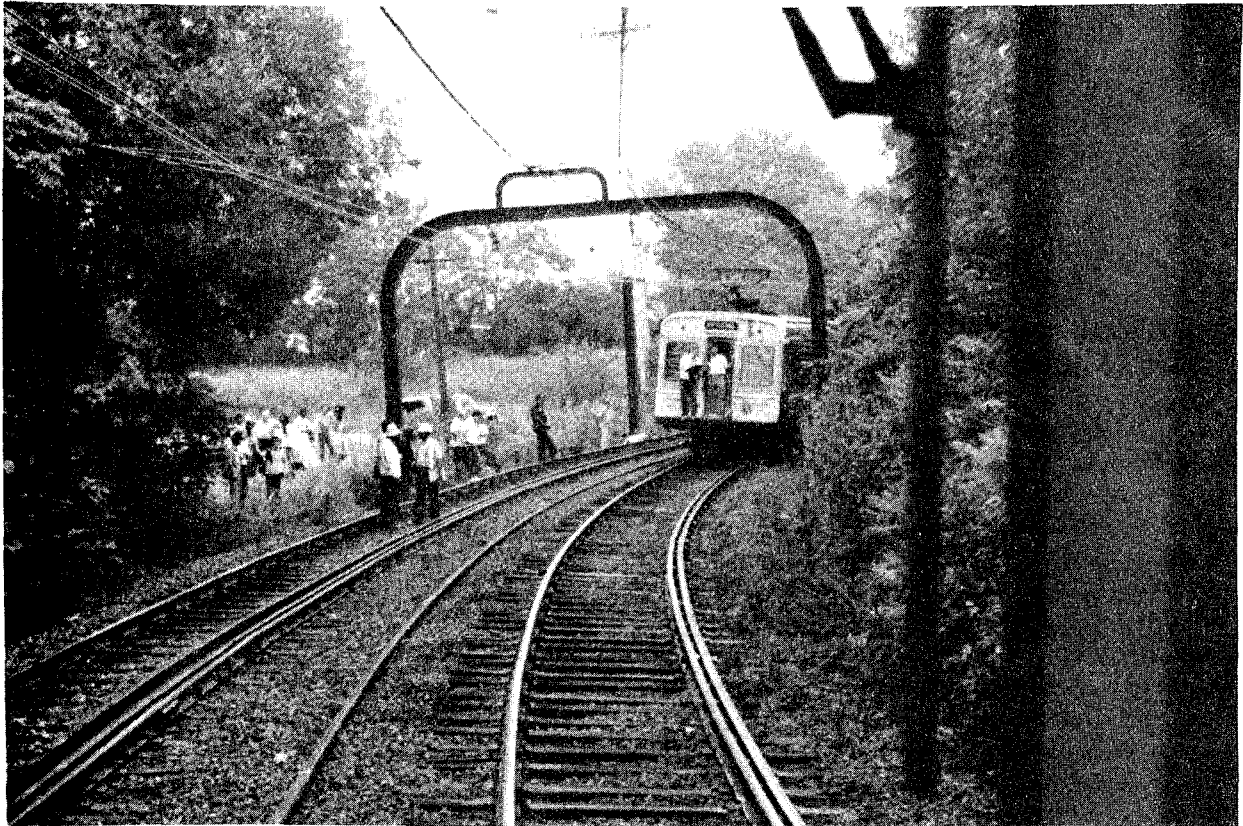
Figure 4.--Train appears at a distance of 140 feet.
