# NATIONAL TRANSPORTATION SAFETY BOARD

## RAILROAD ACCIDENT REPORT

### HEAD-ON COLLISION OF TWO GREATER CLEVELAND REGIONAL TRANSIT AUTHORITY TRAINS

REPORT NUMBER: NTSB-RAR-78-2

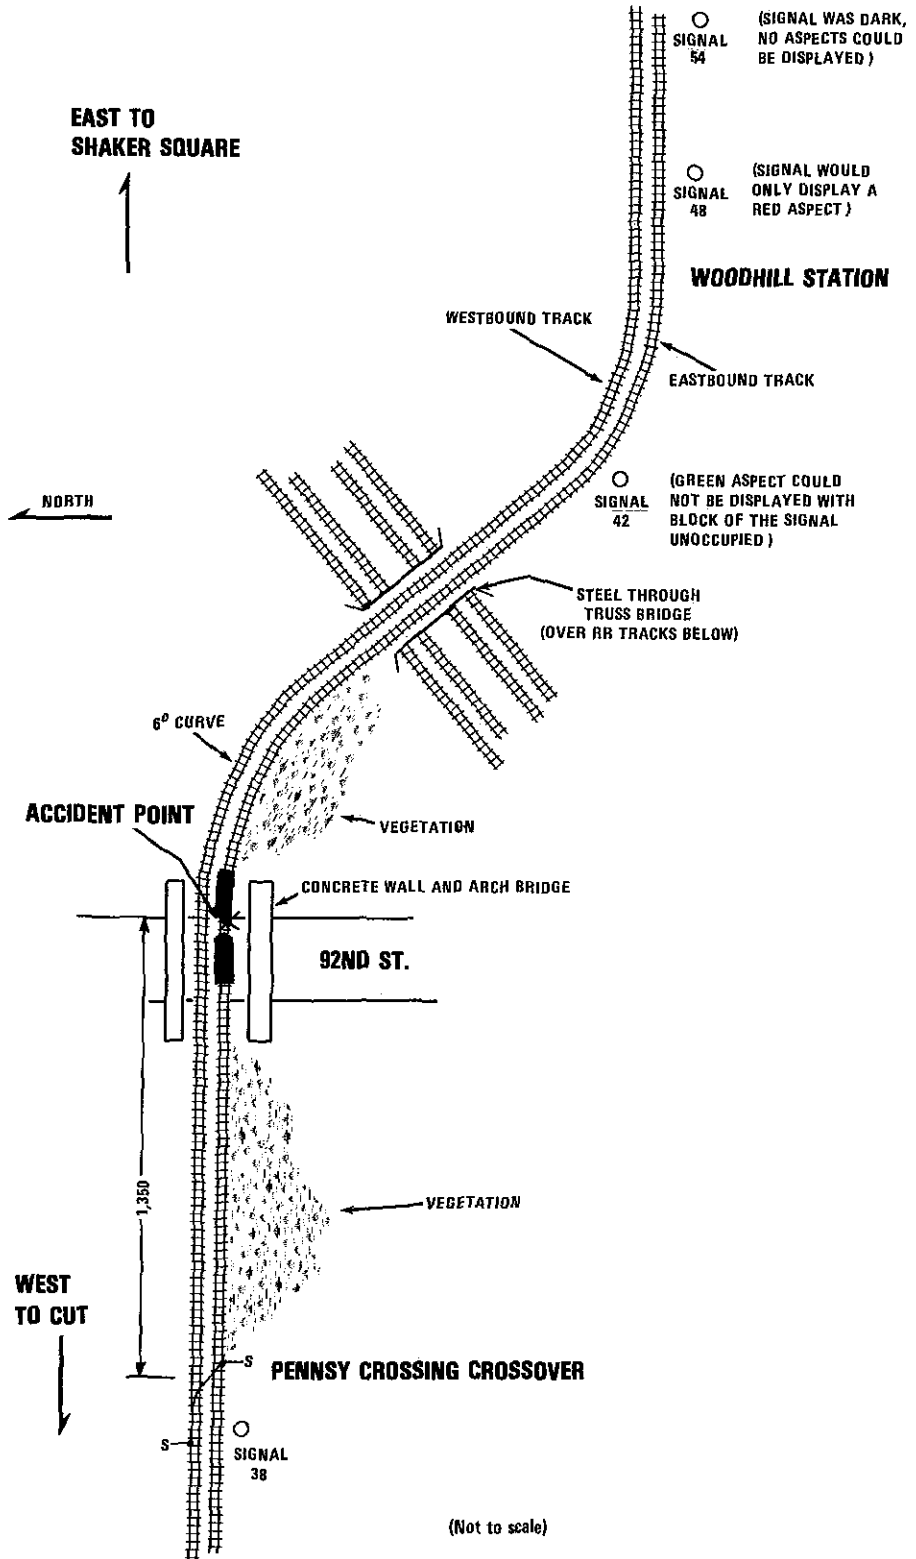
Figure 1. Plan of accident site.

A westbound train leaving Woodhill Station, the first station east of the accident site, ascends a 4 percent grade for about 1 mile. At the summit of the grade the track is laid on a steel through-truss bridge over a railroad. The track then curves 6° to the left. (See figure 1.)

A postaccident inspection and test of the block signal system revealed that more than 150 rail bond wires <sup>2/</sup> were broken on the eastbound track within the limits of the single-track operation. Block signal No. 48 (see figure 1) displayed a red or stop indication regardless of block occupancy, and signal No. 42 displayed a permanent yellow aspect. Block signal No. 54 did not display any aspect; one witness testified that it had been in that condition for about 6 months.

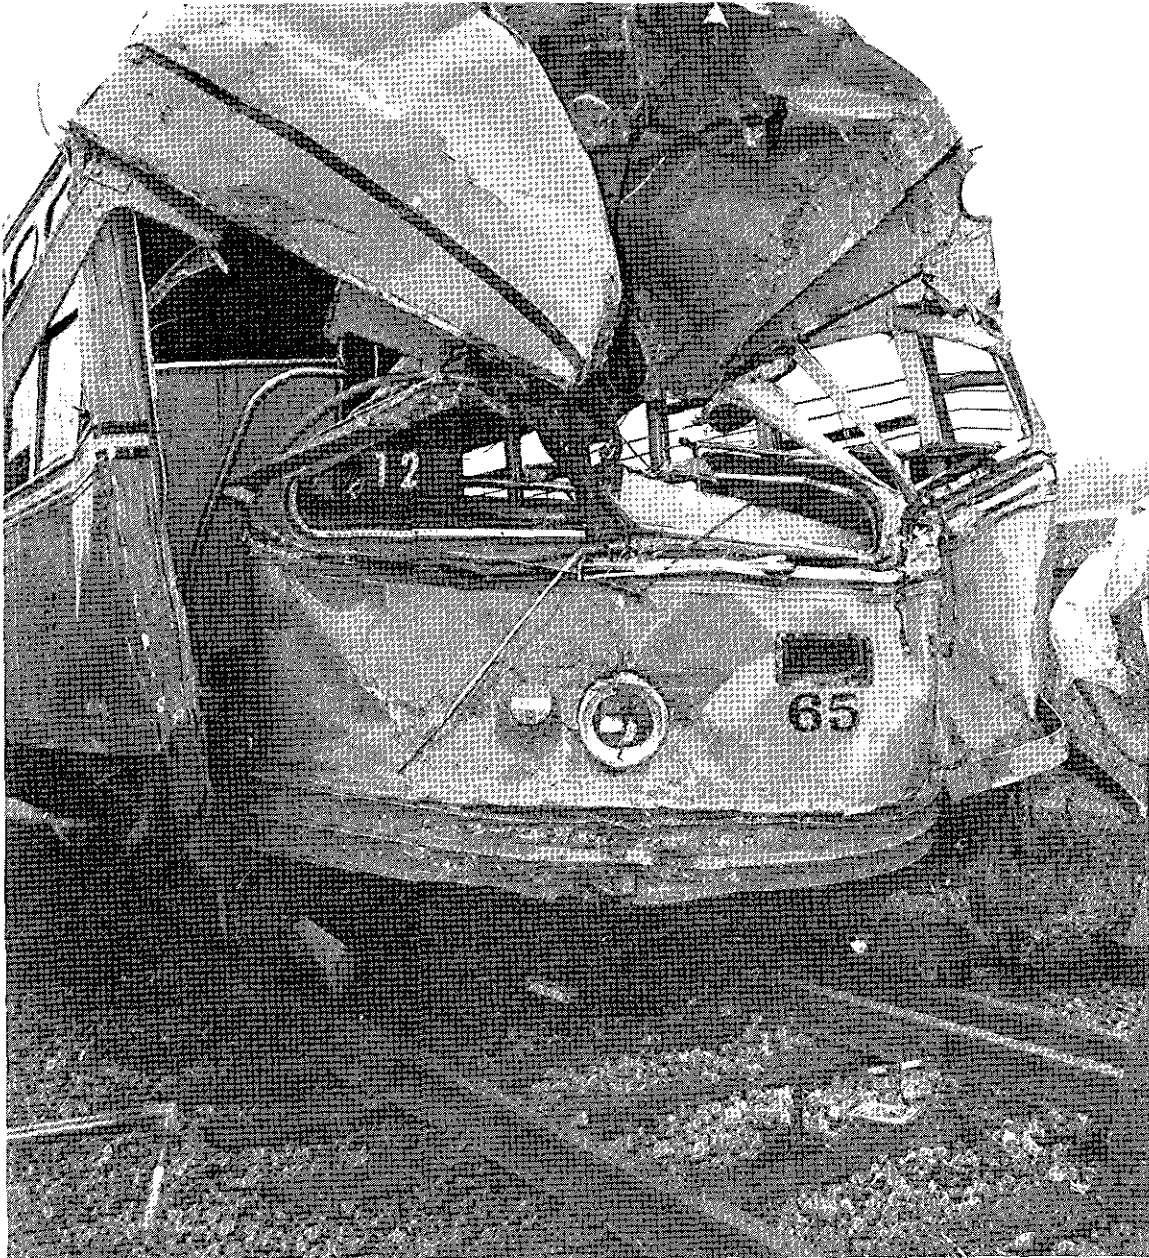
Figure 2. Damaged car No. 65 of Block 12.

The front end of car No. 65 of Block 12 was crushed rearward more than 3 feet. This included the sub-framing, sub-flooring, motorman's platform, formed front of roof and ceiling and side sheets. The front anticlimbers were also damaged. (See figure 2.)

The control compartment was extensively damaged with the dashboard pushed back to the motorman's seat location. The almost total collapse of the entire nose section extended through the front entrance location.

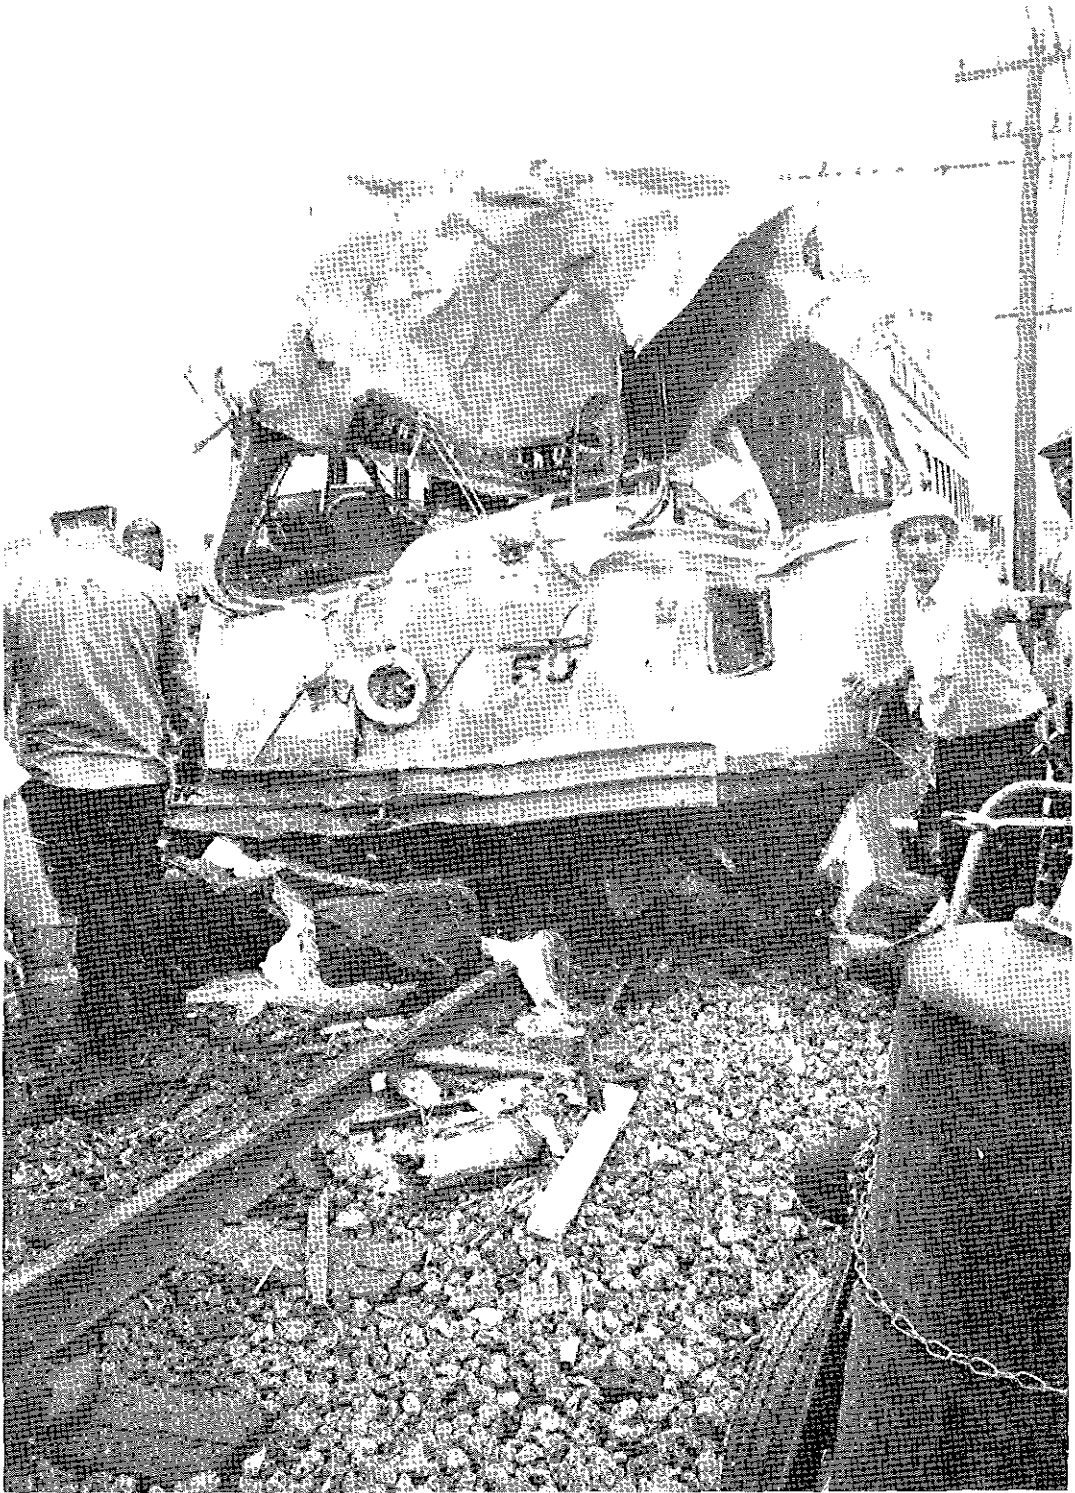
Figure 3. Damaged car No. 59 of Block 4.

Car No. 59 of Block 4 was similarly damaged throughout the front nose section. The sub-framing was crushed rearward equidistant as car No. 65. The sub-floor, motorman's platform, roof, ceiling, sides, and dashboard were all propelled rearward beyond the front entrance. (See figure 3.)

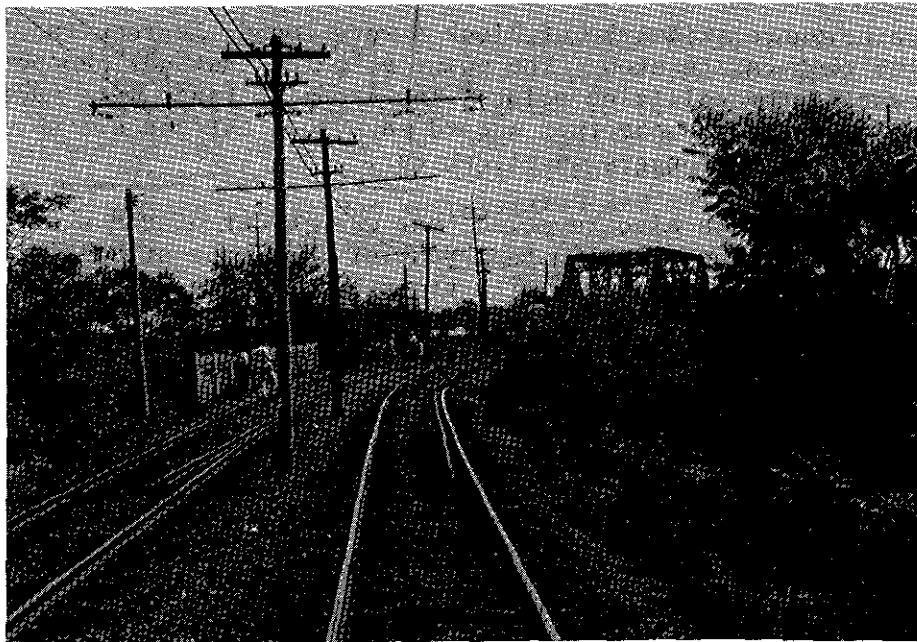
The tests also revealed that when a car of the same type as those in the accident was 160 feet east of the point of collision, it was not visible to the motorman of a train approaching the curve from the west on the eastbound track because of the trackside vegetation. (See figure 4.)

Figure 4. The operator of eastbound Block 4 had this view of the 6° curve approaching the point of collision on the arch bridge (center). There is a transit car 180 feet beyond the collision point, near the truss bridge (background), which is completely hidden by trackside vegetation.

The vegetation along the 6° curve at the accident site was a significant safety hazard even under normal operating conditions. Vegetation should not be allowed to grow to the point where it blocks a motorman's view of a substantial portion of the track ahead. In this case, if the vegetation had not been excessive, the operators could have seen each other's car much earlier and might have stopped before colliding.

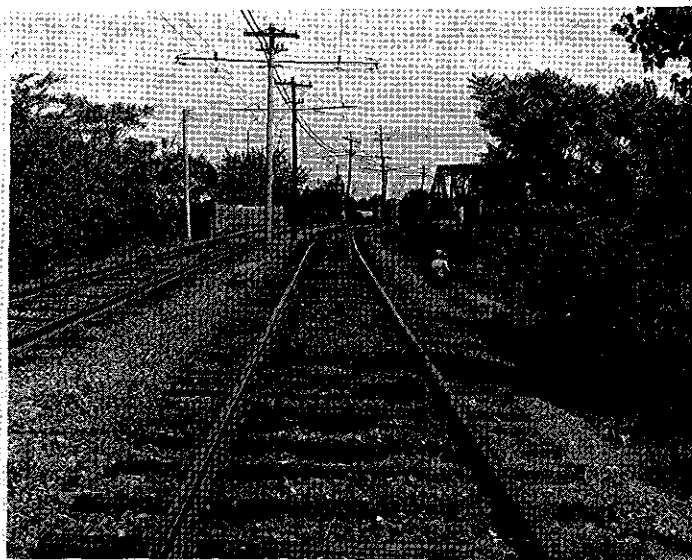
Visibility checks conducted after the vegetation had been removed from the inside of the curve provided sight distances far in excess of the required stopping distances. (See figure 5.)

Figure 5. View of curve after vegetation was removed.
