# RAILROAD ACCIDENT REPORT

Collision of the State-of-the-Art  
Transit Cars with a Standing Car,  
High Speed Ground Test Center  
Pueblo, Colorado  
August 11, 1973

NATIONAL TRANSPORTATION SAFETY BOARD  
Washington, D.C. 20591  
REPORT NUMBER: NTSB-RAR-74-2

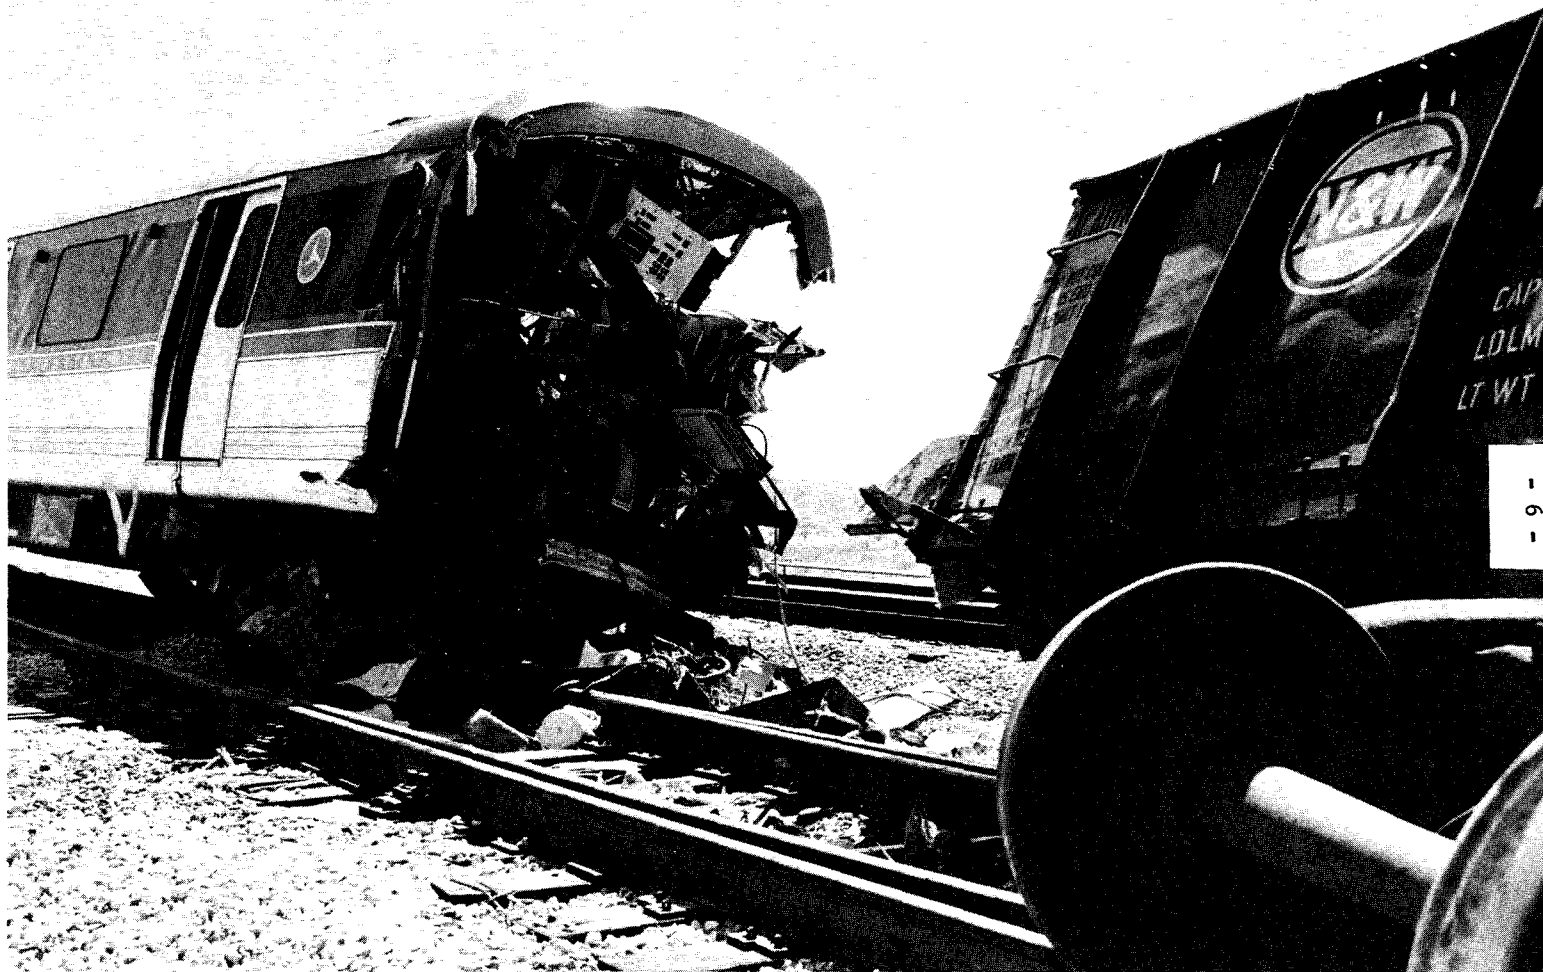
Figure 2. Demolished operating compartment and the east side of the SOAC car. Derailed gondola car is at the right.

The SOAC's. The operating compartment of the lead car was demolished and the passenger compartment was heavily damaged back to the first side door. The side sills and draft sill of the underframe were twisted under the car. The fiberglass car end was shattered into many pieces. The windshield was dislodged and shattered but remained intact in two pieces. Both forward corner posts were torn from the side sills and bent aft from the top. The trailing door posts of both forward side doors were slightly bent. Minor buckles in the side skin were present behind the forward side doors. The car roof also was buckled moderately to the rear of the forward side doors.

As in other rail car collisions investigated by the Safety Board <sup>2/</sup> the major structural damage in this accident occurred when one vehicle overrode and penetrated the other vehicle. When the dissimilar cars came together, the makeshift anti-climber on the gondola failed and the gondola overrode the SOAC. The override and penetration destroyed the operating compartment of the SOAC and crushed the motorman.

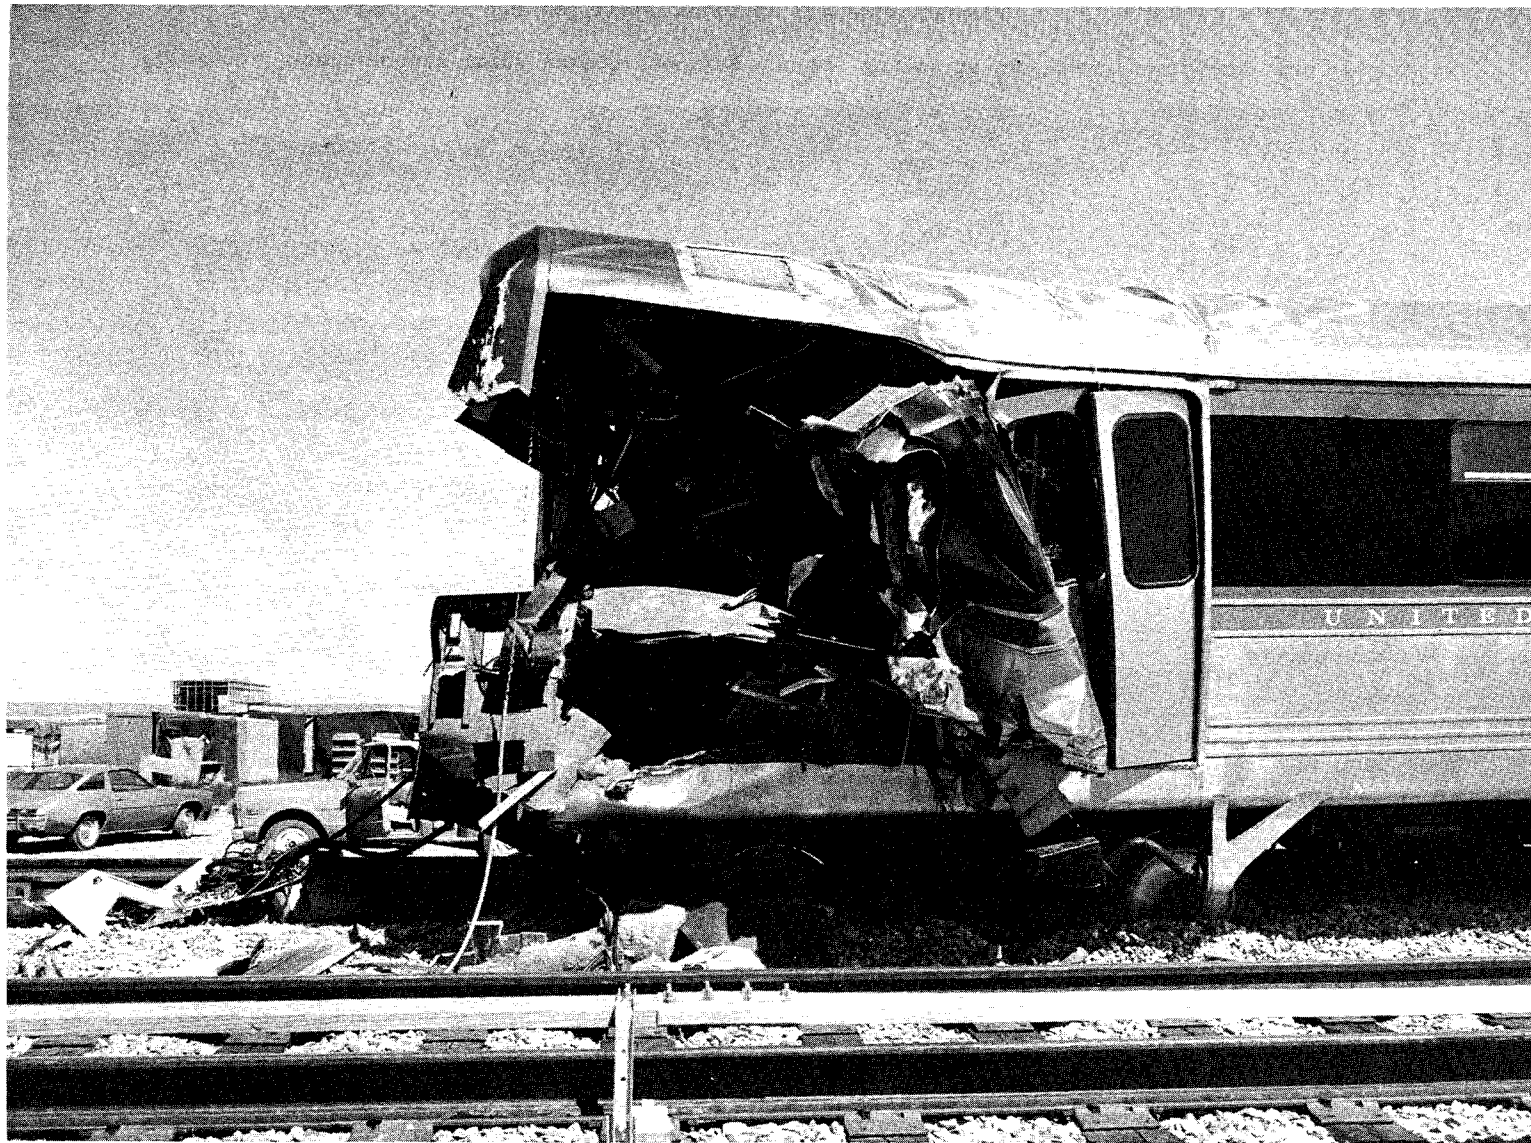
Figure 3. Damage to the west side of the SOAC .

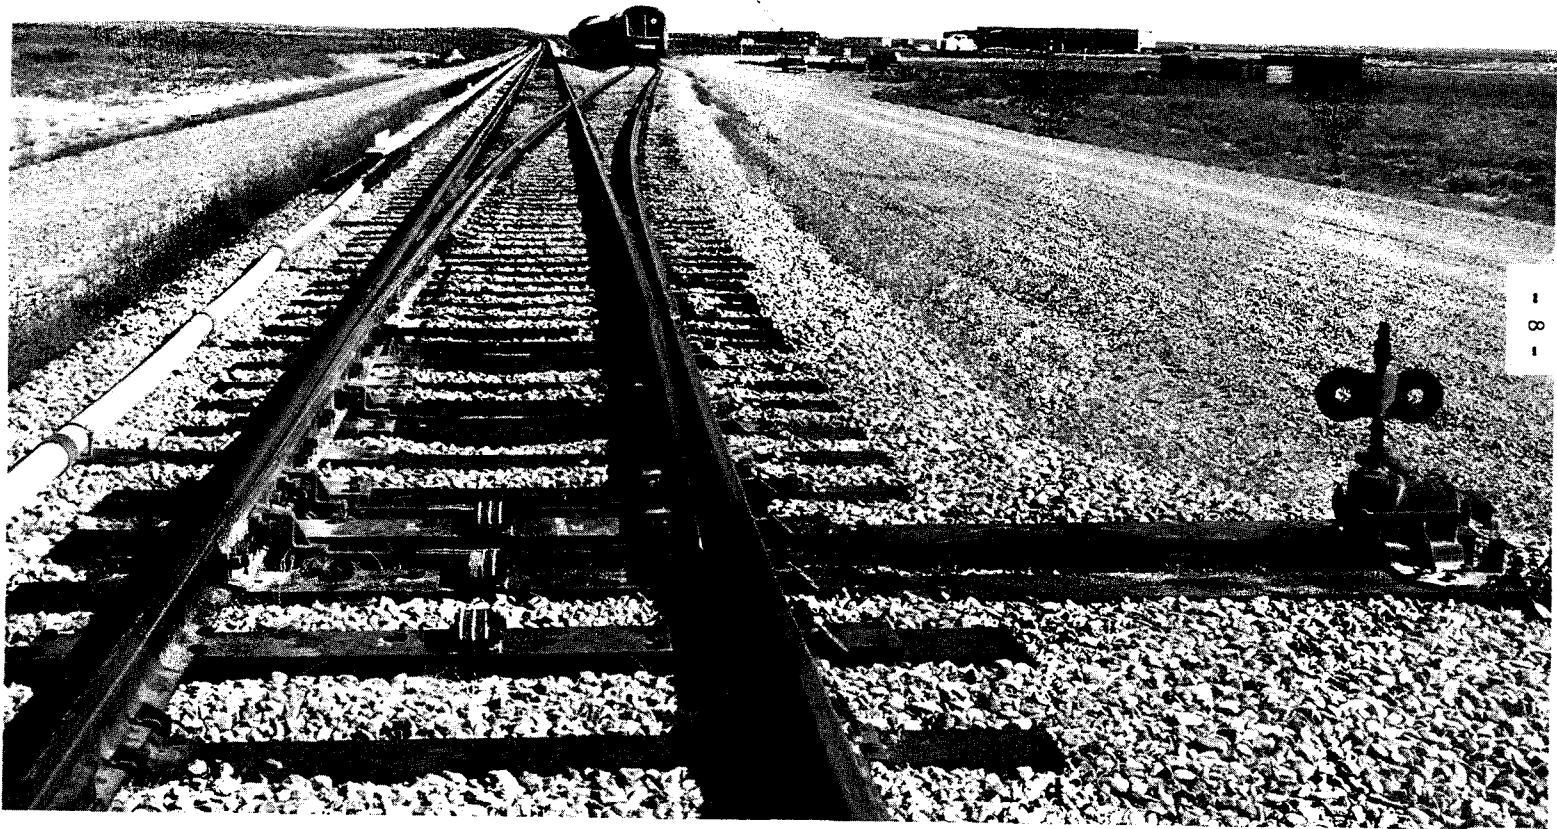
Figure 4. North access track switch, looking north. Switch is in "open" position. The SOAC's are visible at the collision point in the background.

The north access track switch was found in an open position so that traffic was directed onto the north access track from the transit test track. The switch stand handle was in a position opposite to that of the chain and padlock. The padlock was lying on the top of a headblock tie and was open. The switch stand target displayed a red aspect for traffic operating on the transit test track. The switch points were in good condition and they fitted snugly against the stock rail when they were moved to either position. There were no unusual marks on the switch points or stock rails.

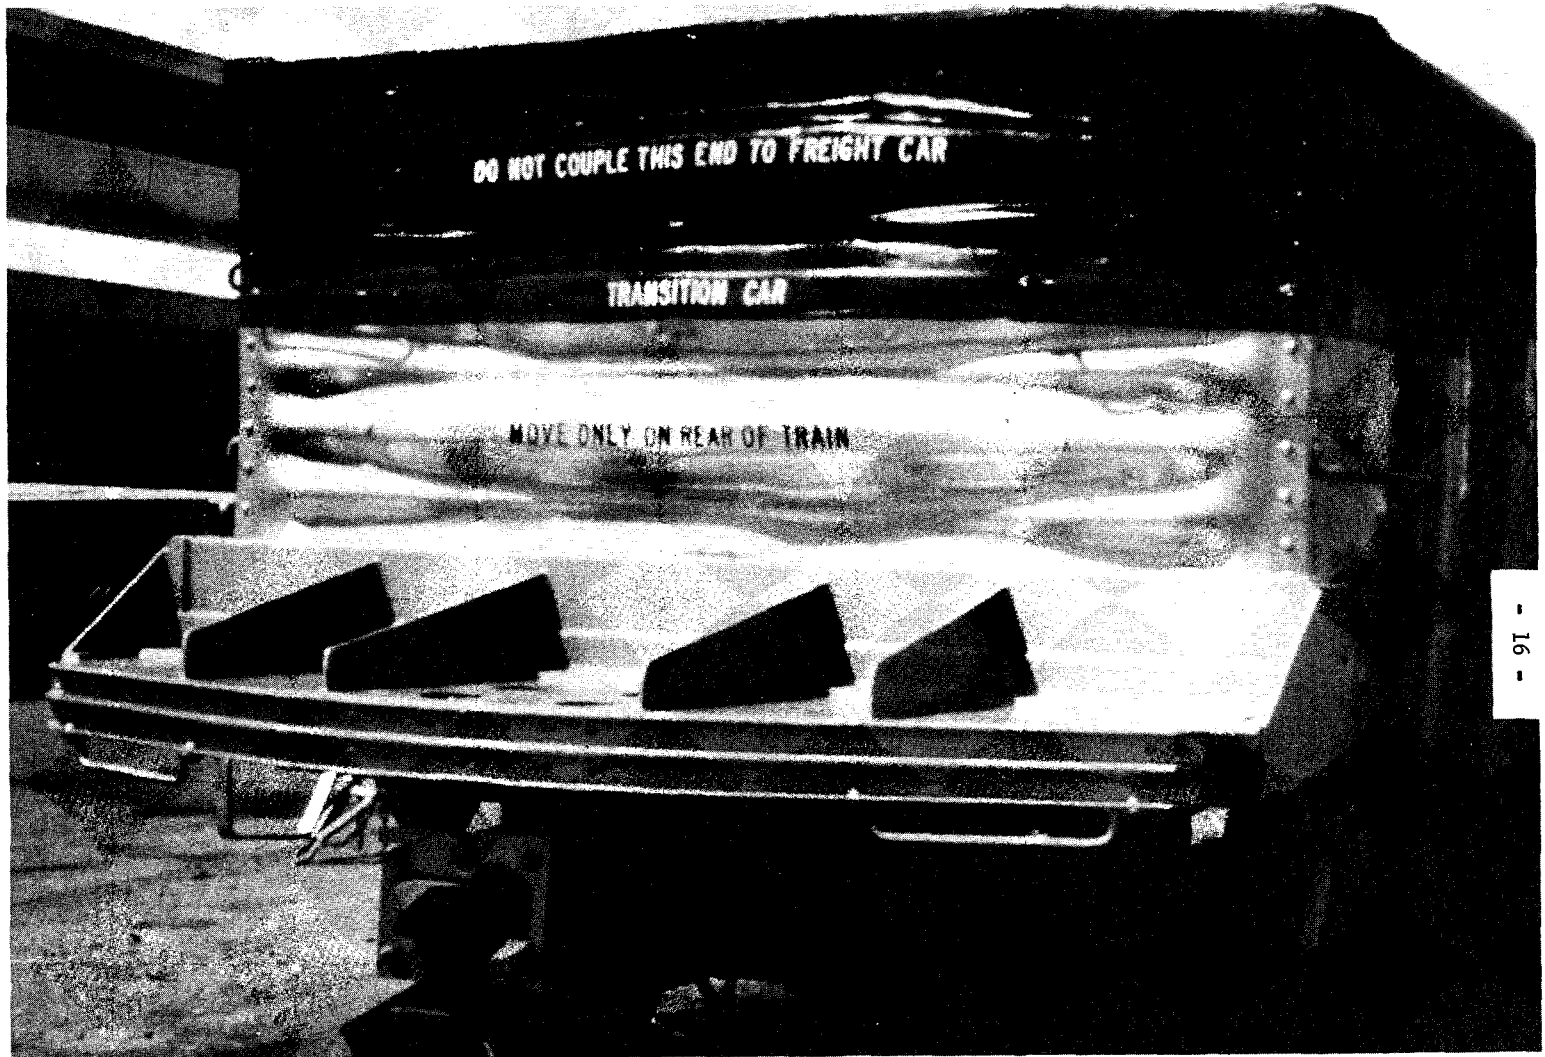
Figure 6. A gondola car modified to allow coupling with the SOAC's.

Other vehicles. Damage to the gondola generally was limited to the anti-climber assembly, the coupler, and the end of the car that was impacted. The locomotive was essentially undamaged. All brakes on the locomotive were found released, and the knuckle of the south coupler was in the closed position.

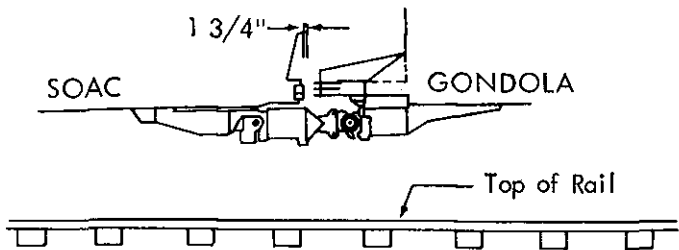
1

Couplers Engage. Load in Couplers.

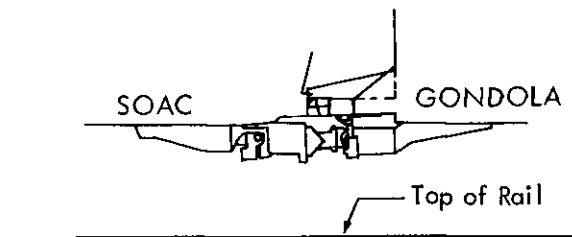
2

Coupler Emergency Release Shears, Couplers Foreshorten Total 7.50 in. Under a Buff Load in Excess of 225,000 lb. Anticlimbers Engage, Load Shared With Anticlimbers.

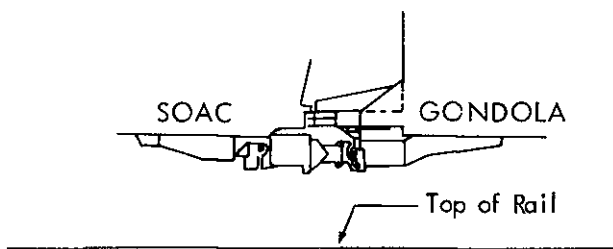
3

Anticlimber on Gondola Peels Downward off the Gussets. Load Transfers Back to the Couplers.

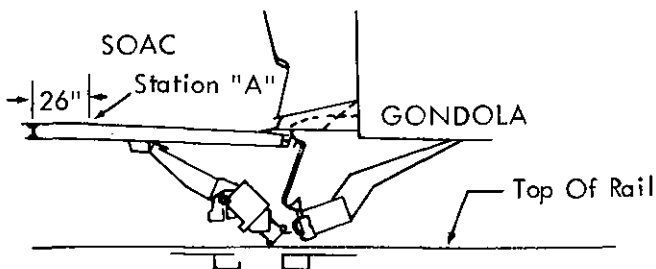
Any event in a crash which results in the vertical misalignment of end frames shown in Diagram 4 of Appendix F could deflect the couplers downward, because downward movement of the couplers is not restrained by any major structural element near the outboard end of the coupler shank. Factors which could permit such downward movement include design misalignment of the anti-climbers on two cars, failure of the anti-climbers to engage or loss of engagement because of derailling of one car, or lateral movement of frames, which might be induced by the convex plan-profile of the anti-climbers. The downward deflection of coupler shanks produced the akimbo misalignment of couplers which destroyed the potential of the engaged (but partially broken) coupler parts to hold a compressive load. In addition, the potential anti-climbing action of the engaged couplers, if structurally supported against downward deflection, was lost.

Down Load in Gondola Coupler Pulls Down the Coupler Carrier and the Plate it is Mounted to, Pulling the Anticlimber Face of the Gondola Further Down, This Permits the Gondola to Override the SOAC Anticlimber.

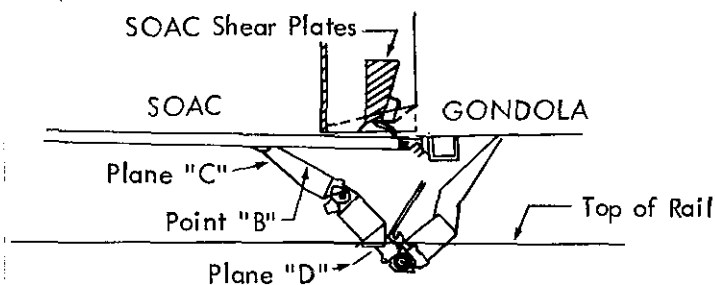
- 5 Anticlimber Gussets Puncture Top Plate of the SOAC End Weldment. End of the Gondola Impacts Top of Center Sill, This Causes Contact Between SOAC Coupler Shank and Anchor Casting at Point "B" Resulting in Shear Failure of the Shank at Plane "C". The SOAC End Weldments (Between Side and Center Sills) Were Torn Off by the Outer Gussets, Penetrate Past Shear Plates and Corner Angles, Into Motorman's Area. SOAC Anticlimber Drives Gondola Anticlimber Into Coupler Attachment Area Forcing Coupler Downward. Step at Side of Gondola Rides Upon SOAC Side Sill.

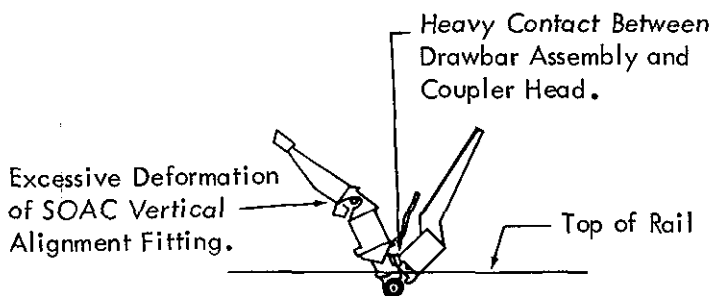
- 6 In the Same Sequence Extreme End Load and Misalignment Causes Rotation of Coupler Heads Resulting in the Damage Observed.

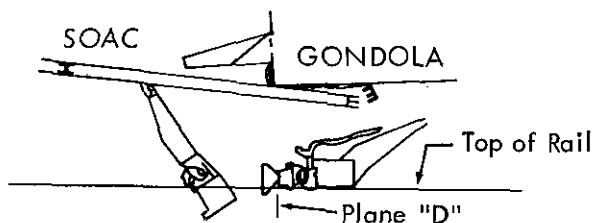
- 7 The Couplers Hit Rail and Disengage. Both Couplers Are Sheared Off and the Rear of the SOAC Coupler is Jammed Into the Right Side of the Draft Sill.
