INVESTIGATION NO. 3141
GULF, COLORADO AND SANTA FE RAILWAY COMPANY
REPORT IN RE ACCIDENT
AT BROWNWOOD, TEX., ON
NOVEMBER 8, 1947

INVESTIGATION NO. 3141

GULF, COLORADO AND SANTA FE RAILWAY COMPANY

January 20, 1948

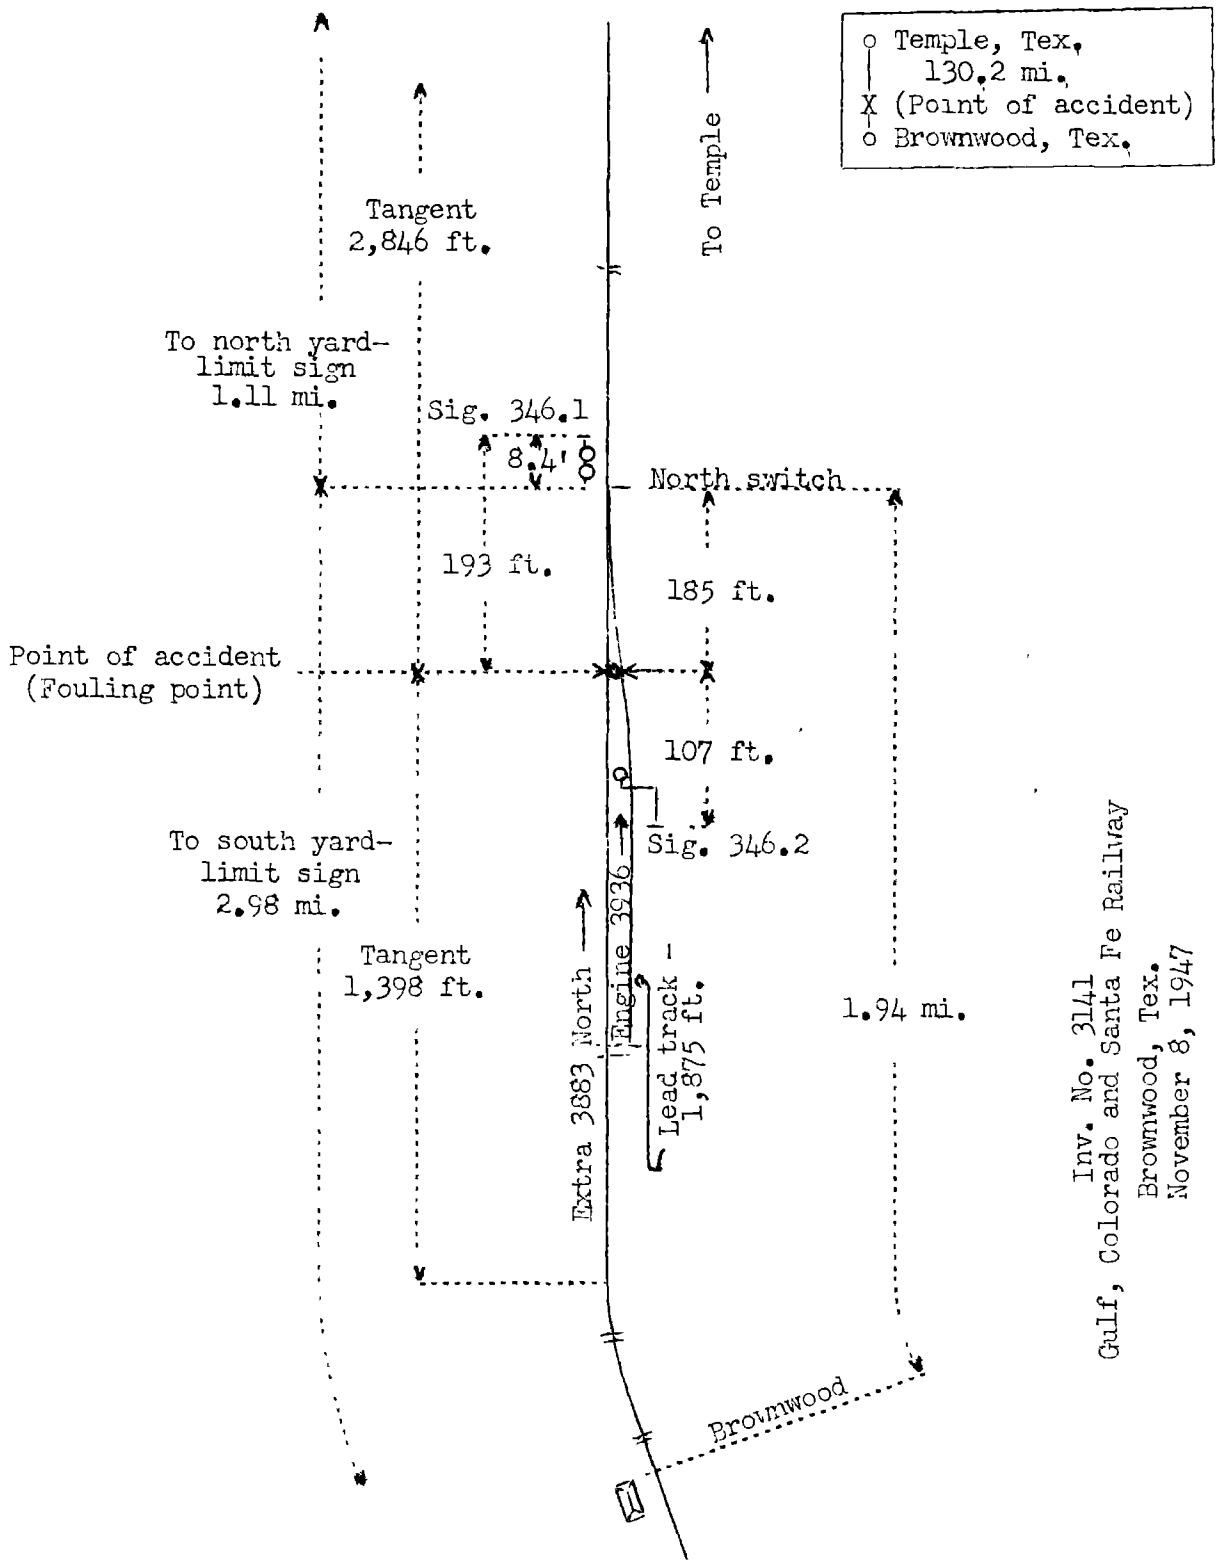
Inv. No. 3141
Gulf, Colorado and Santa Fe Railway
Brownwood, Tex.
November 8, 1947

This accident occurred on that part of the Southern Division extending between Brownwood and Temple, Tex., 130.2 miles, a single-track line in the vicinity of the point of accident, over which trains are operated by timetable, train orders and an automatic block-signal system. Within yard limits at Brownwood, the tracks of a freight classification yard parallel the main track on the east. The north switch of a lead track 1,875 feet in length, which connects the main track and the tracks of the classification yard, is 2.98 miles north of the south yard-limit sign, 1.94 miles north of the station and 1.11 miles south of the north yard-limit sign. The accident occurred at the fouling point of the main track and the turnout of the north lead-track switch, at a point 185 feet south of the switch. The main track is tangent throughout a distance of 1,398 feet immediately south of the point of accident and 2,846 feet northward. The grade is 0.0143 percent descending northward.

Automatic signal 346.2, governing north-bound movements, and automatic signal 346.1, governing south-bound movements, are, respectively, 107 feet south and 193 feet north of the point of accident. These signals are of the color-light type and are continuously lighted. The involved aspects and corresponding indications and names are as follows:
