RAILROAD ACCIDENT INVESTIGATION

REPORT NO. 4111

GULF, MOBILE AND OHIO RAILROAD

FEBRUARY 27, 1967

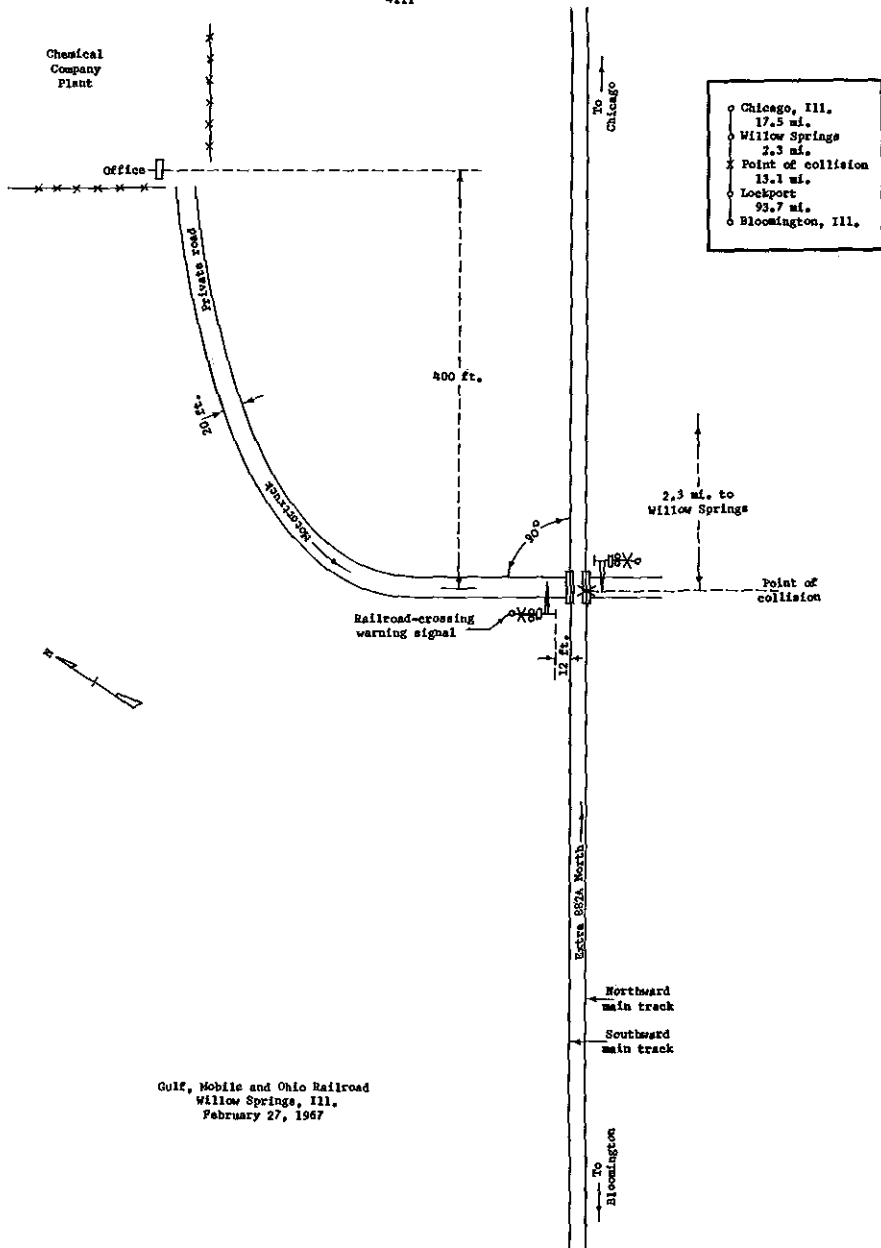
Gulf, Mobile and Ohio Railroad
 Willow Springs, Ill.
 February 27, 1967

The plant of a chemical company is located in the northwest angle of the crossing, as indicated in the sketch appended to this report. The office of the plant is 405 feet west and 400 feet north of the crossing. The private road involved extends from the chemical company plant.
