RAILROAD ACCIDENT INVESTIGATION

Report No 3783

HUDSON & MANHATTAN RAILROAD COMPANY

SEPTEMBER 16, 1957

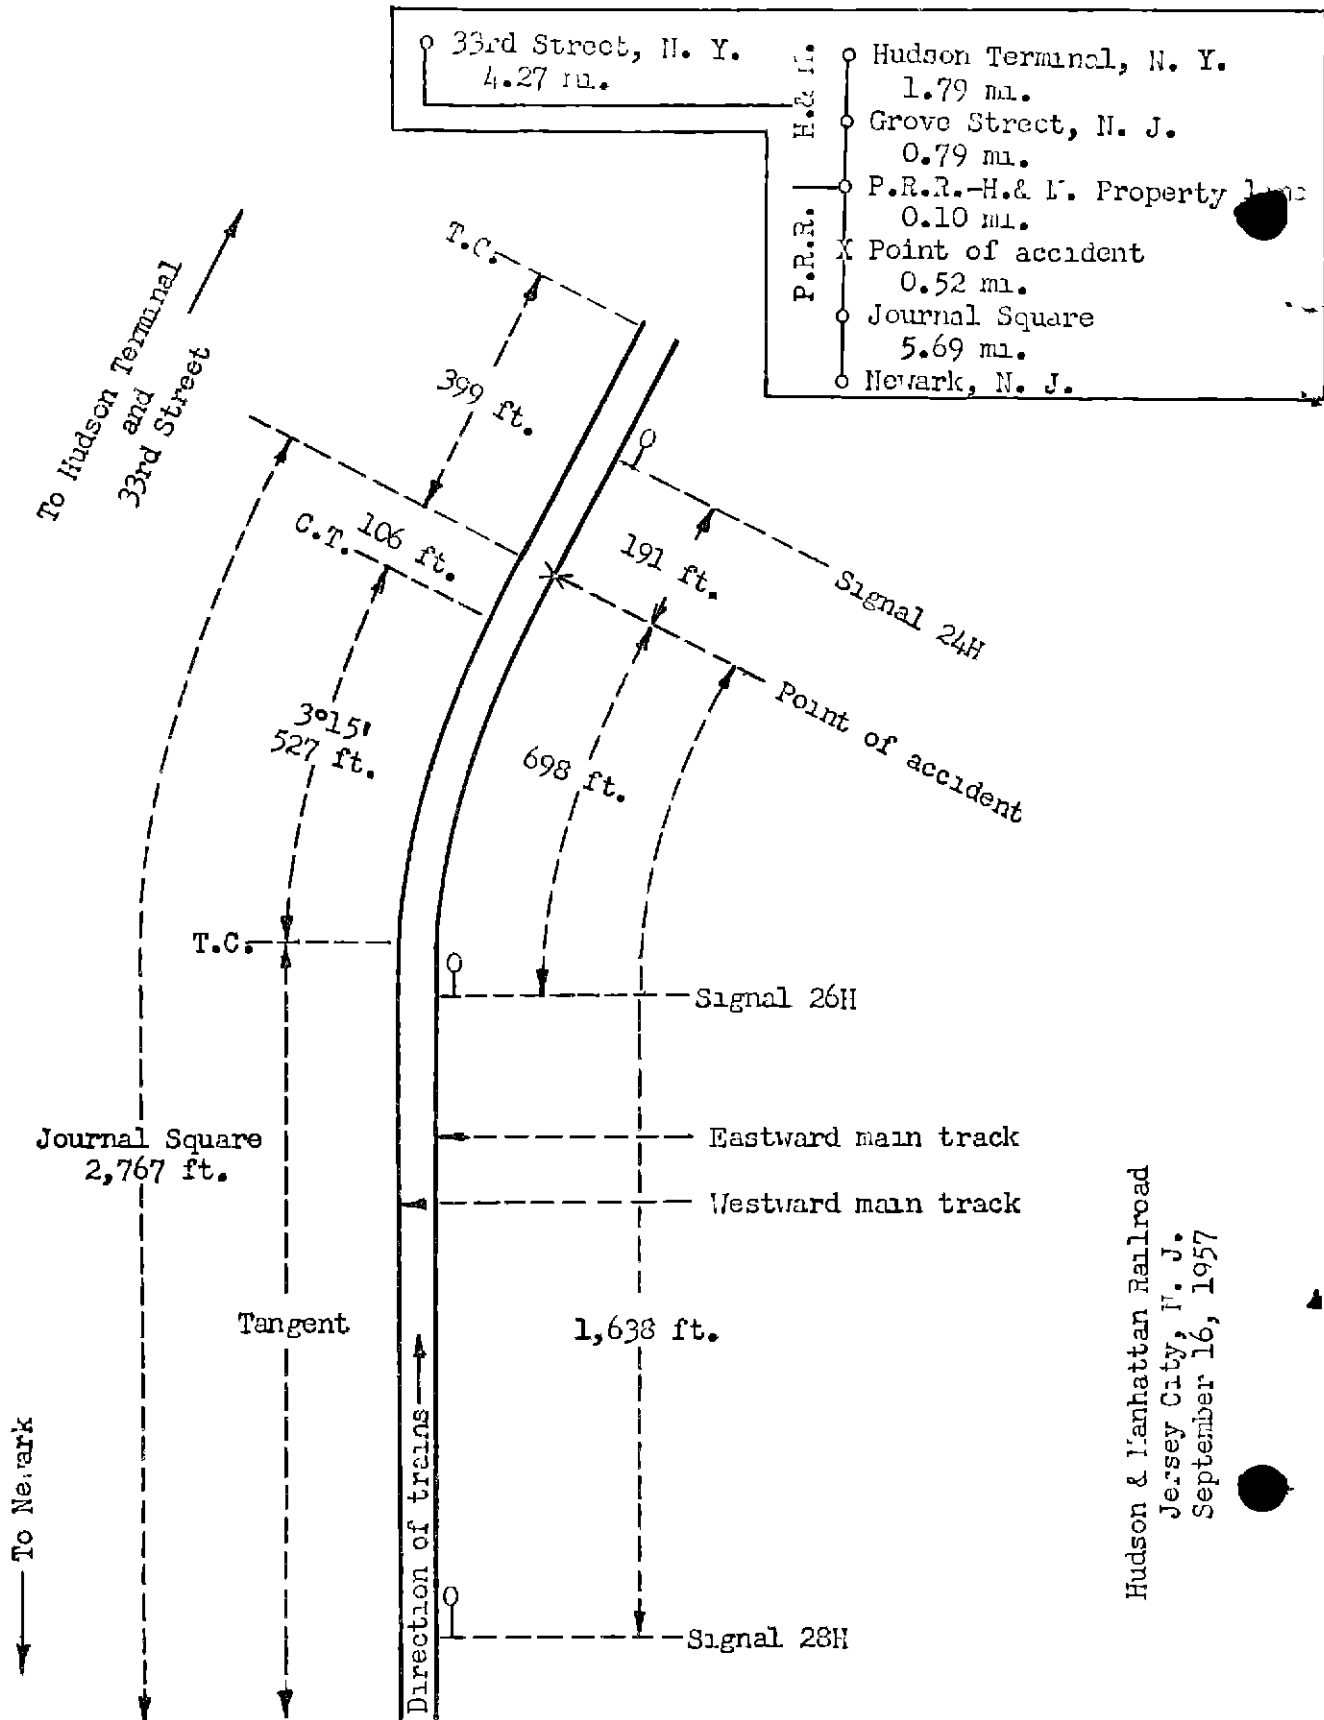
Hudson & Manhattan Railroad
 Jersey City, N. J.
 September 16, 1957

Location of Accident and Method of Operation
