RAILROAD ACCIDENT REPORT

COLLISION OF
ILLINOIS CENTRAL GULF RAILROAD
COMMUTER TRAINS,
CHICAGO, ILLINOIS
OCTOBER 30, 1972

NATIONAL TRANSPORTATION SAFETY BOARD
Washington, D.C. 20591
REPORT NUMBER: NTSB-RAR-73-5

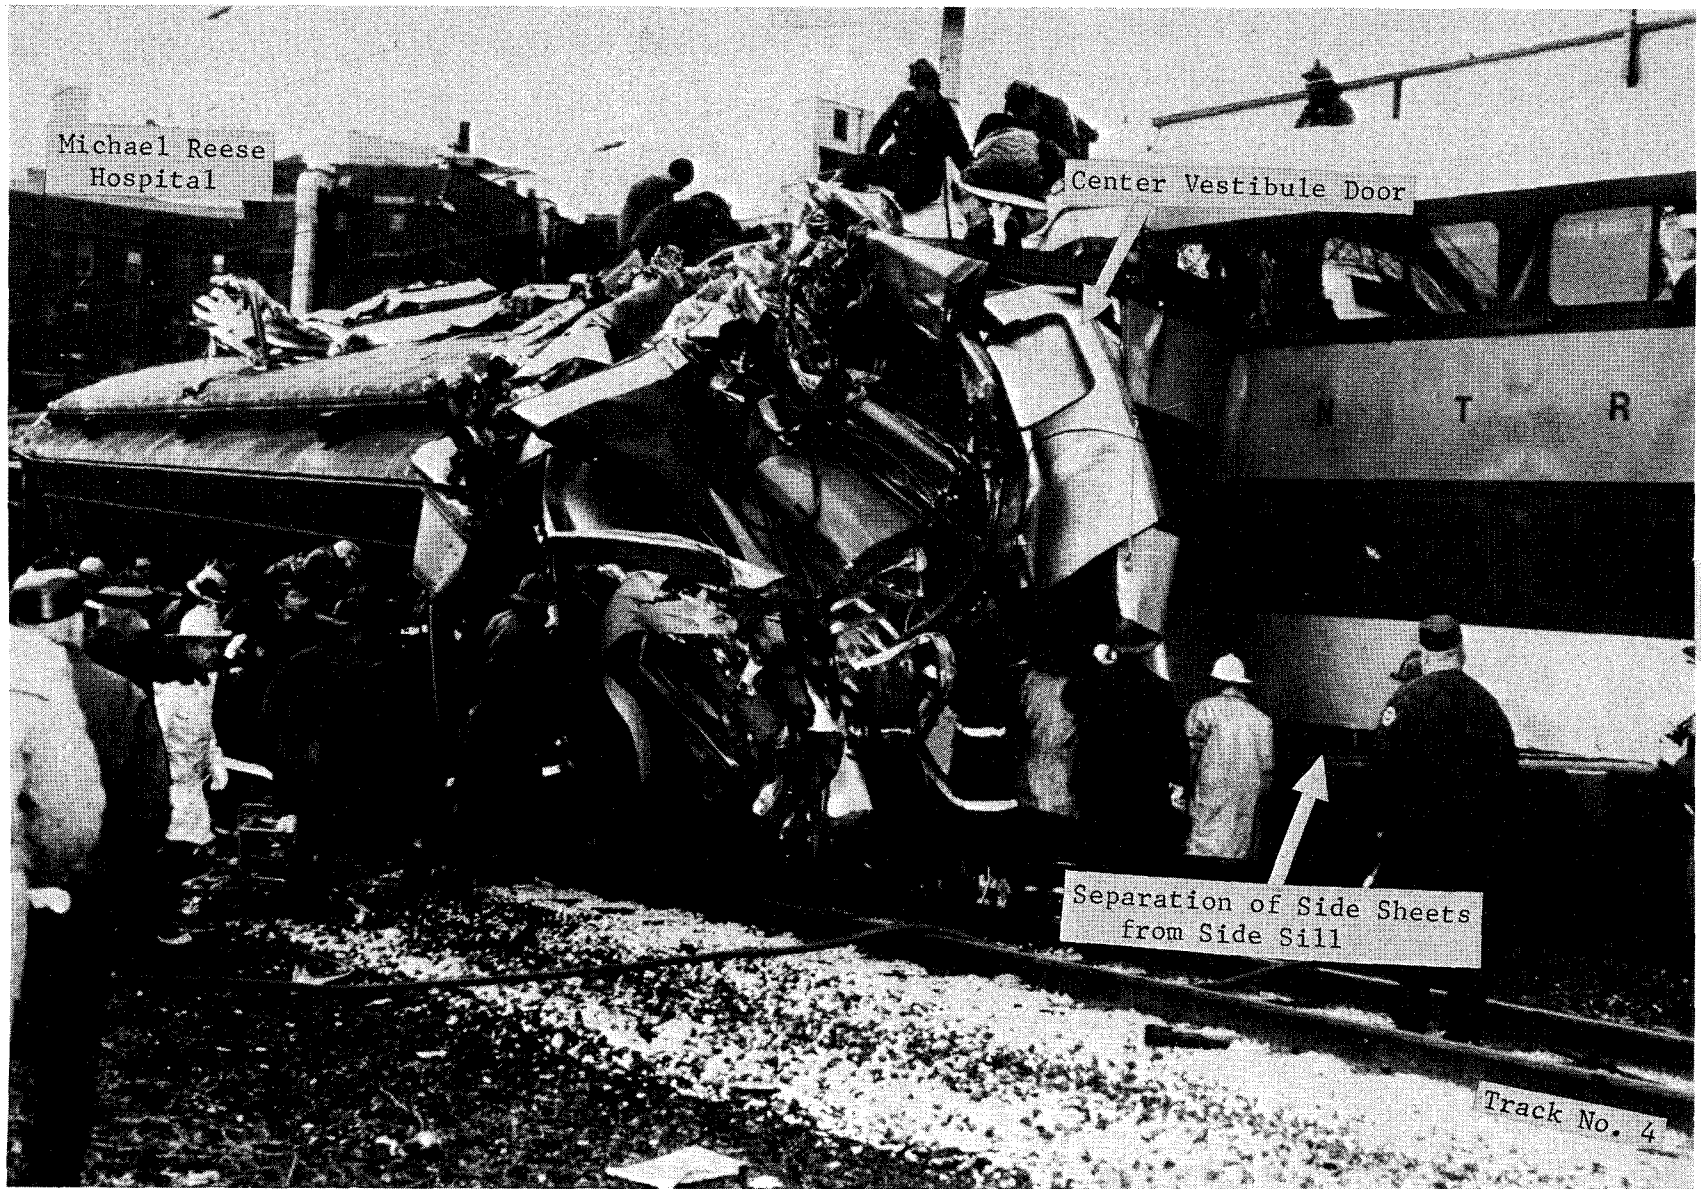
Figure 2. Trains After Collision.

The collision. The leading coupler of the first car of train 720 was broken off by the impact, and the car overrode the underframe of the rear car of 416. The first car of 720 then sheared off the collision posts on the rear car of 416, veered slightly to the right, and moved through the passenger section. (See Figure 2.) The lead truck on 720's first car was thrown from under the car and came to rest along the east side of the track. The rear truck was derailed and came to rest against the rear truck of the Highliner car.

Train damage. The rear half of the last car of train 416 was demolished. The end of the car and most of the right side were sheared off at floor level. A portion of the left side and several seats on the upper level remained intact. All lower-level seats were destroyed. The underframe of the car was not buckled, and the three other cars of 416 received only minor damage and were returned to service.

The first 10 feet of the lead car of train 720 was demolished. The center sills and couplers on several of the other cars of the train were broken, and these cars sustained sufficient damage to prevent prompt return to service.

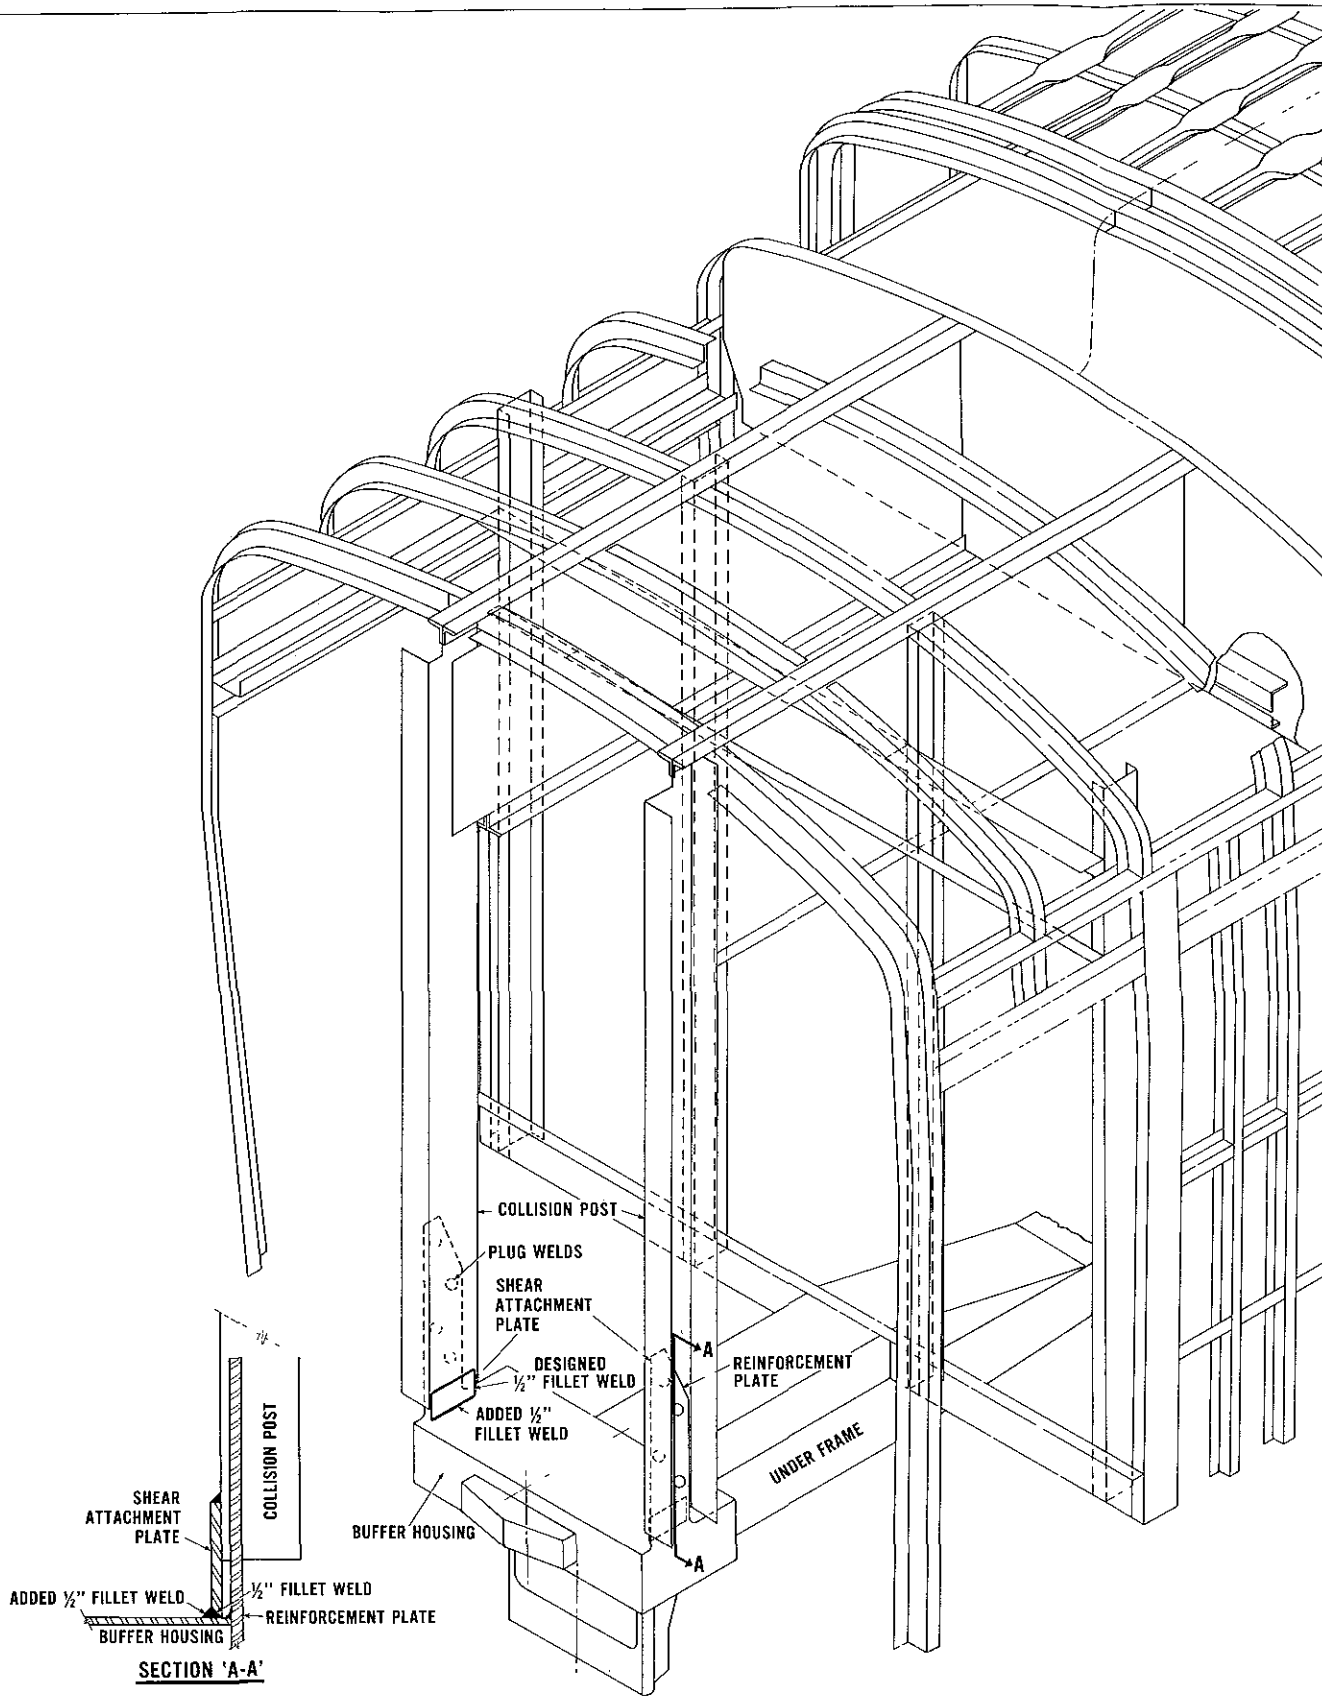
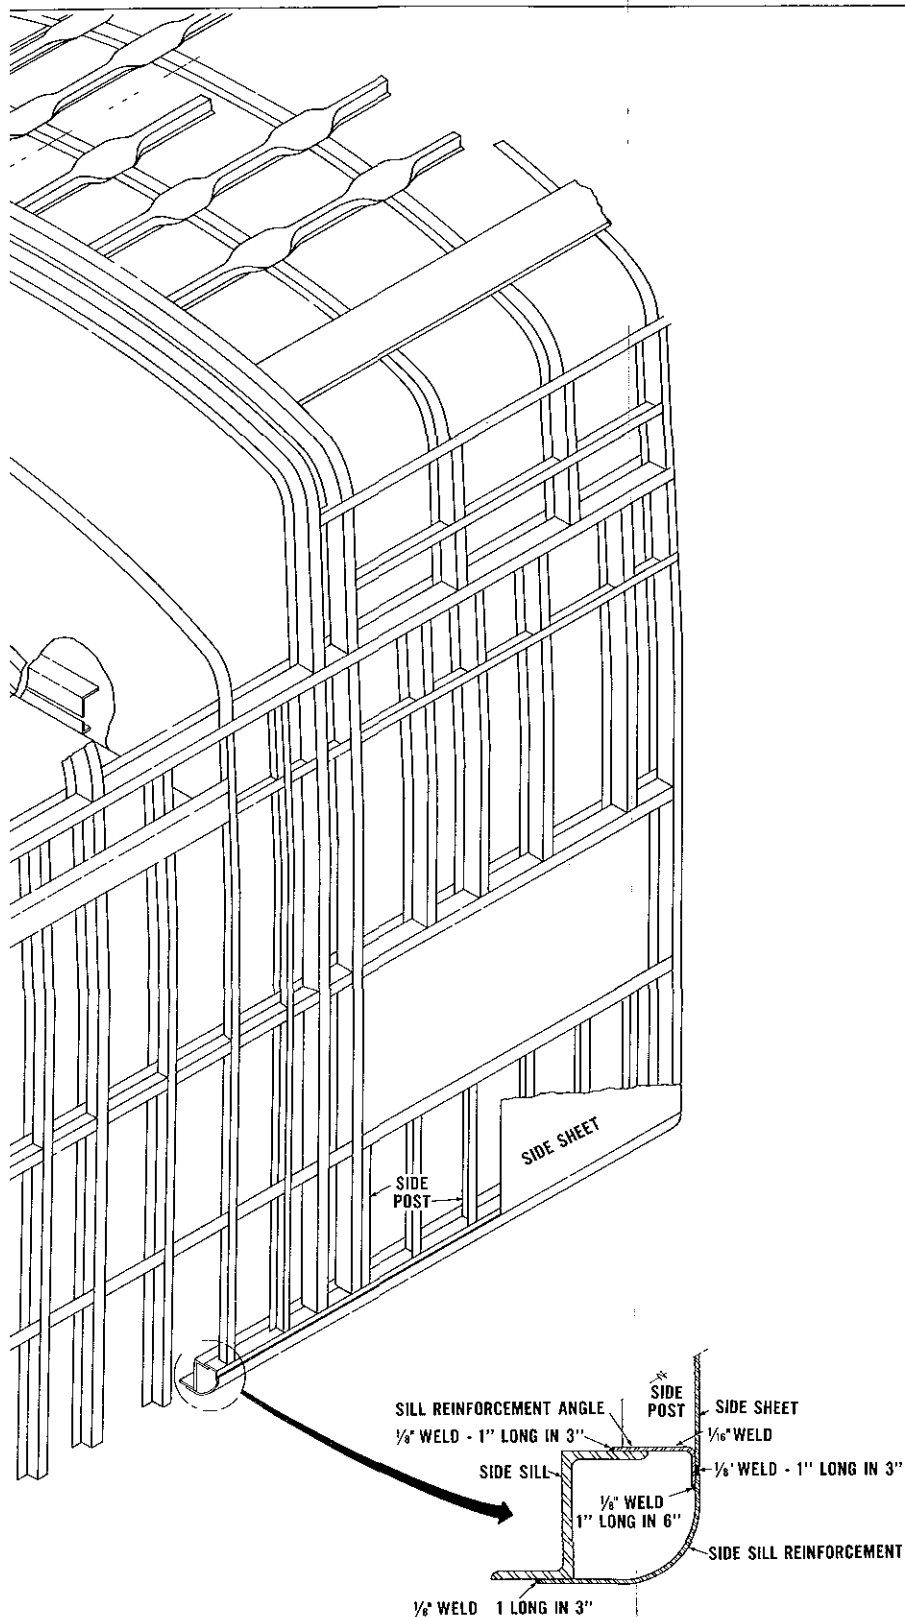
FIGURE 5

Train equipment. The collision posts of the Highliner car struck by 720 failed in the weld which attached the shear attachment plate to the underframe. Tests disclosed incomplete fusion between the plate and about 75 percent of the weld. The bottom edge of the plate was bevelled to permit the weld to penetrate through the plate to the underframe from one side. However, the bevel of the shear attachment plate extended only five-sixteenths of an inch into the plate, instead of the full one-half inch as designed. An additional 1/2-inch fillet weld which had been applied adjacent to the original weld failed in the parent materials of the underframe and shear plate. The plug welds which attached the reinforcing plate to the collision posts were fused incompletely. Further description of the design and failures of the collision posts can be found in Appendix G, which contains an interim recommendation made by the Safety Board to the FRA on April 25, 1973.

Some of the side posts on the rear car were sheared off through the welds which attached the posts to the sill reinforcing angle. Other posts were sheared off above the welds and were bent outward, which contributed to the failure of the sill reinforcing angle. Many of the intermittent welds which attached the sill reinforcing angle to the side sill broke in the welds and thus permitted the sill reinforcing angle to be torn from the side sill for about one-half of the damaged area. The intermittent welds which attached the bottom of the side sheets to the sill reinforcing angle broke and allowed the side sheets to separate. (See Figure 5.)
