RAILROAD ACCIDENT REPORT

ILLINOIS CENTRAL GULF RAILROAD COMPANY
FREIGHT TRAIN DERAILMENT
FORT KNOX, KENTUCKY
MARCH 22, 1983

NTSB/RAR-83/07

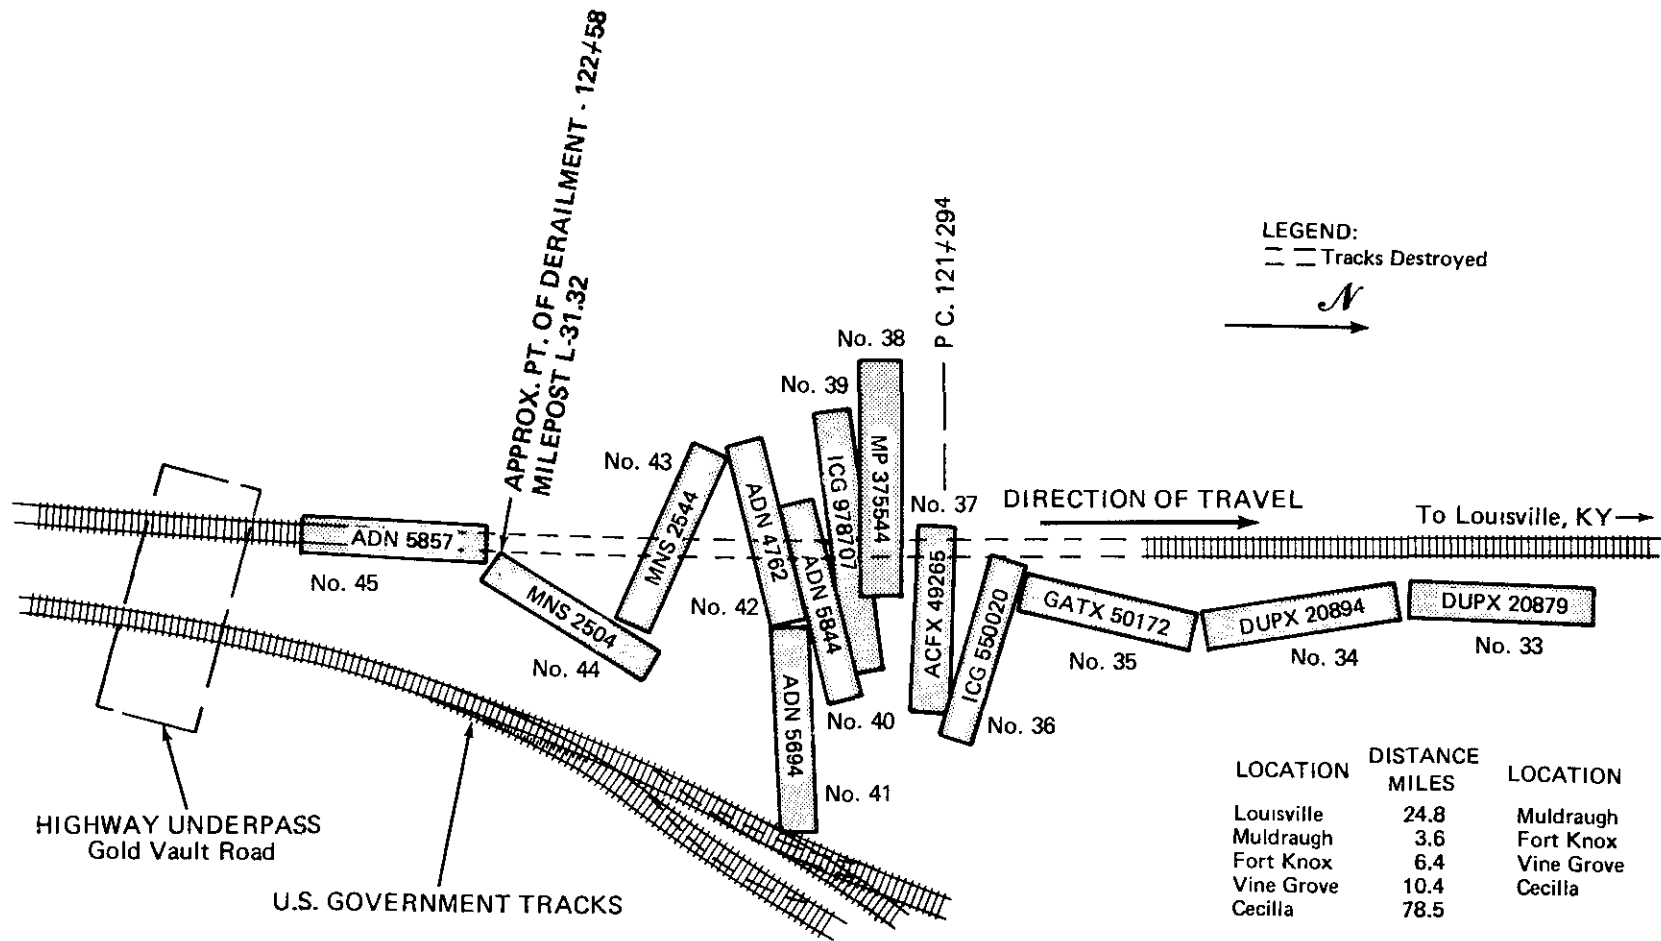
Figure 1.—Derailed of Illinois Central Gulf Freight Train,
1st No. 64, At Fort Knox, Kentucky on March 22, 2983.

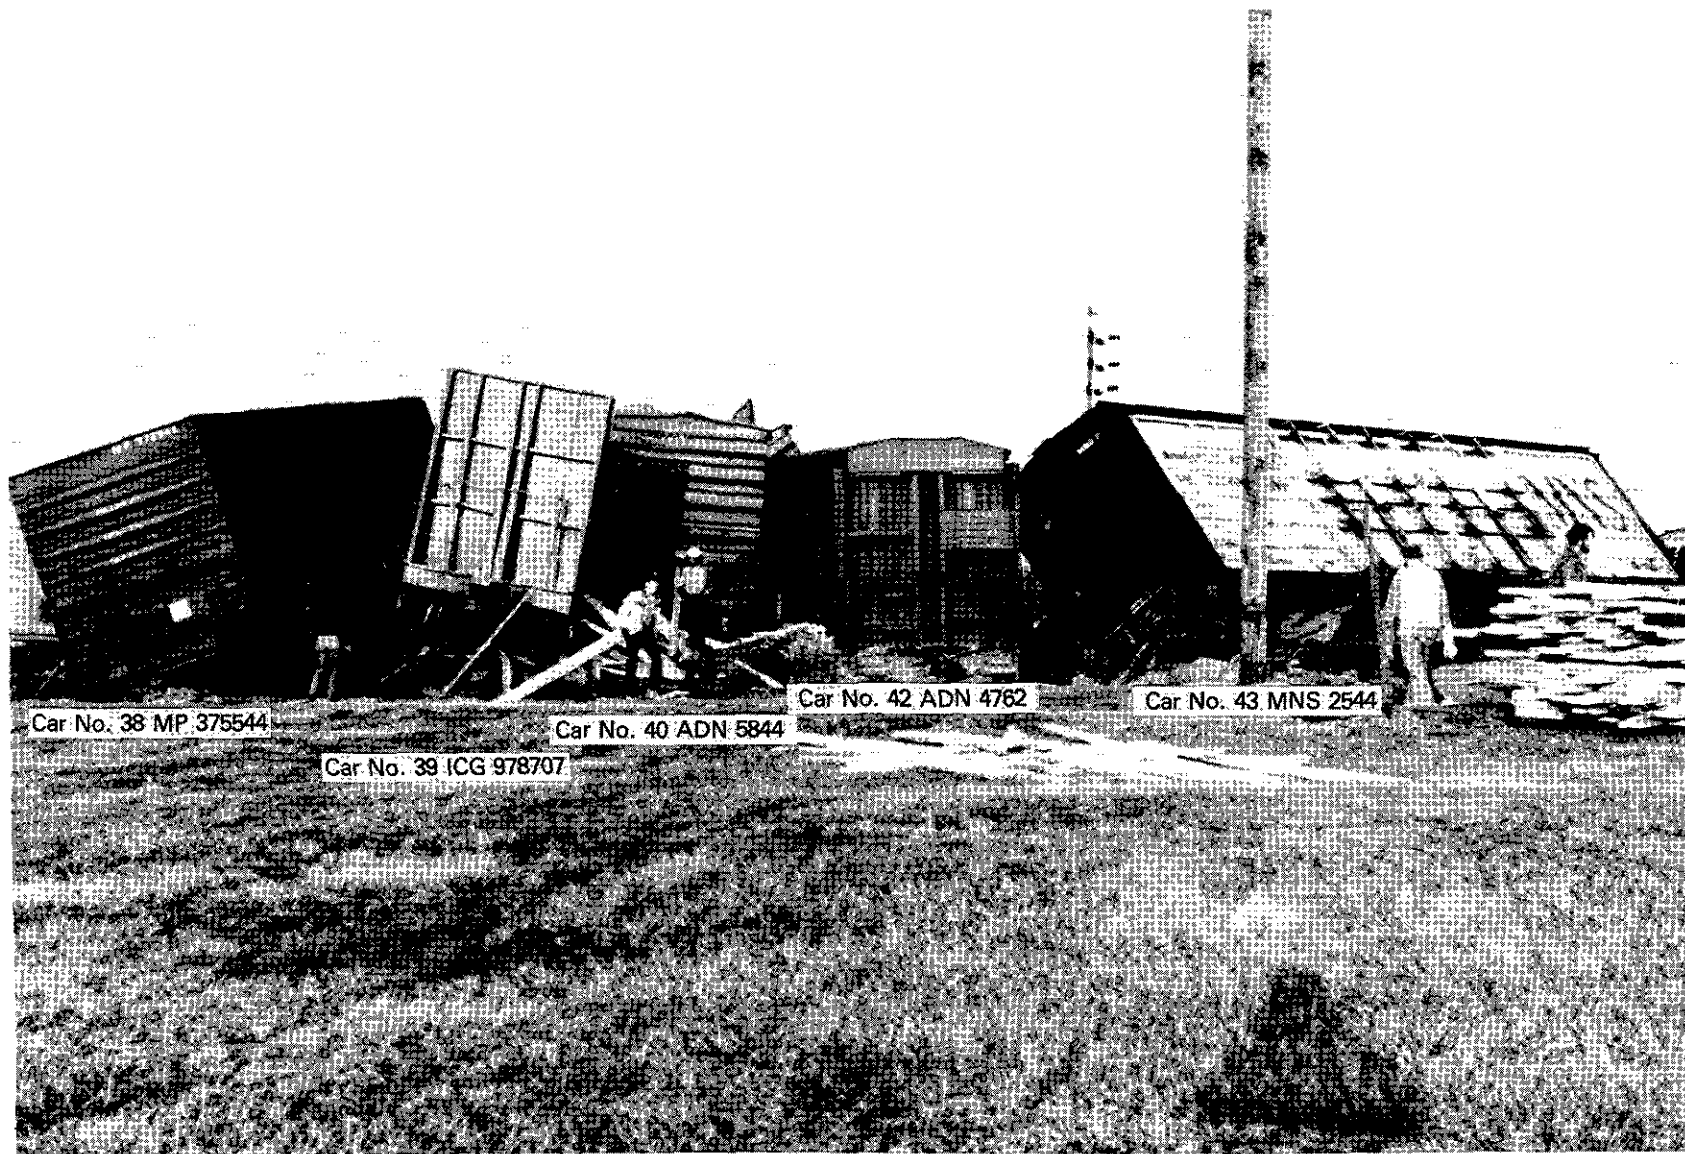
Figure 2.—Boxcar pile up at Fort Knox.
Direction of travel - right to left

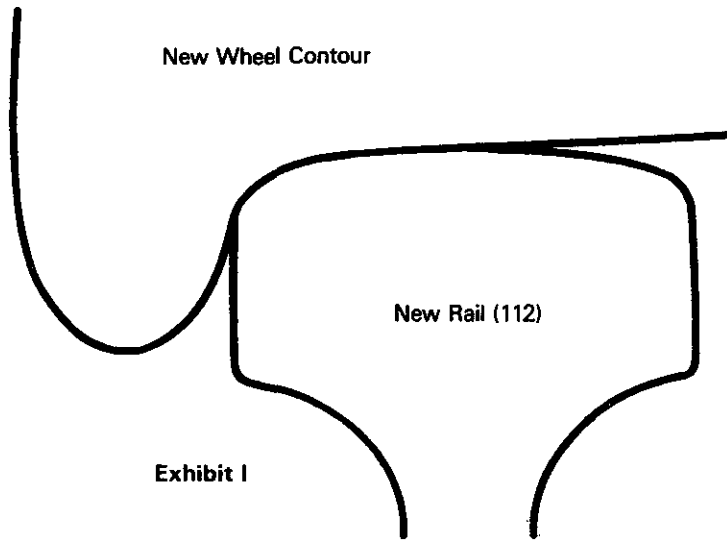
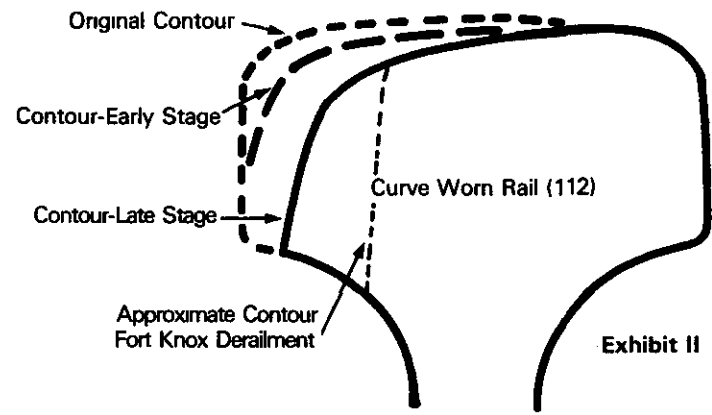
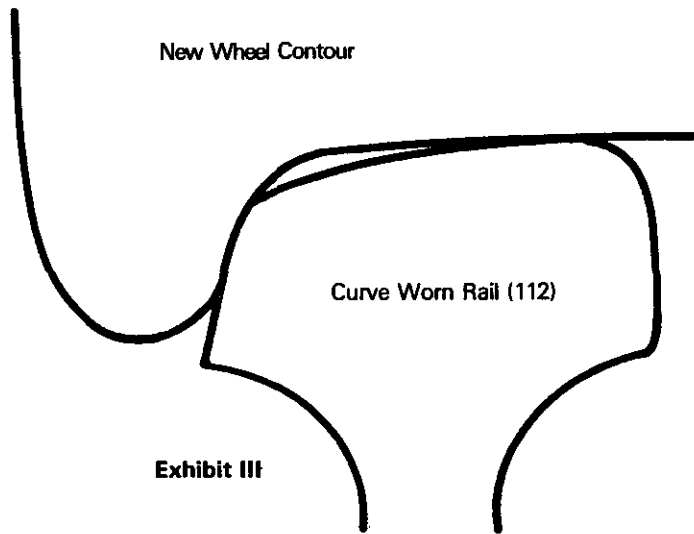
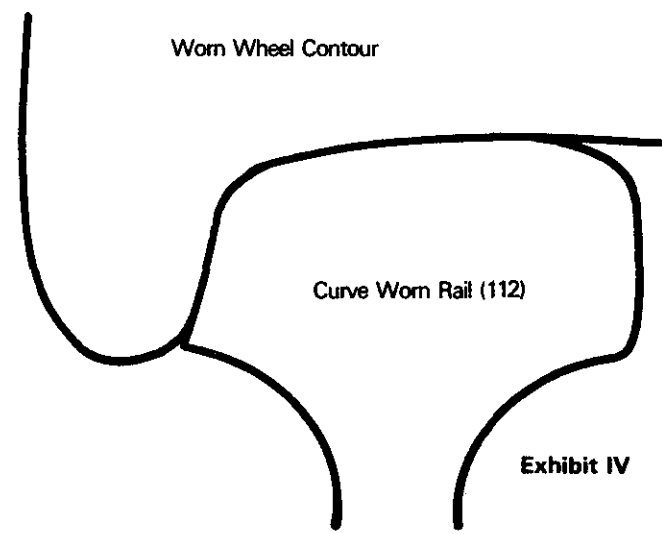
The rail was placed in service during 1944. The outside (curve) railhead was worn about 7/8 inch on the gage side and it was badly shelled. The railhead of a new 112-pound RE-rail measures 2 23/32 inches. Some typical wheel-rail contact configurations are shown in figure 3.

Figure 3.--Typical wheel-rail contact configurations.

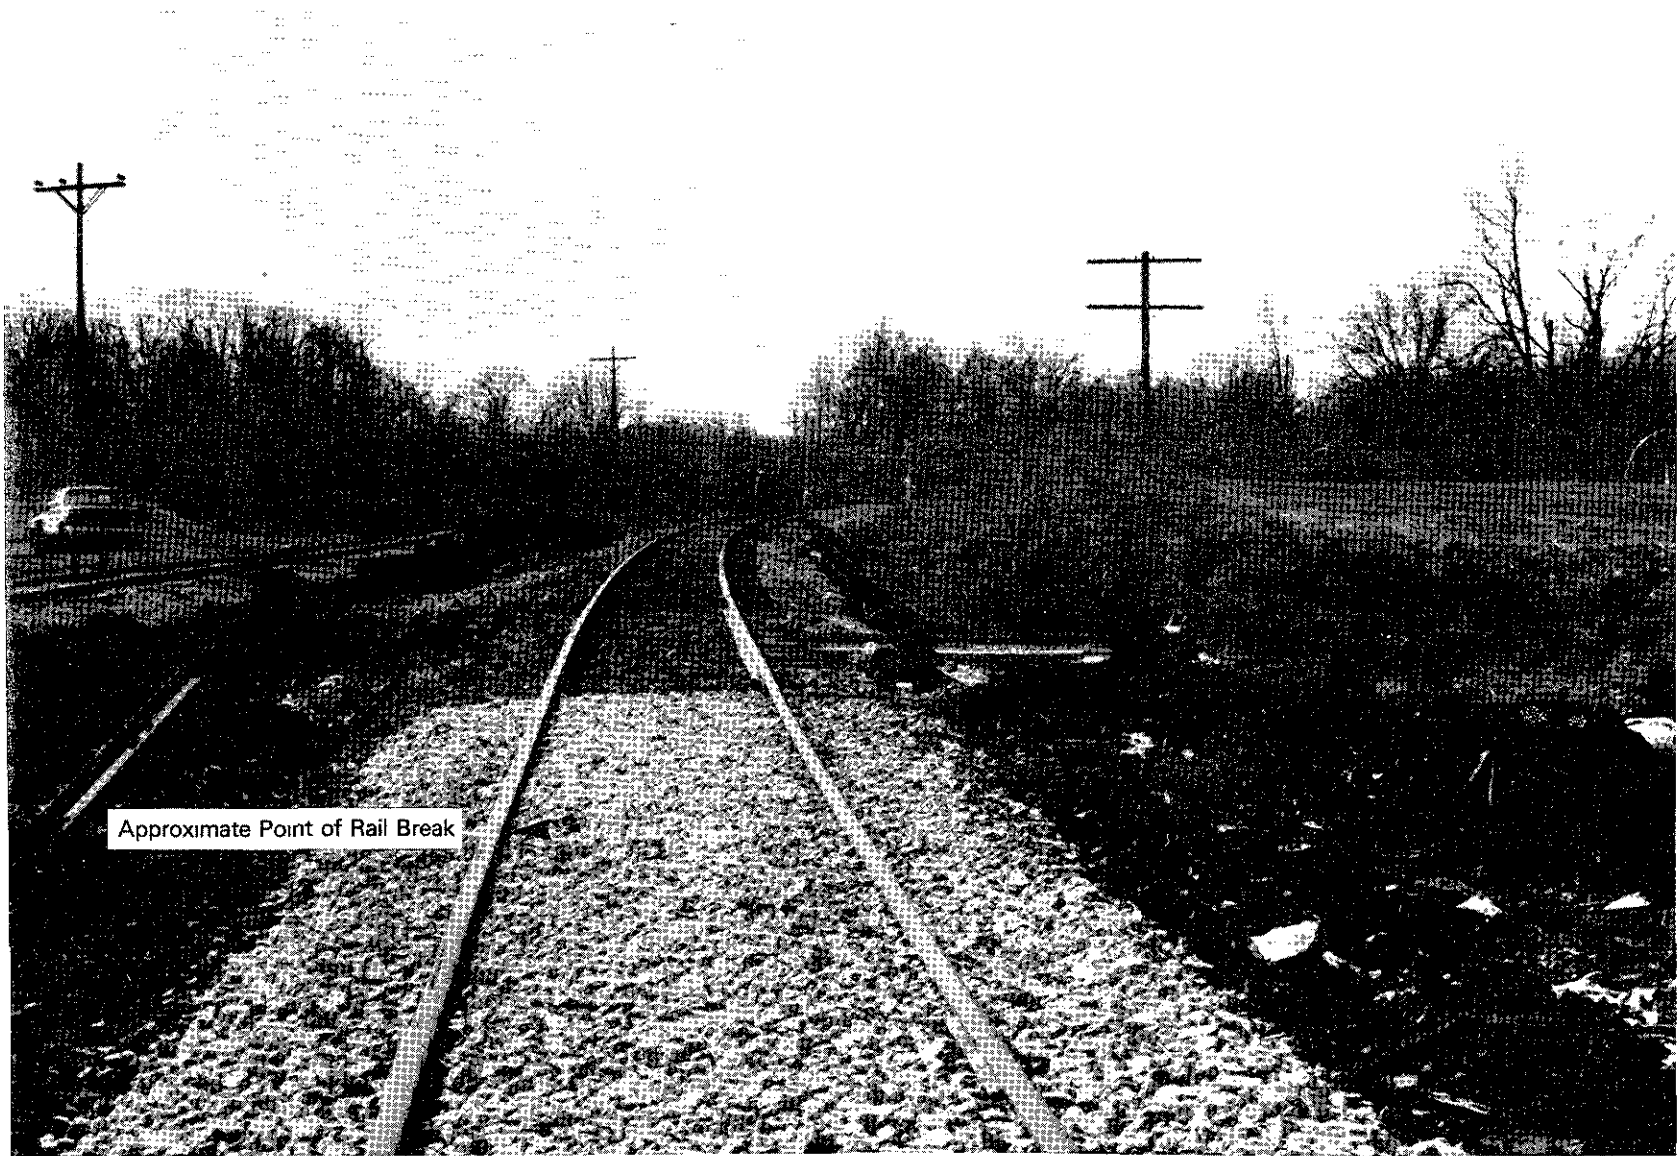
A broken outside rail was found at the beginning of the exit spiral of the 2° left curve. (See figure 4.) The rail broke into six pieces, all of which were recovered, except for one short section. (See figures 5 and 6.) The first break occurred 29 feet from the south end of the rail. A detail fracture 4/ was evident at the first break and at least one other detail fracture was evident at another break.

Figure 4.—View looking south from point of derailment.

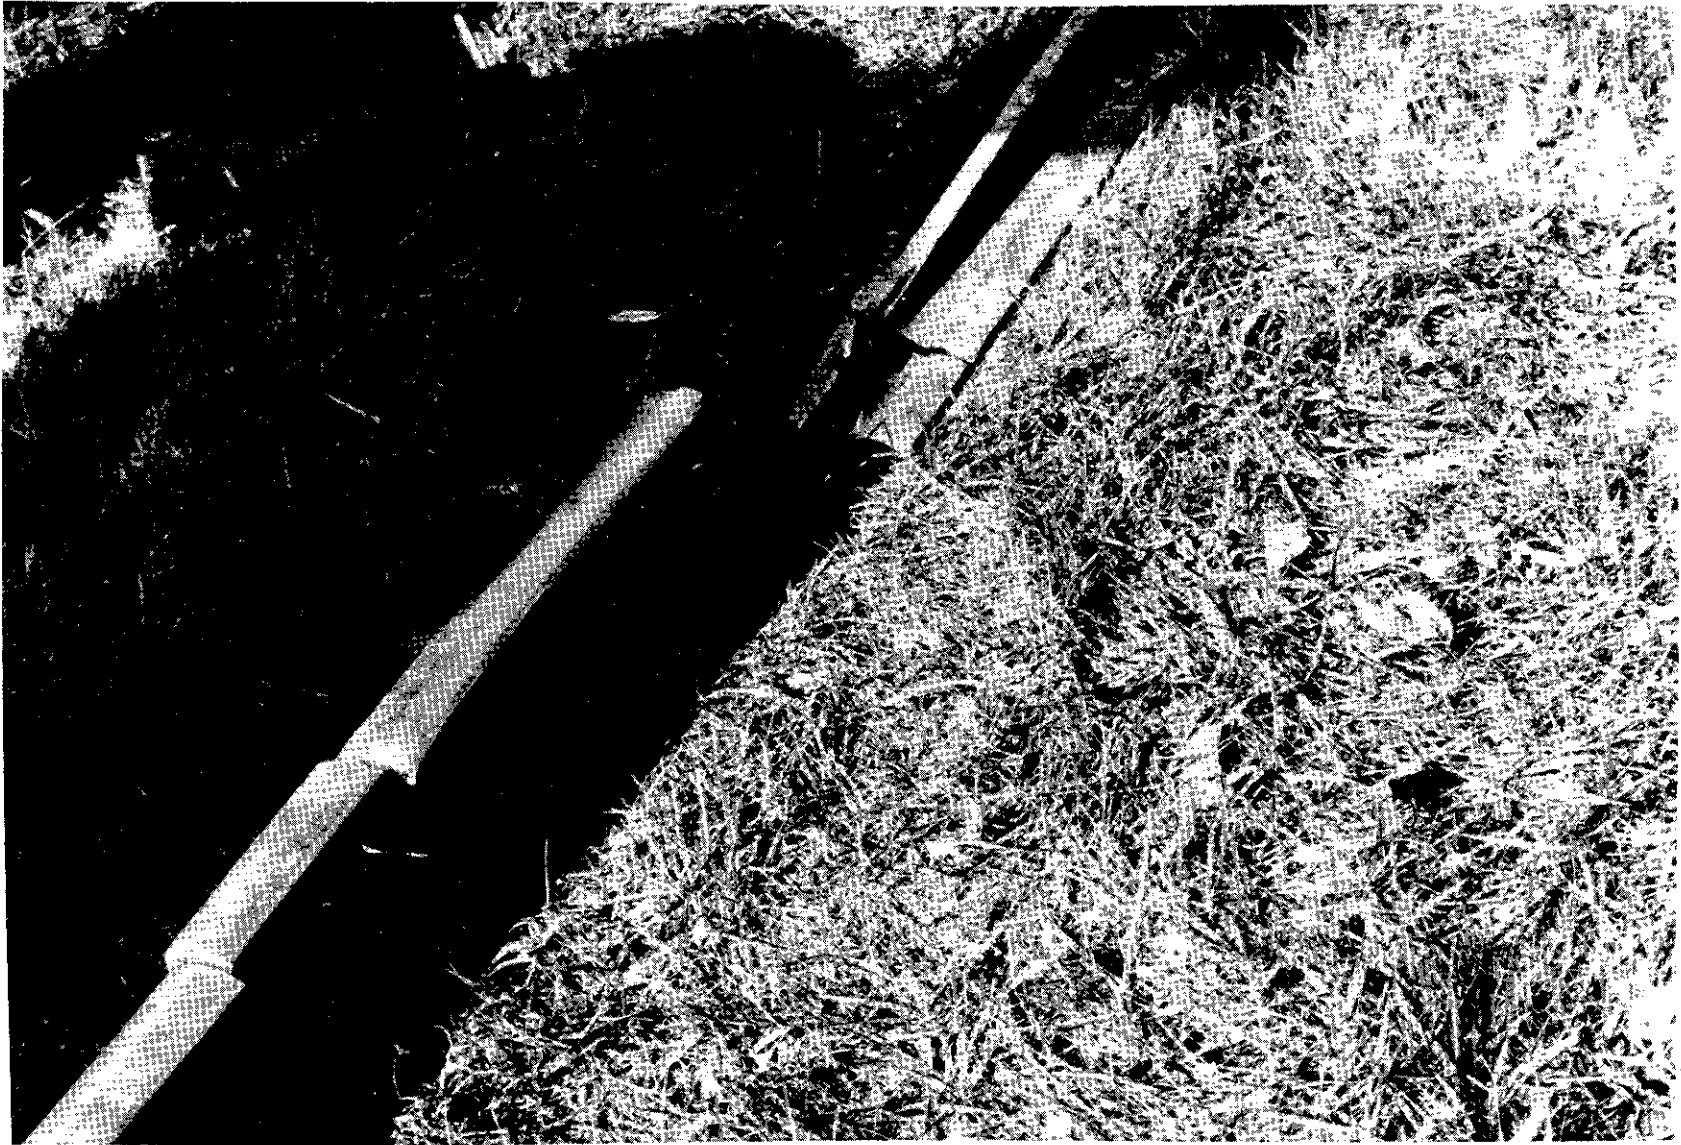
Figure 5.—Sections of broken rail. Direction of travel -- left to right. Gap is section of rail not found by investigators.

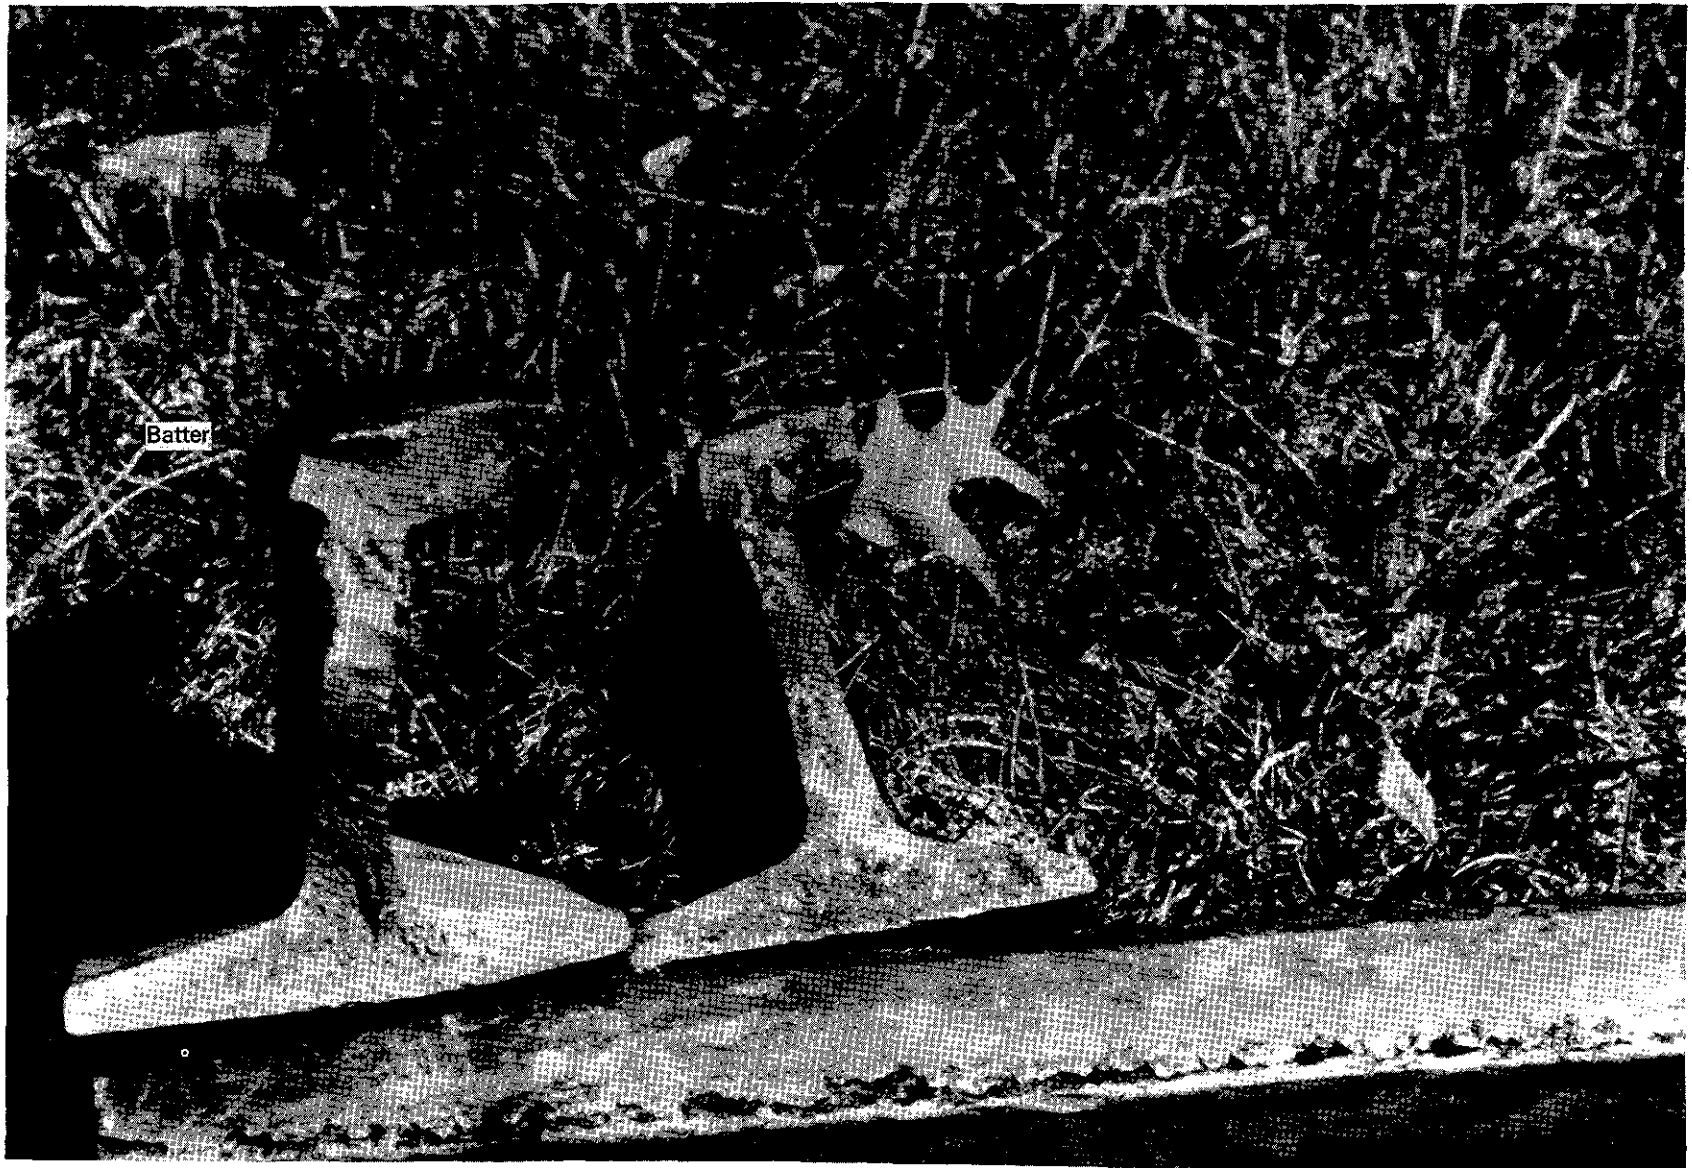
Figure 6.—Batter marks on section of broken rail.

The flange marks on the web of the rail stopped abruptly at the first break in the rail. The batter marks on the piece of rail further indicates that the rail broke initially at that point and allowed the wheels of DUPX 20879 to move to the outside of the rail. (See figure 6.) Apparently, when the wheel struck the railhead at the initial break, the impact force caused the rail to break at other points. Also when the rail broke, the unbroken rail reseated itself into position and provided usable rail for following cars. Wheel batter marks on portions of the railhead and web portions of other pieces of the broken rail indicate that the cars immediately following DUPX 20879 initially passed over the segmented rail and remained on the track until the emergency brake application. The broken rail then was displaced, and the following cars derailed.

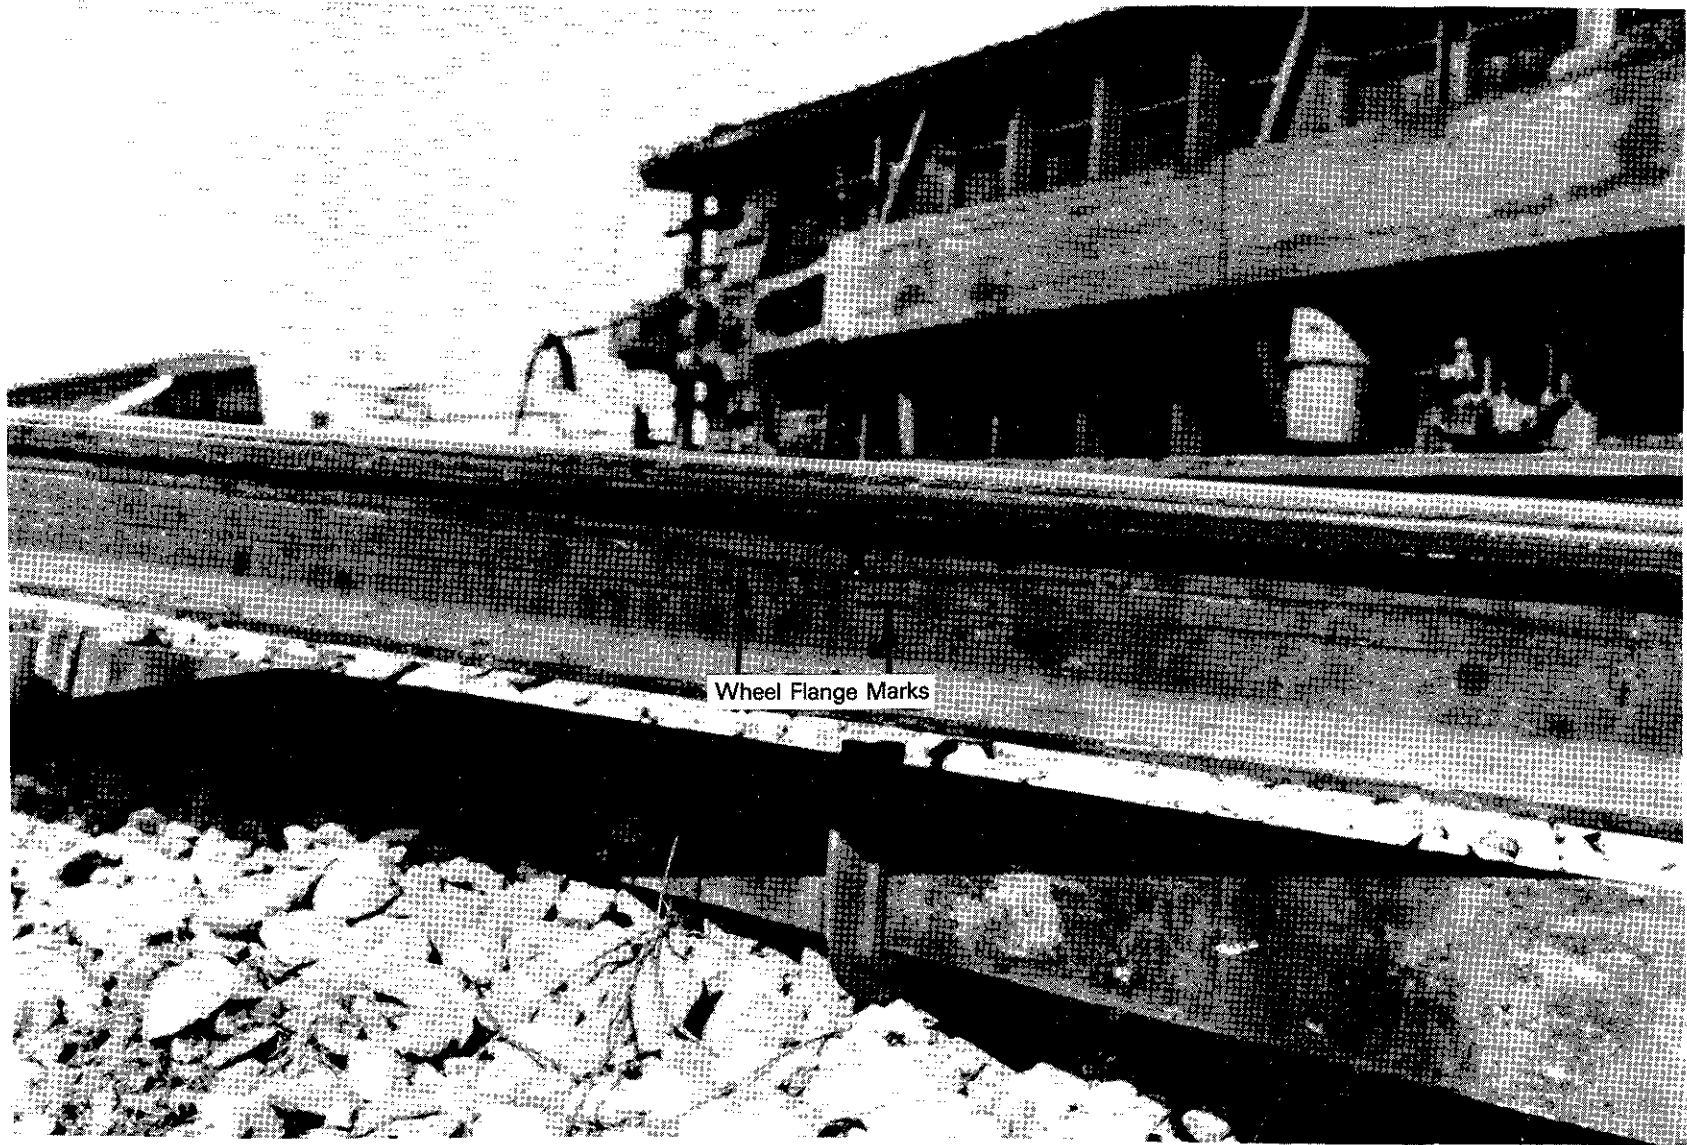
Flange marks which were evident in the web of the rail just before the first break did not extend beyond that break. (See figure 7). A small batter mark was visible on the gage side of the rail across the first break. The broken rail was sent to the ICG Engineering Offices in Chicago, Illinois, for forwarding to the Association of American Railroads (AAR) laboratory in Chicago, for metallurgical analysis. However, after ICG engineering personnel examined the rail and determined that the defect was an obvious detail fracture, the rail was not forwarded to the AAR for further analysis.

Figure 7.--Flange marks on web of broken rail ahead of first break.

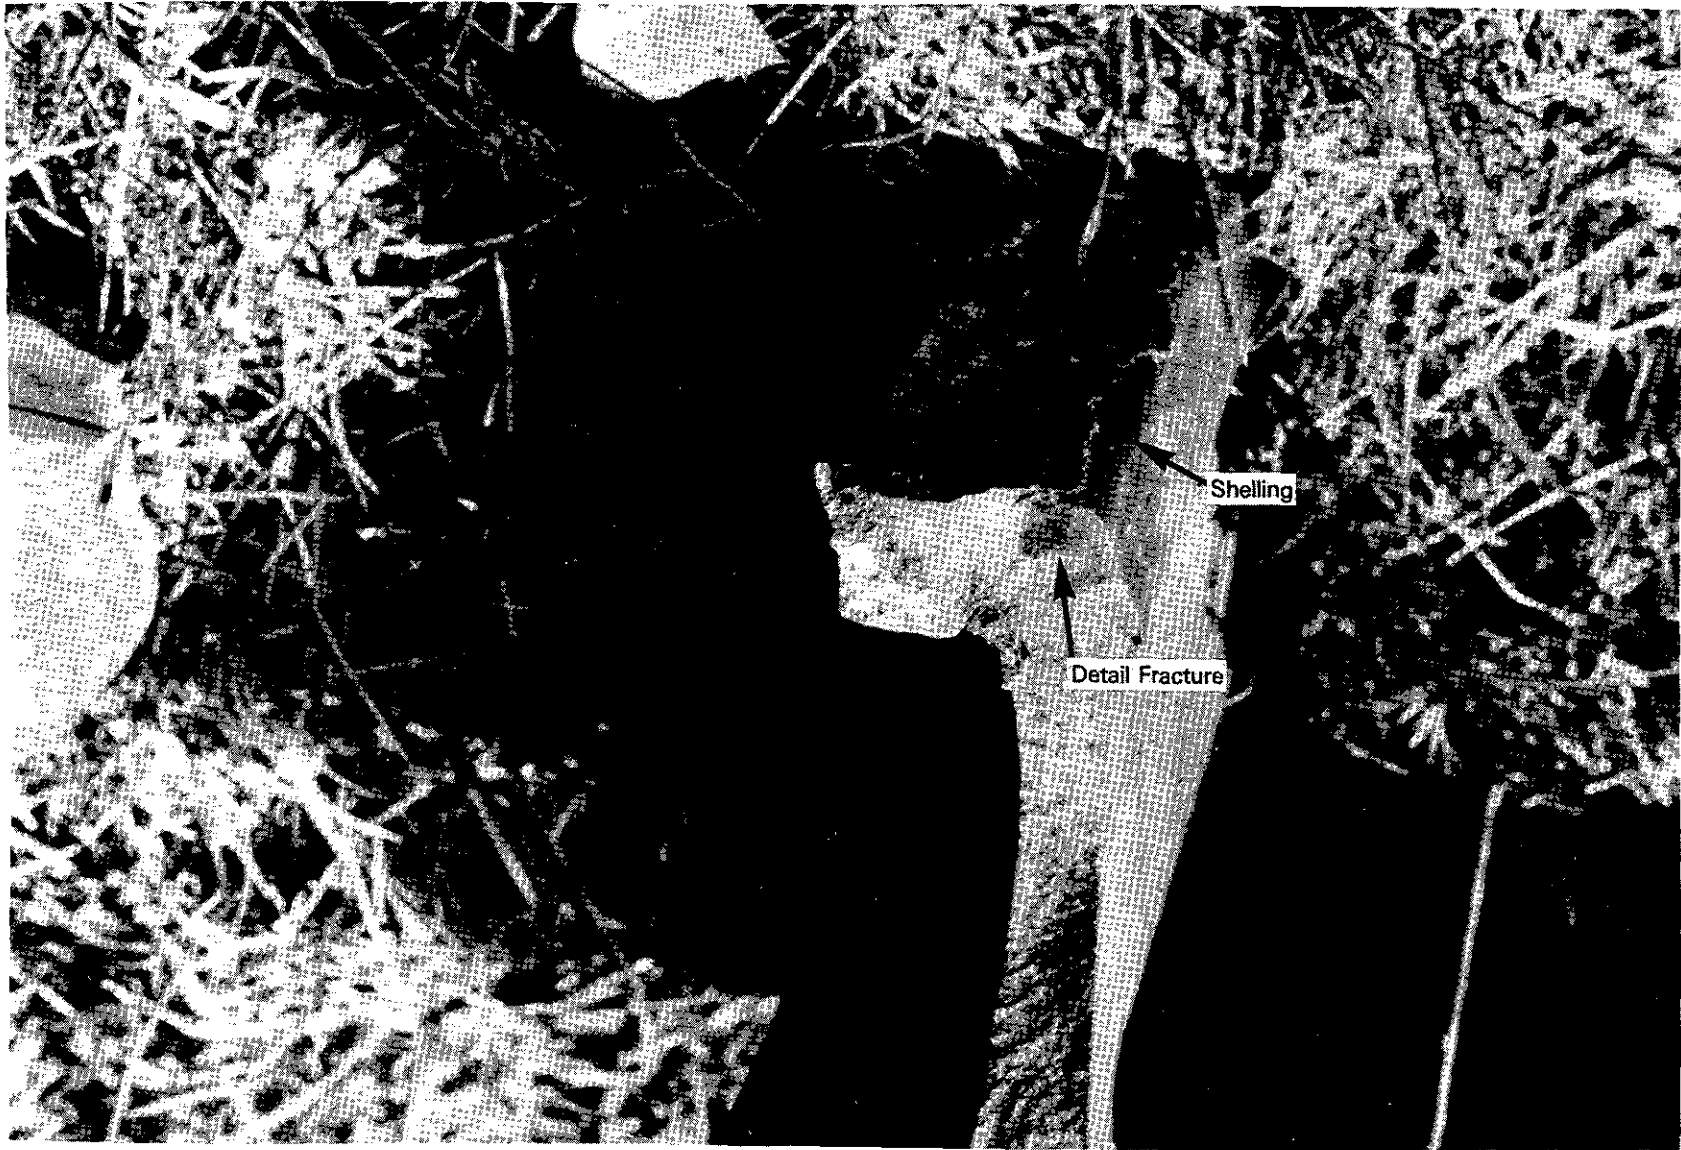
The postaccident investigation revealed that the outside curve rail was excessively worn and was shelling. (See figure 8.) Experience indicates that shelling leads to detail fractures in the railhead and weakens the rail. Detail fractures are the result of the excessive contact stresses of heavy wheel loads repeated over a long period of time and, as such, are fatigue-related defects. The growth of a detail fracture from shelling occurs rapidly in contrast to other transverse fissures. The continued use of the worn rail led to shelling and the subsequent development of detail fractures.

Investigators determined that the initial break in the outside curve rail was caused by lateral force on the excessively worn, shelly rail. The break occurred at a detail fracture which resulted from shelling. The progressive fracture started from a longitudinal separation close to the running surface of the railhead and then turned downward to form a transverse separation substantially at right angles to the running surface. (See figure 8.) According to the Sperry Rail Service's Rail Defect Manual, this condition is most frequently found on the gage corner of the railhead and is caused by metal flow at the gage corner of the head which breaks away and leaves a shallow cavity.

Figure 8.--End view of broken rail showing detail fracture and shelling.

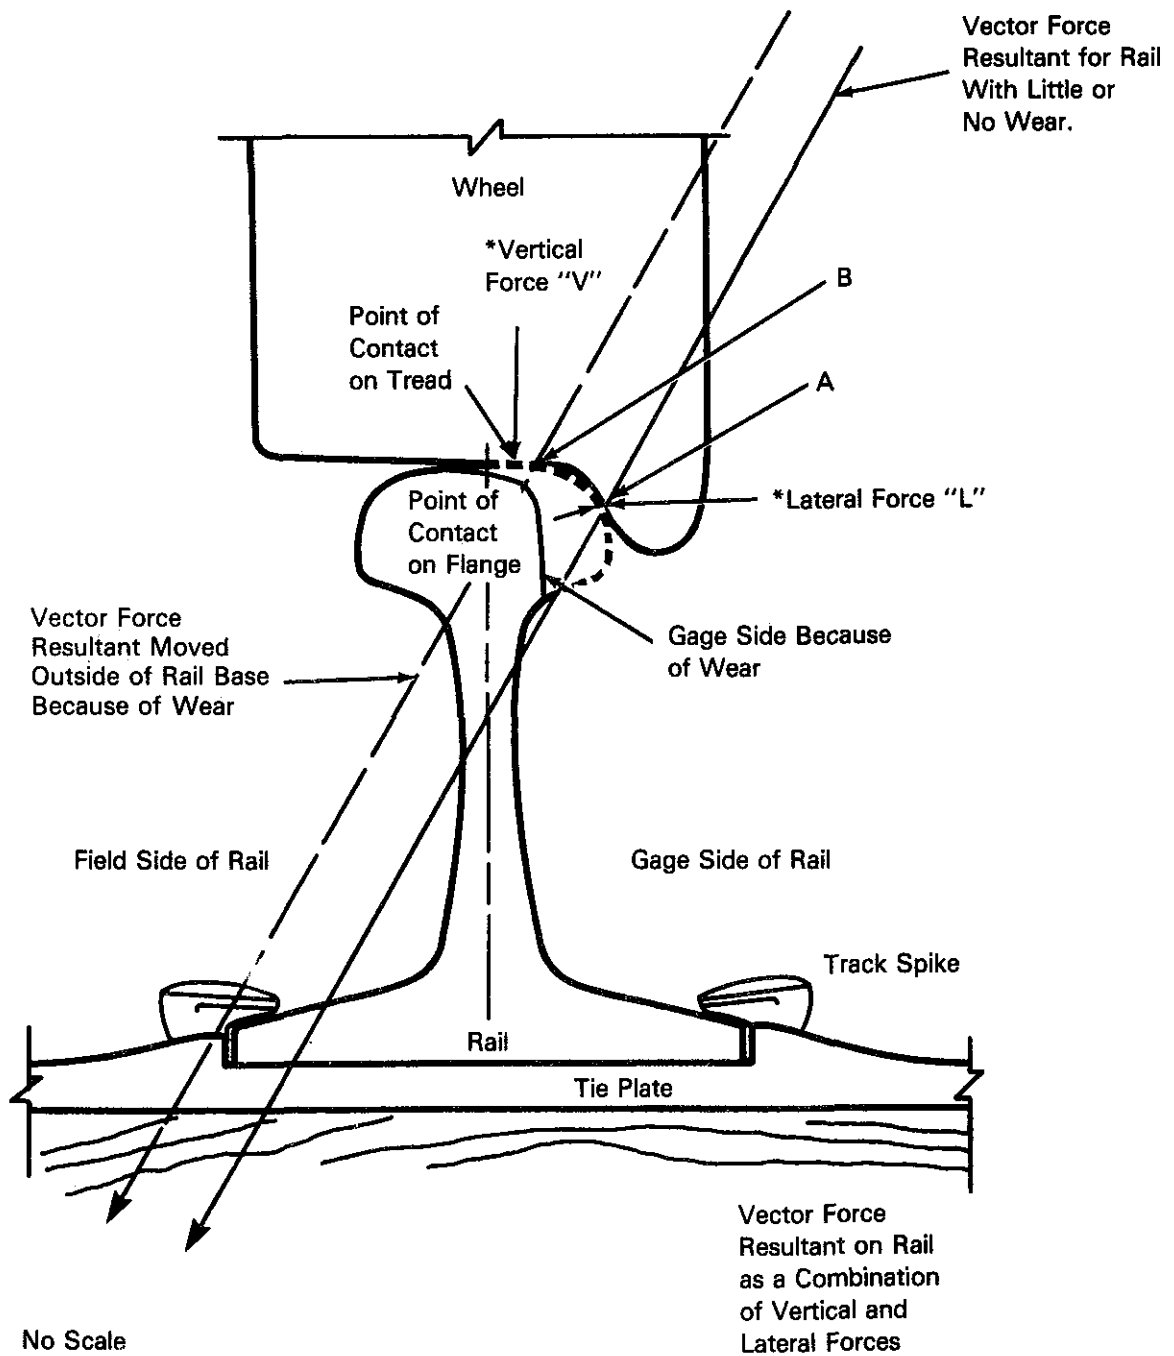
In the absence of superelevation in the 2° curve and because of extreme wear of the railhead at the derailment site, the resultant force of the rail cars would have been manifested in a manner that would have increased the outward force on the outside curve rail. (See figure 9.) Because of the 7/8-inch railhead wear, a vector diagram constructed at the railhead would show the vector resultant has moved outward on the railhead. Unless the wheel climbed over the rail (and there are no marks on the railhead to indicate it had) the shift of the resultant vertical and centrifugal forces from A to B on the rail would cause the rail to move laterally and/or to tip.

Figure 9.—Loading effect on rail.

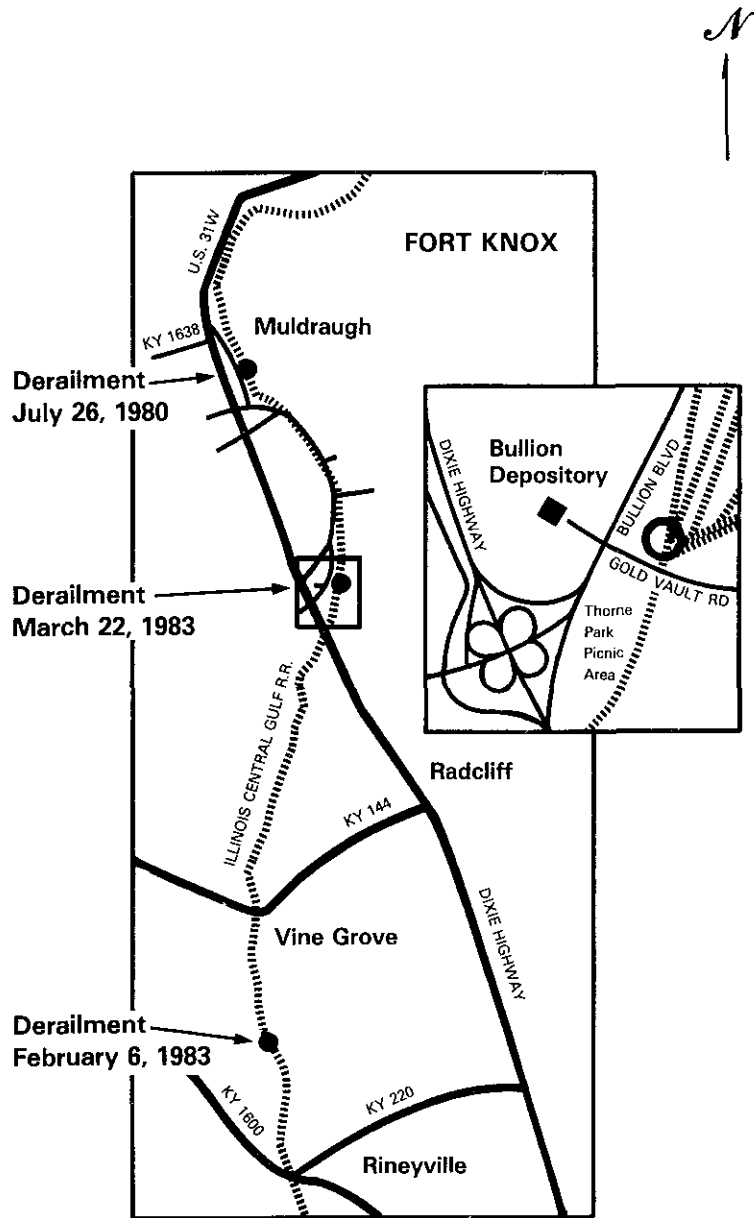
Figure 10.—Locations of derailments in the Fort Knox area.
