RAILROAD / HIGHWAY ACCIDENT REPORT

ILLINOIS CENTRAL GULF RAILROAD
FREIGHT TRAIN AND
MOBIL OIL COMPANY
TRACTOR / CARGO-TANK SEMITRAILER
COLLISION AND FIRE
KENNER, LOUISIANA
NOVEMBER 25, 1980

NTSB-RHR-81-1

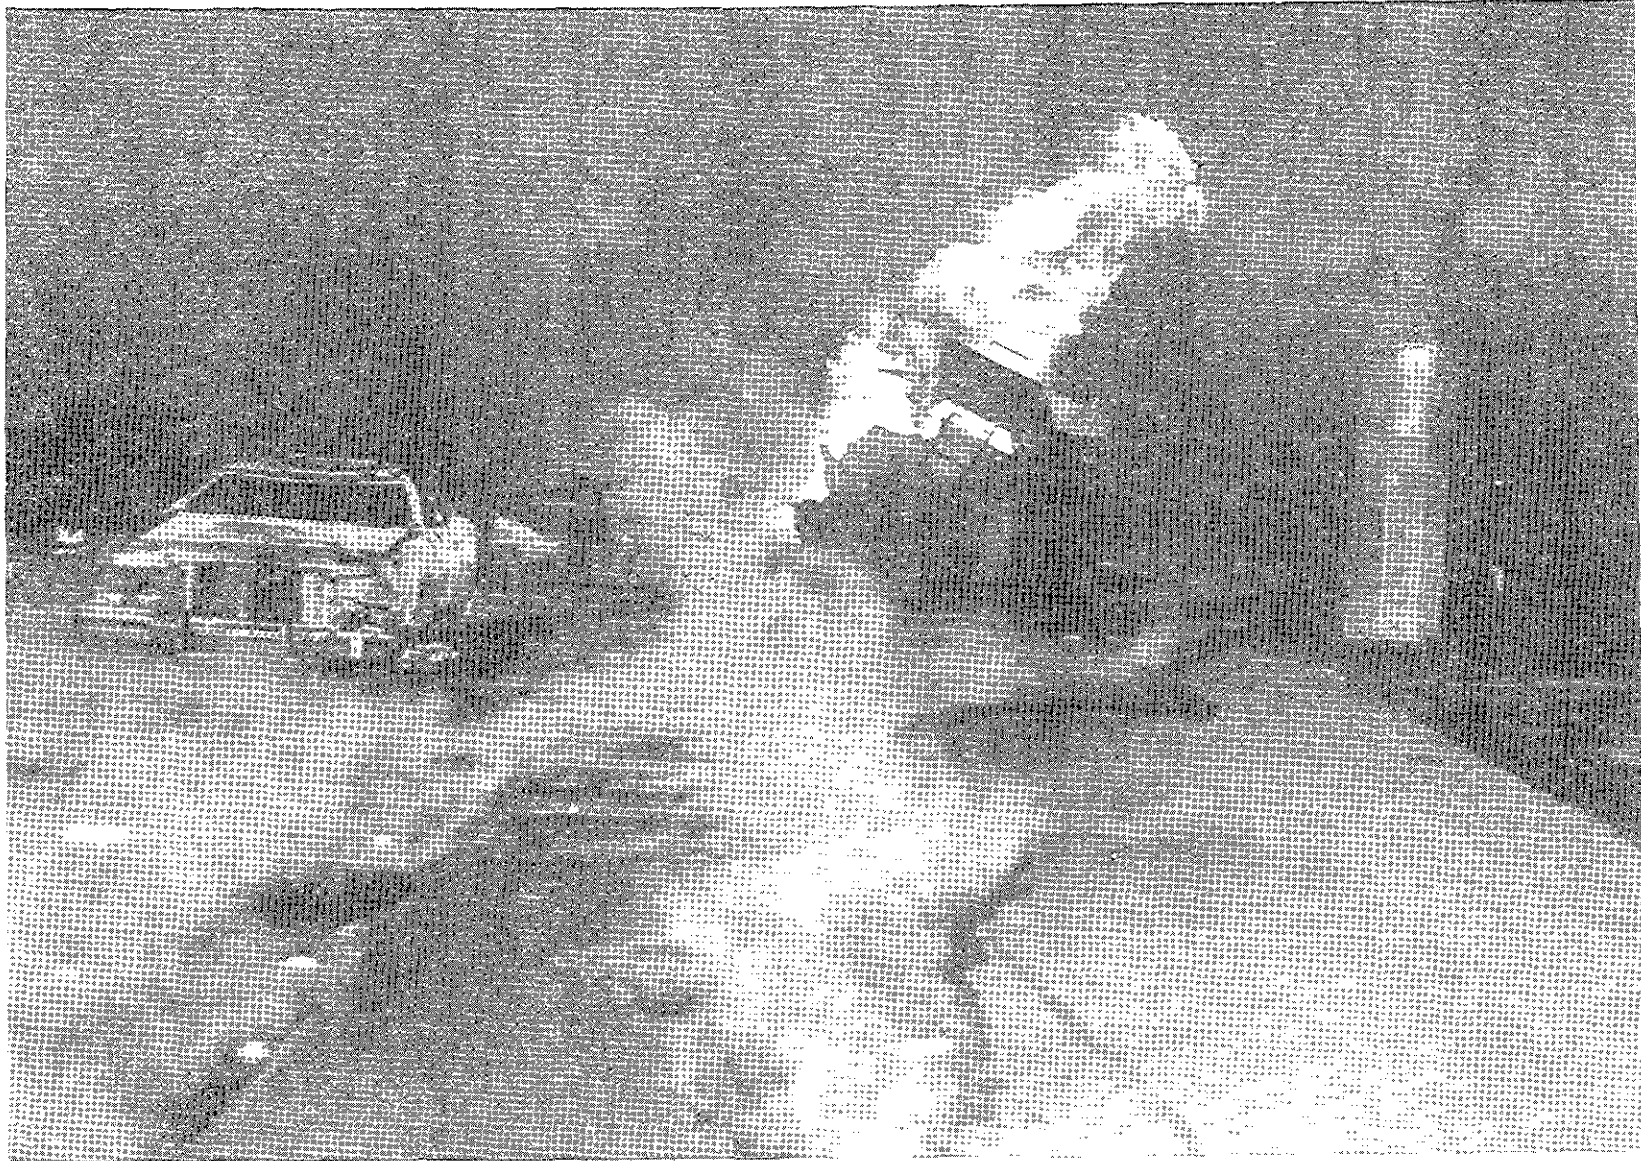
Figure 2.--Burning trailer and fuel flow pattern.

As the locomotive struck the semitrailer, the cargo tank ruptured, rolled upside down, and spilled a large amount of cargo fuel which ignited immediately on the roadway just south of the tracks. (See figure 2.) The track level was elevated above the roadway grade and the burning fuel ran 40 feet to the south and 50 feet to the east around a building on the southeast corner of the intersection that housed a bar and an upholstery shop. The burning fuel flowing to the south surrounded the stopped Camaro and the truck tractor and ran past the west (front) door of the bar. The fuel flowing to the east ran into the north foundation and around to the east side of the bar past the north door. (See figure 1.)

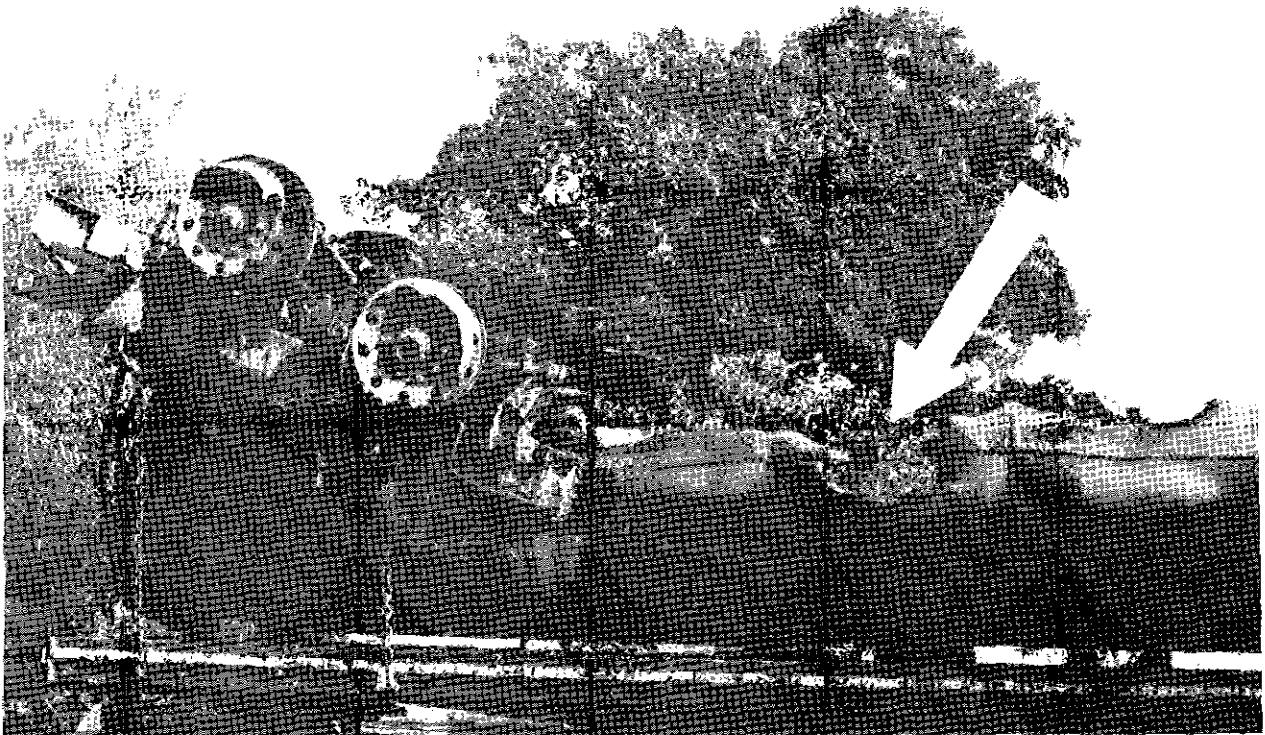
Figure 4.--Left side of trailer.
Note hole from locomotive coupling penetration.

Physical damage was observed at the semitrailer tandem. A large puncture hole that matched the size and shape of the locomotive coupling was found in the left-side tank shell 14 1/2 feet forward of the rear bumper. All six cargo tank manhole covers were undamaged, closed, and none was leaking.

The centerline of the locomotive struck the semitrailer on the right side at a point 14 1/2 feet from its extreme rear, as demonstrated by trailer subframe damage and a hole that matched the contour of the locomotive coupling on the left side of the tank. The coupling penetrated the tank as it rolled to its left away from the train. As the semitrailer rolled, it separated from the tractor at the fifth wheel. The front of the

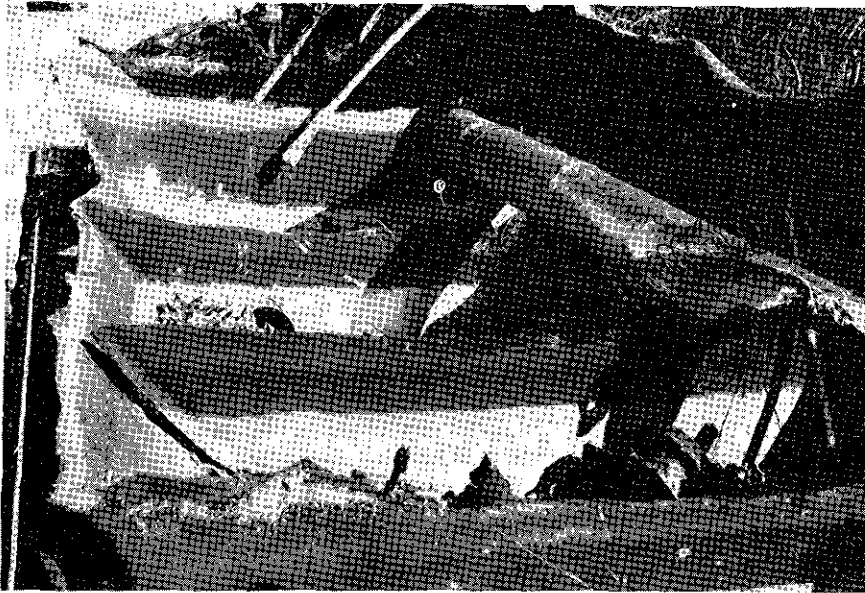
The semitrailer wreckage also had been placed on a flatbed trailer. (See figure 4.) Only steel components and approximately one-third of the aluminum cargo tank survived the postcrash fire. The entire underside of the tank had been consumed by fire. (See figures 5 and 6.)

Figure 5.--Underside of trailer tank involved in the accident.

The maximum distance from the soot line on the bulkheads, baffles, and inner surfaces of the shell and heads (see figure 5) to the inner surface of the shell was measured for each compartment (see figure 7). Evaluation of the burn damage and soot level on the remaining portions of the cargo tank indicated 6,856 (80 percent) of the 8,600 gallons of fuel either burned or escaped during the postcrash fire. The manhole covers ordinarily at the top of the tank retained the fuel in the inverted position.

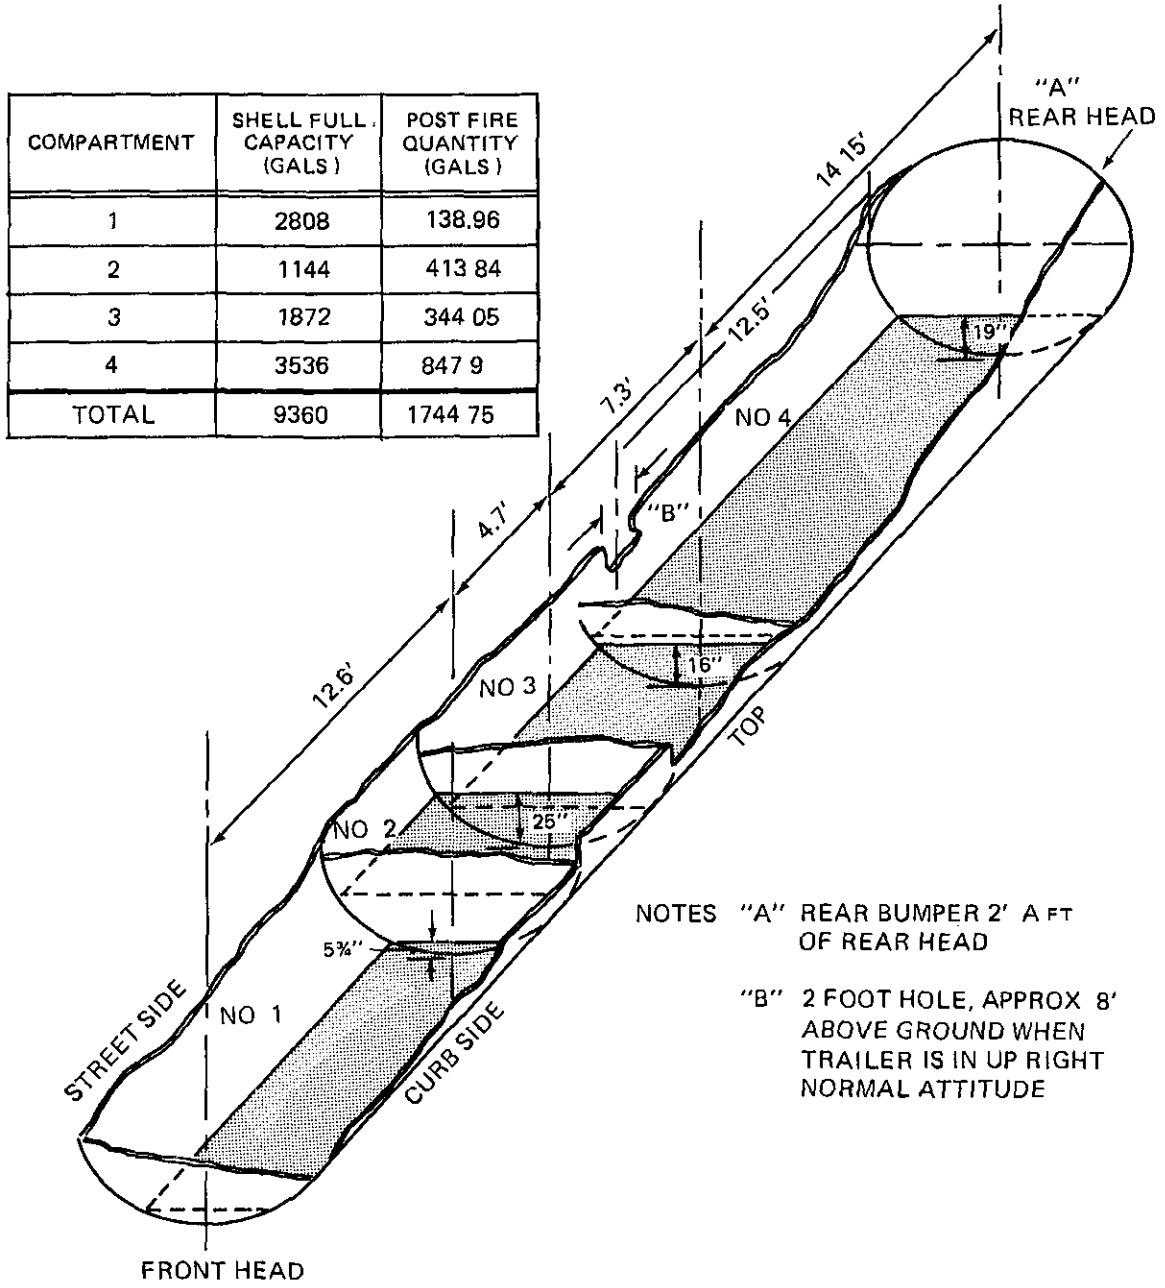
Figure 7.--Diagram of cargo tank shell in postaccident upside-down attitude.

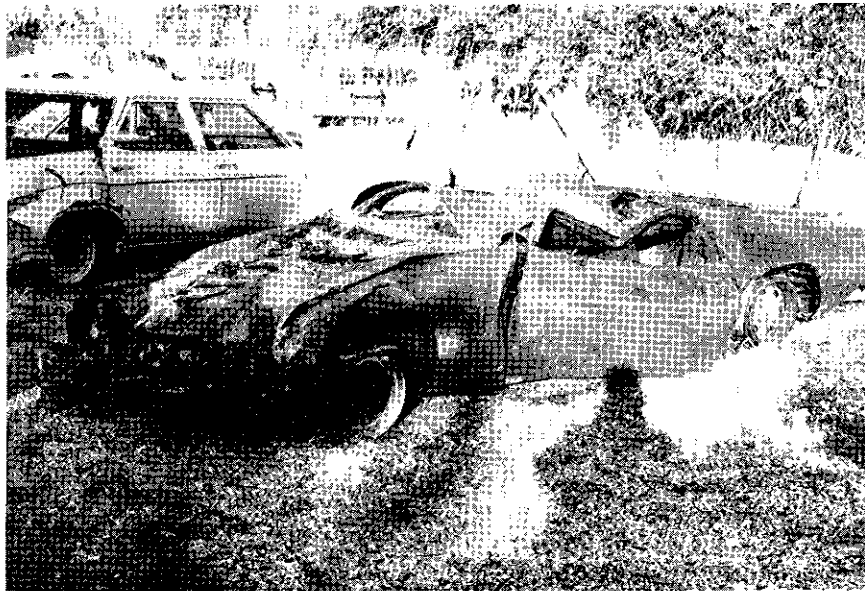
A 1977 Chevrolet Camaro was involved in the accident because of its position in the roadway. Its engine was running but none of the mechanical aspects of the vehicle are pertinent. It was completely burned. All sheet metal was warped from the heat and all combustibles, soft metals, and all instruments were destroyed. The top collapsed during the fire along a longitudinal line near its center with the A and B pillars bent toward the center. The front of the hood was crushed downward to the radiator and engine. (See figure 8.)

Figure 8.--Automobile struck by cargo tank.

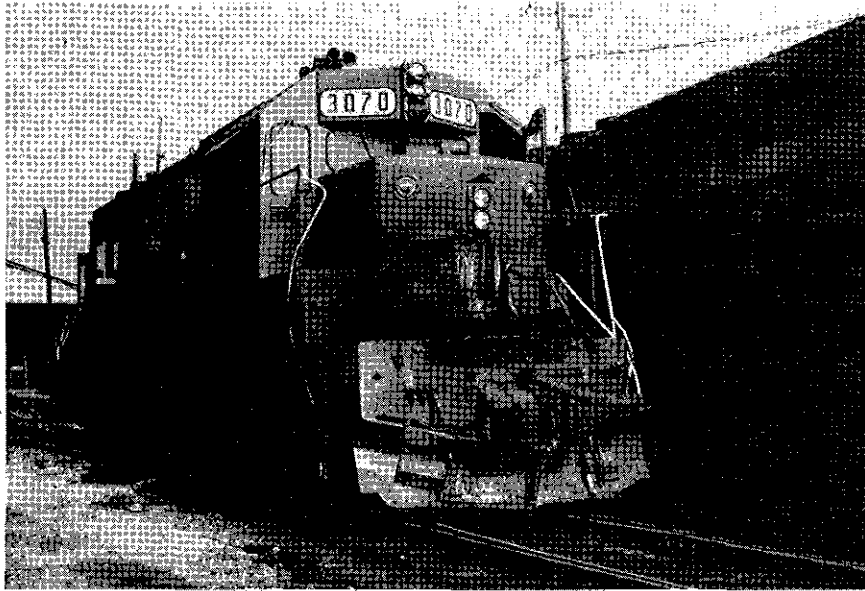
Because of the cool ambient evening temperature, the cab windows were closed tightly at the time of the collision. The cab doors remained closed and cab window glazing remained intact during impact. The interior of the lead locomotive unit's cab was not exposed to the fire. Exterior fire damage to the unit consisted of charred paint and clouded window glass. Mechanical damage at the front end of ICG unit No. 3070 consisted of rearward bent handrails and vertical grabirons at each stairwell. There was a dent approximately 12 inches wide and 24 inches high below the front headlight. Its average depth below the front headlight was about 3 inches. The right-front corner of the forward breastplate of this unit was bent backward 3 to 4 inches. (See figure 9.)

Figure 9.--Locomotive front-end damage.

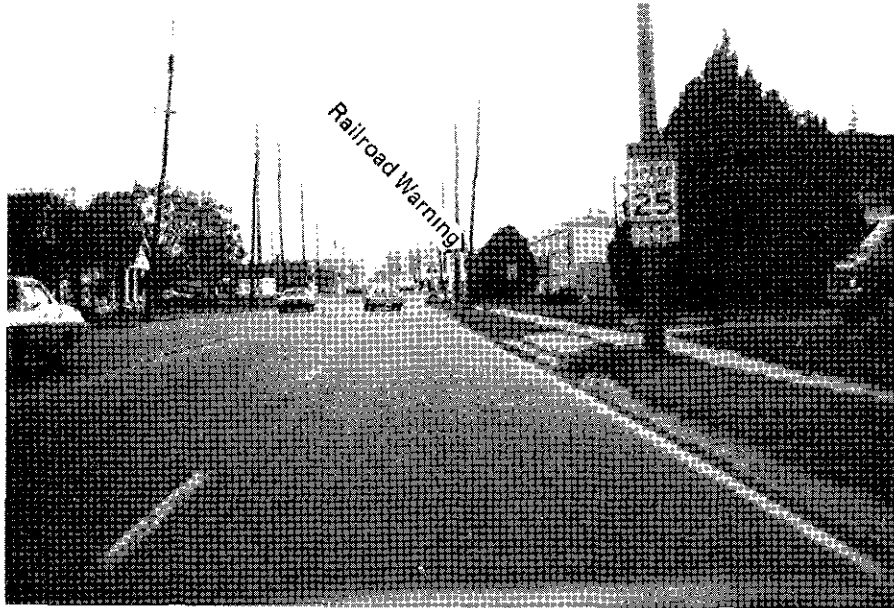
On the southbound approach to the crossing, a railroad advance warning sign was posted at the right edge of the roadway, 360 feet north of the north track. (See figure 12.) The pavement markings consisted of surface white bands across the lanes 170 feet and 120 feet north of the north track with the appropriate dual "X" and the letters "RR" inbetween. All markings showed signs of traffic wear. (See figure 13.)

Figure 12.--Southbound approach to crossing.

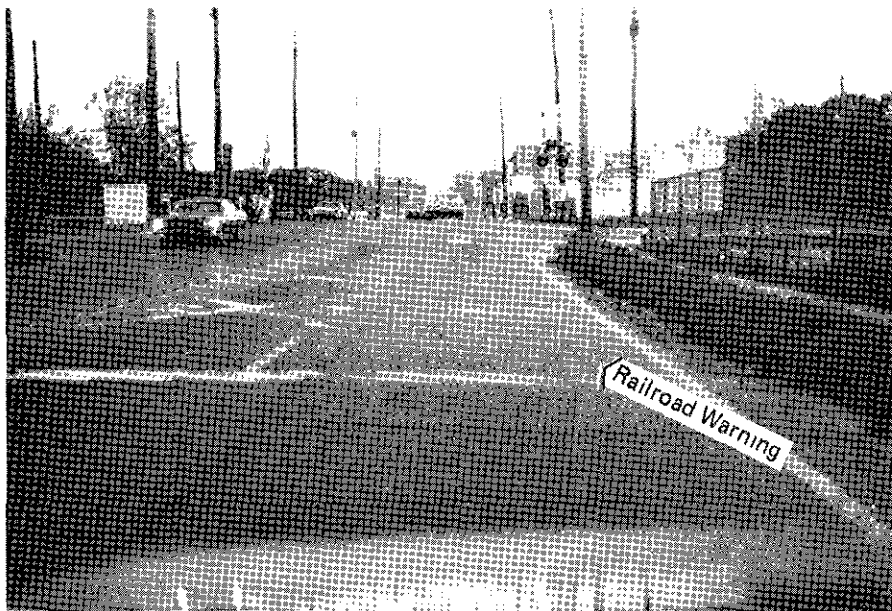
Figure 13.--Pavement marking warning sign north of crossing.

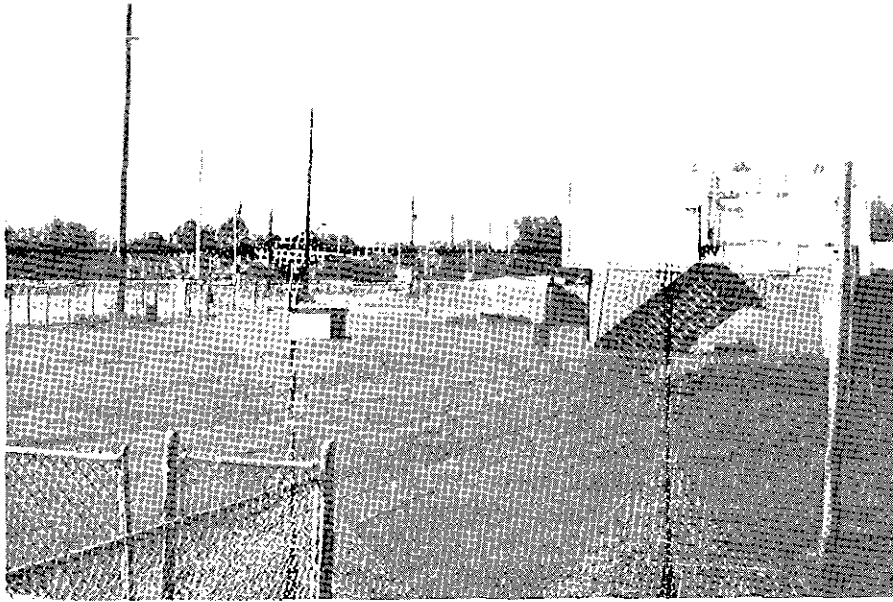
Figure 14.--Line of sight west from a point on Williams Boulevard 240 feet north of the crossing. The tracks were visible for 1,469 feet.

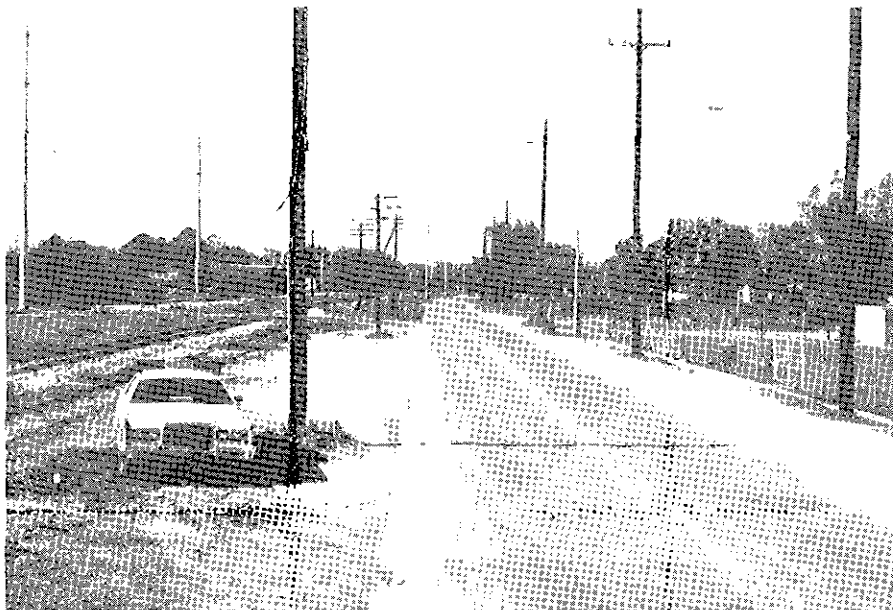
Figure 15.--View from the approximate position of the tractor 105 feet north of the crossing on Williams Boulevard before it went around the crossing gate. The sight distance west along the tracks was 2,110 feet.
