# NATIONAL TRANSPORTATION SAFETY BOARD

## RAILROAD ACCIDENT REPORT

DERAILMENT OF ILLINOIS CENTRAL GULF RAILROAD  
FREIGHT TRAIN EXTRA 9629 EAST (GS-2-28)  
AND RELEASE OF HAZARDOUS MATERIALS  
AT LIVINGSTON, LOUISIANA  
SEPTEMBER 28, 1982

NTSB/RAR-83/05

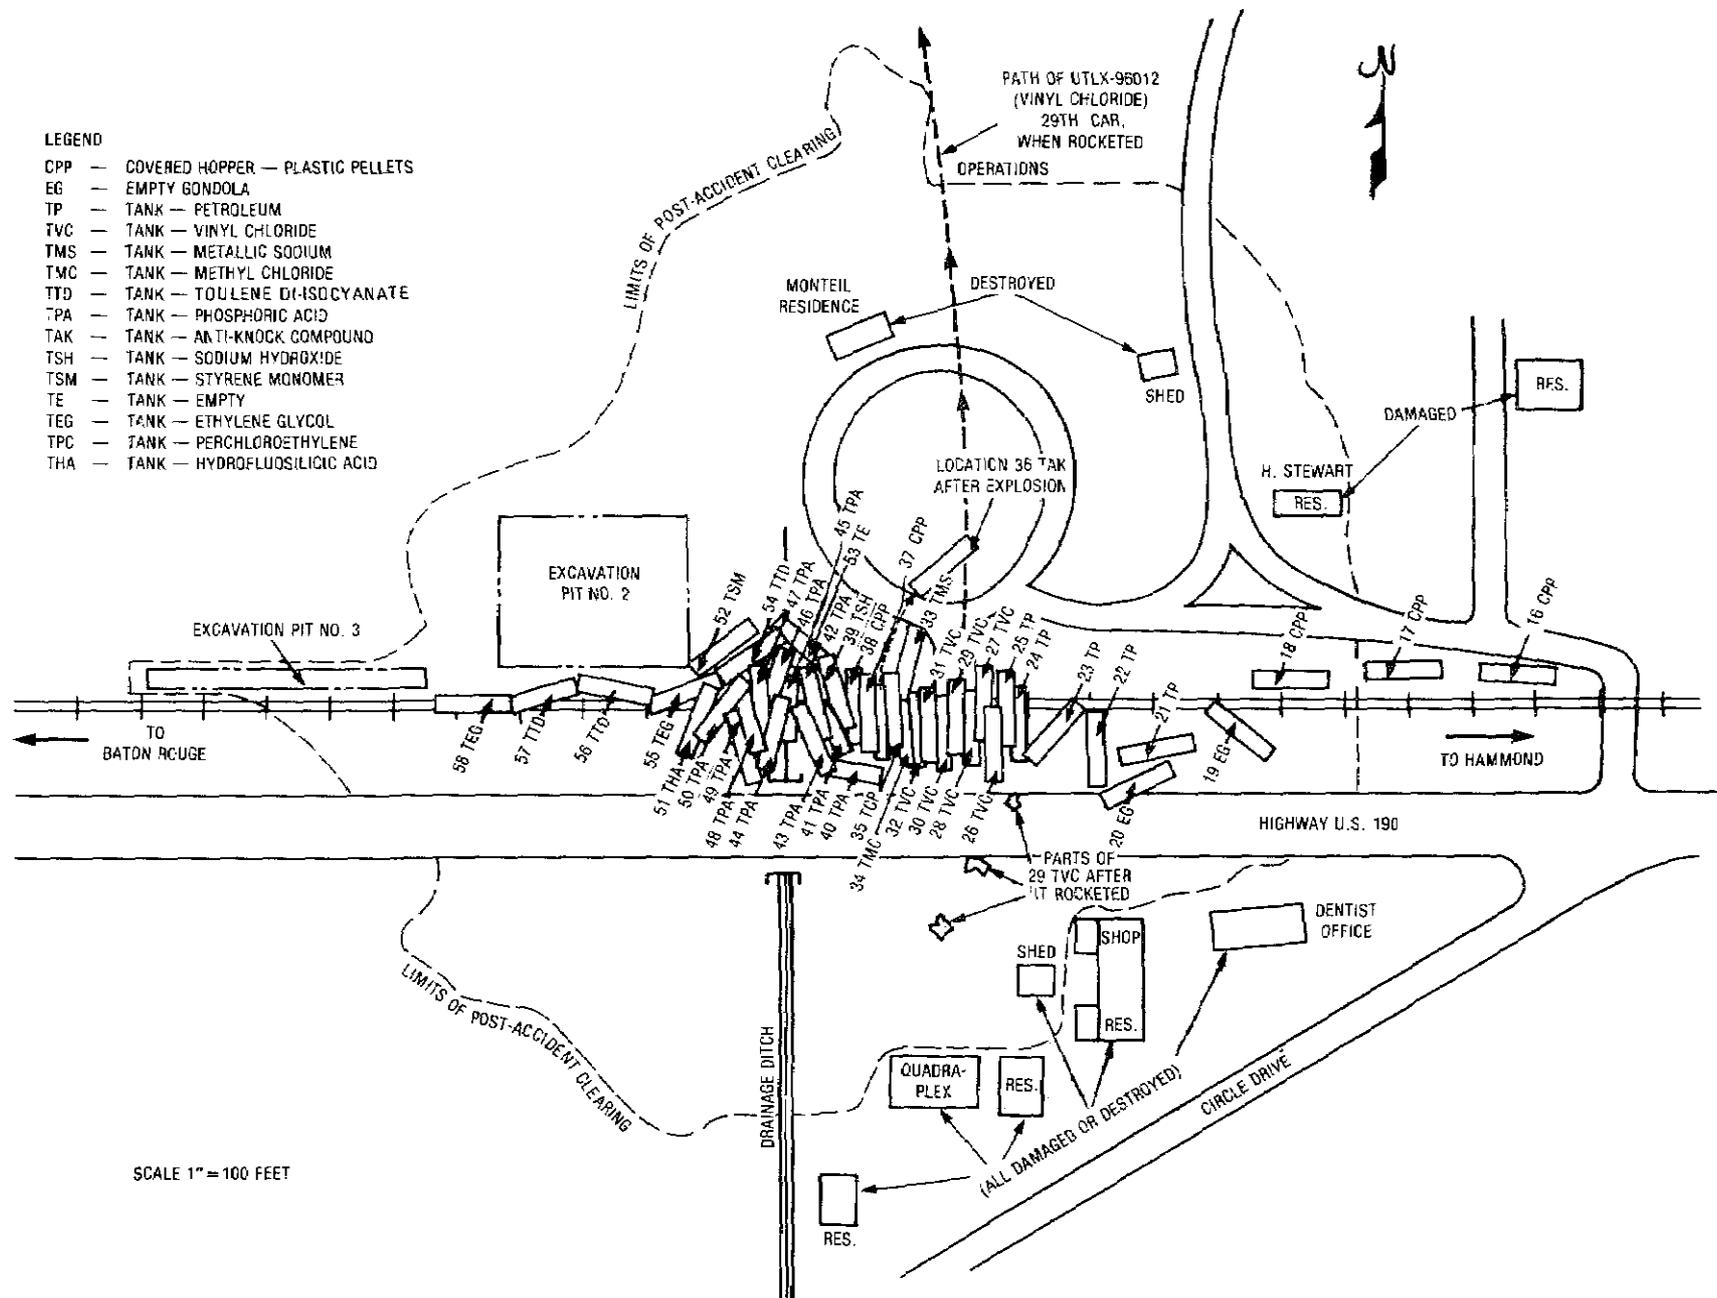
Figure 3.--Derailment site and wreckage distribution.

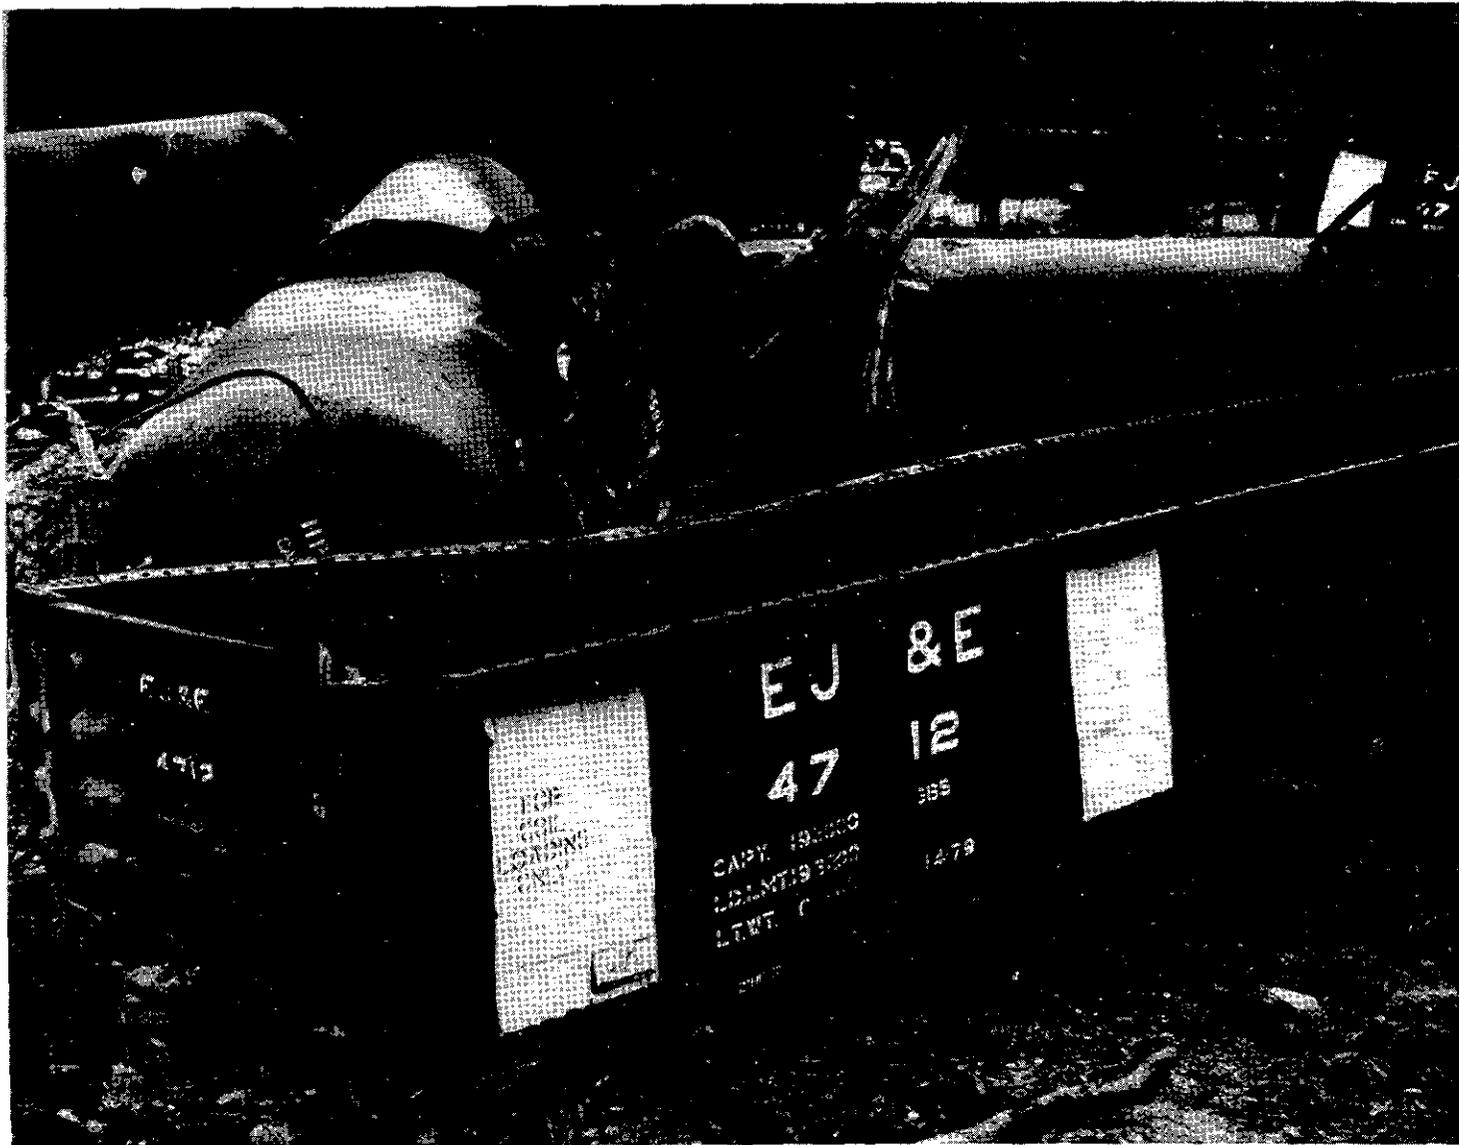
Figure 4.--Lead end of gondola car EJ&E 4712 showing strike damage to end and side. The tank car standing alongside was immediately behind the gondola car in the train.

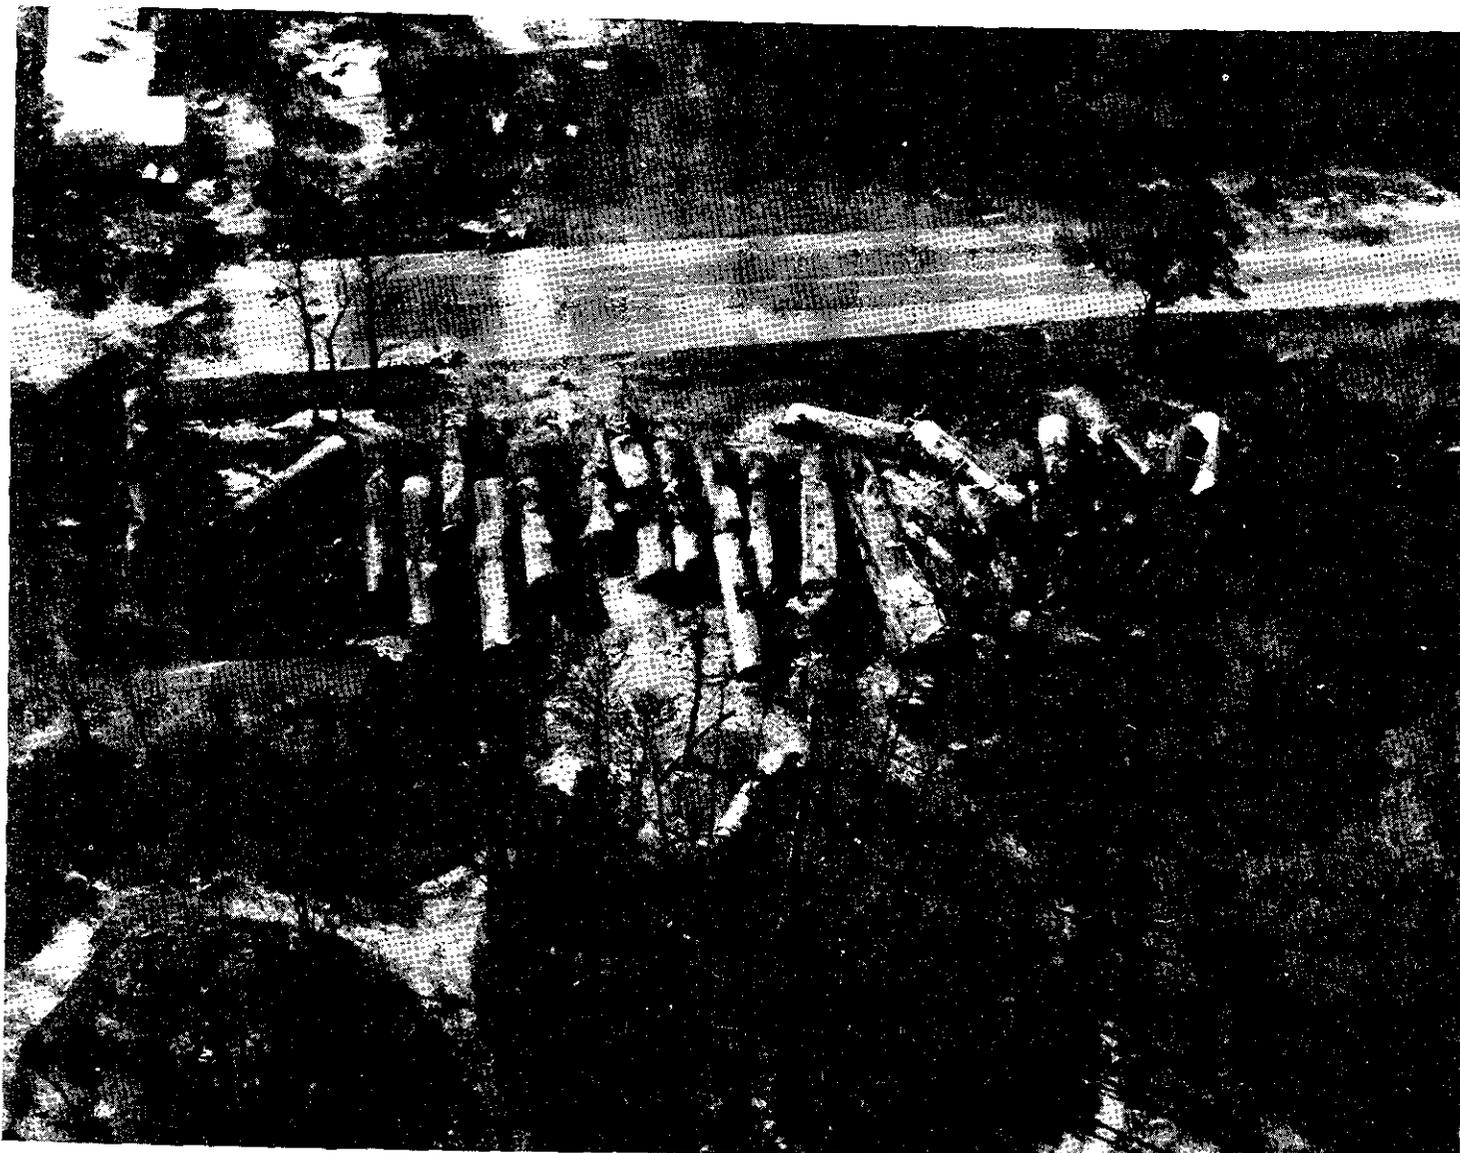
Figure 6.--The derailment site on October 4, 1982, viewed facing south.  
Parts of the vinyl chloride tank car which rocketed are on and just south of the highway. Buildings that were destroyed or severely damaged are shown in the upper left corner.

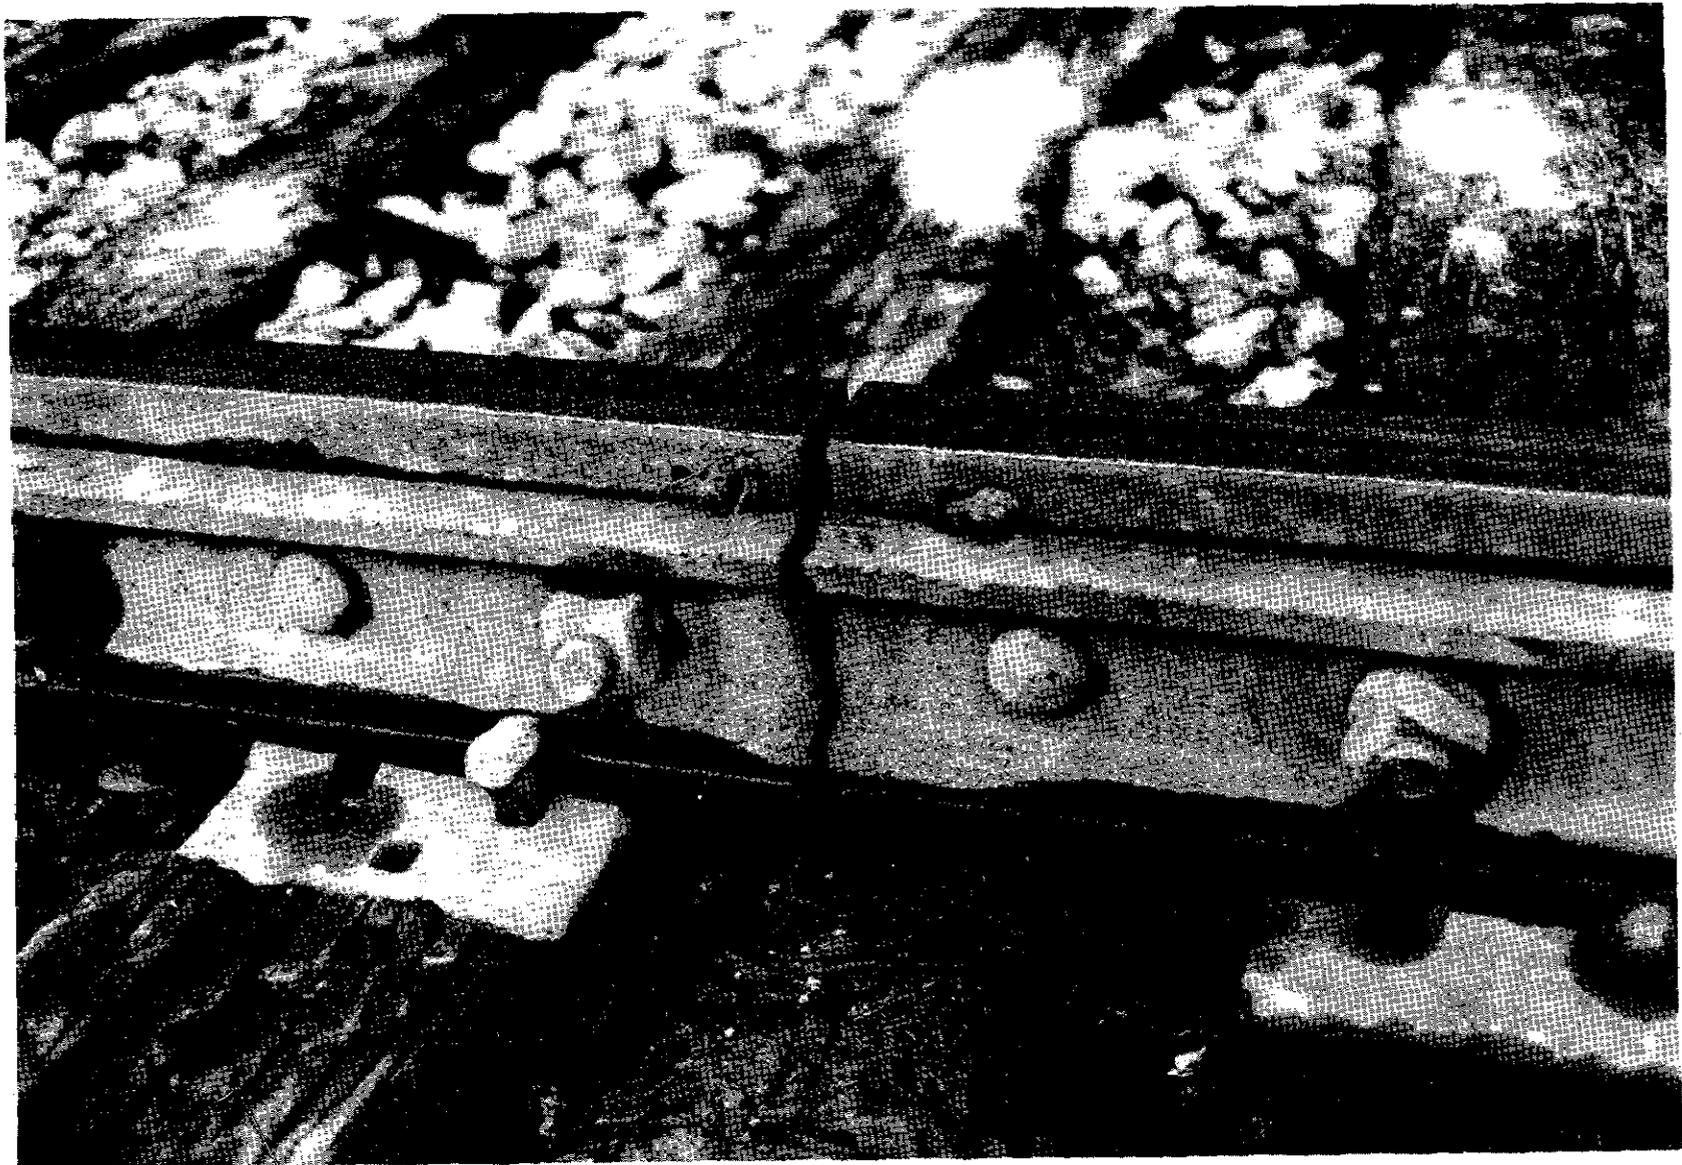
Vertically-pumping joint conditions were found at mileposts 26.45, 26.66, 26.96, 26.99, and 27.1. All but the first of these were near grade crossings. None of the pumping joints were beyond the limits of the track standards, but the bars in the joint at milepost 27.1 fractured on a transverse plane under a work train following the accident. The fractures were similar to those in the bars found in the wreckage at milepost 26.8. (See figure 7.)

Figure 7.--Joint bar with center transverse fracture located at a pumping joint near milepost 27.1. This failure occurred after the Livingston derailment and was similar to the joint-bar failure at the culvert (milepost 26.8)

The fractured joint bars were examined by ICG's metallurgist and the Safety Board's metallurgist on December 31, 1982. The bar on the gauge side of the rail exhibited characteristics of fatigue cracking in two regions. The larger of these two regions was in the head with initiation from numerous places along the interface with the rail. Fatigue propagation was downward to a depth of about 1 1/4 inches. The second fatigue area was in the toe with upward propagation of about 1 inch. Approximately 30 percent of the fractured cross section of this joint bar was cracked by slow growth fatigue. Most of the fracture between the two fatigue regions was typical of fast propagation stemming upward from the toe.

Examination of the field side joint bar disclosed a fatigue crack in the toe region with upward propagation to a depth of about one-half inch. Rapid fracture stemming upward from the fatigue region was indicated.

According to the Safety Board's metallurgist, the deformation of the rail heads at the joint appeared to have been caused by repeated pounding by wheels moving in both directions. The extent of batter, or deformation, was considered to be consistent only with the rails being separated either vertically or horizontally as a result of complete fractures of both joint bars.

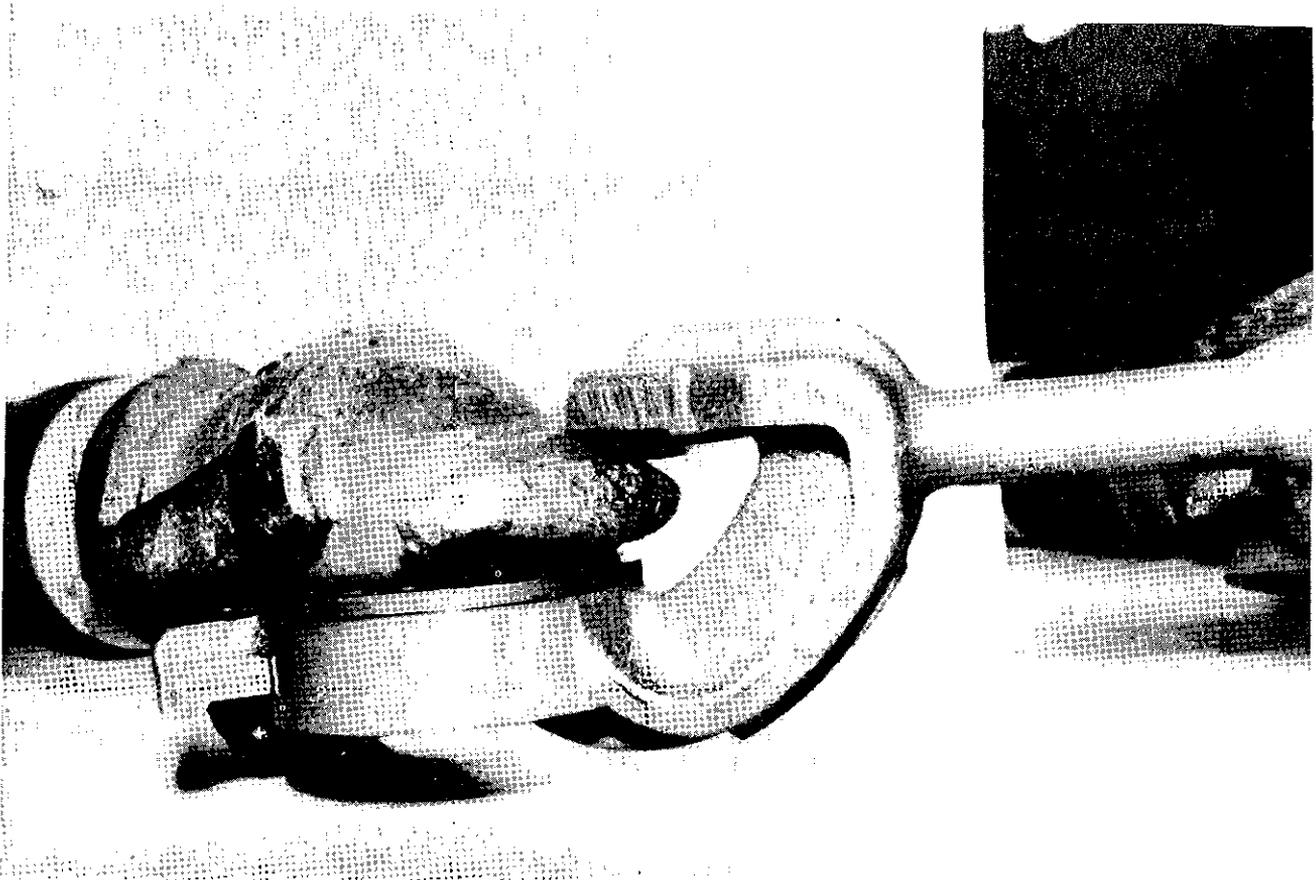
Figure 9.--AAR gage applied to air hose coupling from ICG Unit 3022.  
The gage could not be fully or properly applied.

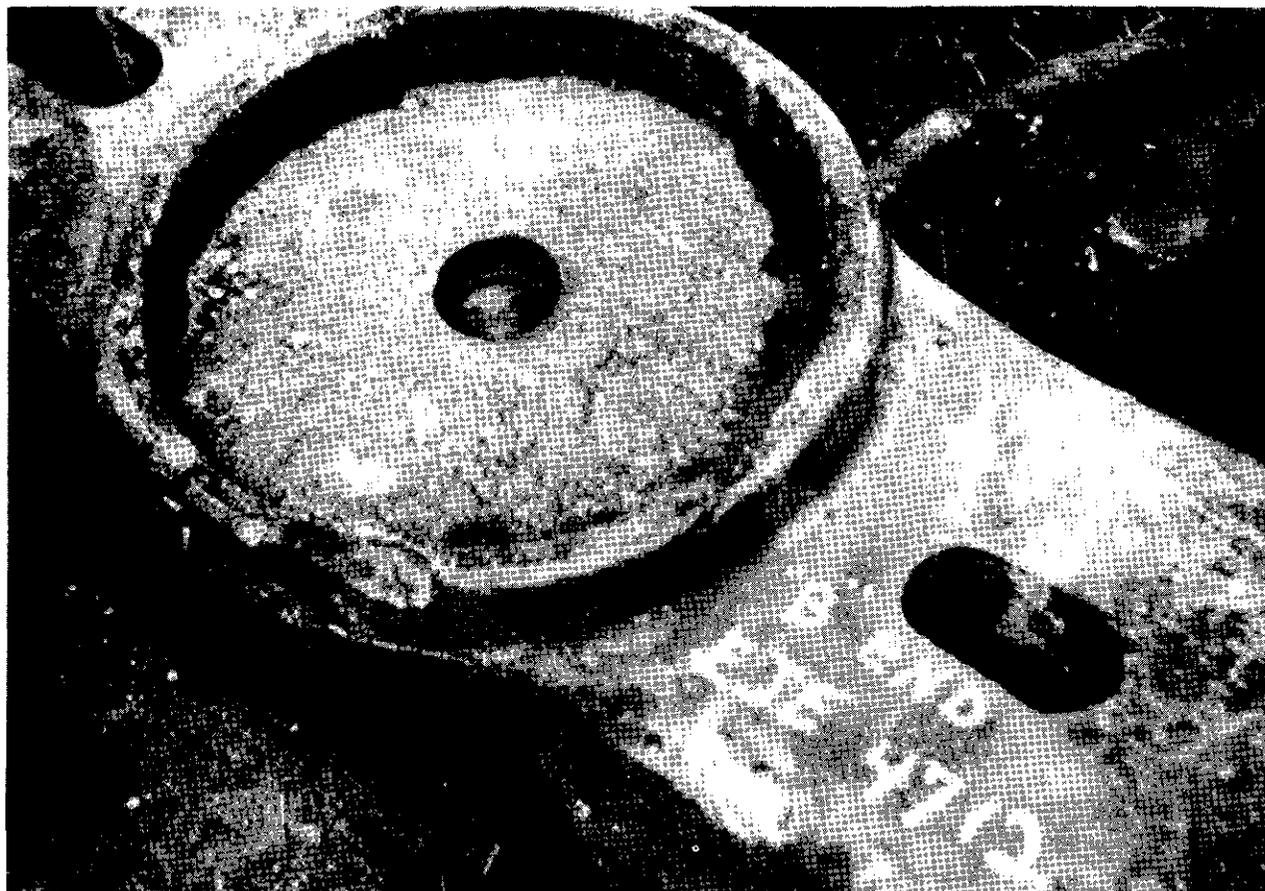
The trailing truck's bolster and wheels were subsequently taken to the metallurgist's laboratory. It was necessary to saw the bolster into two pieces in order to remove the center pin remnant which was bent and had been heavily mushroomed at the fracture face. (See figure 11). In his final report, <sup>18/</sup> the metallurgist stated that the mushrooming of the lower center pin remnant resulted from repeated battering by the upper remnant over a long period of time. This was subsequently confirmed upon examination of the pin by the Safety Board's metallurgists. The wheels were radially sectioned, ground, and etched to reveal their microstructure and heat pattern. None of the wheels revealed any abnormal heat pattern, but the ICG's metallurgist concluded that intense heat generated by the rocketing and detonation of the vinyl chloride cars had obliterated thermal evidence.

Figure 10.--Center plate of trailing truck bolster, gondola EJ&E 4712, with lower remnant of center pin lodged in the bolster.

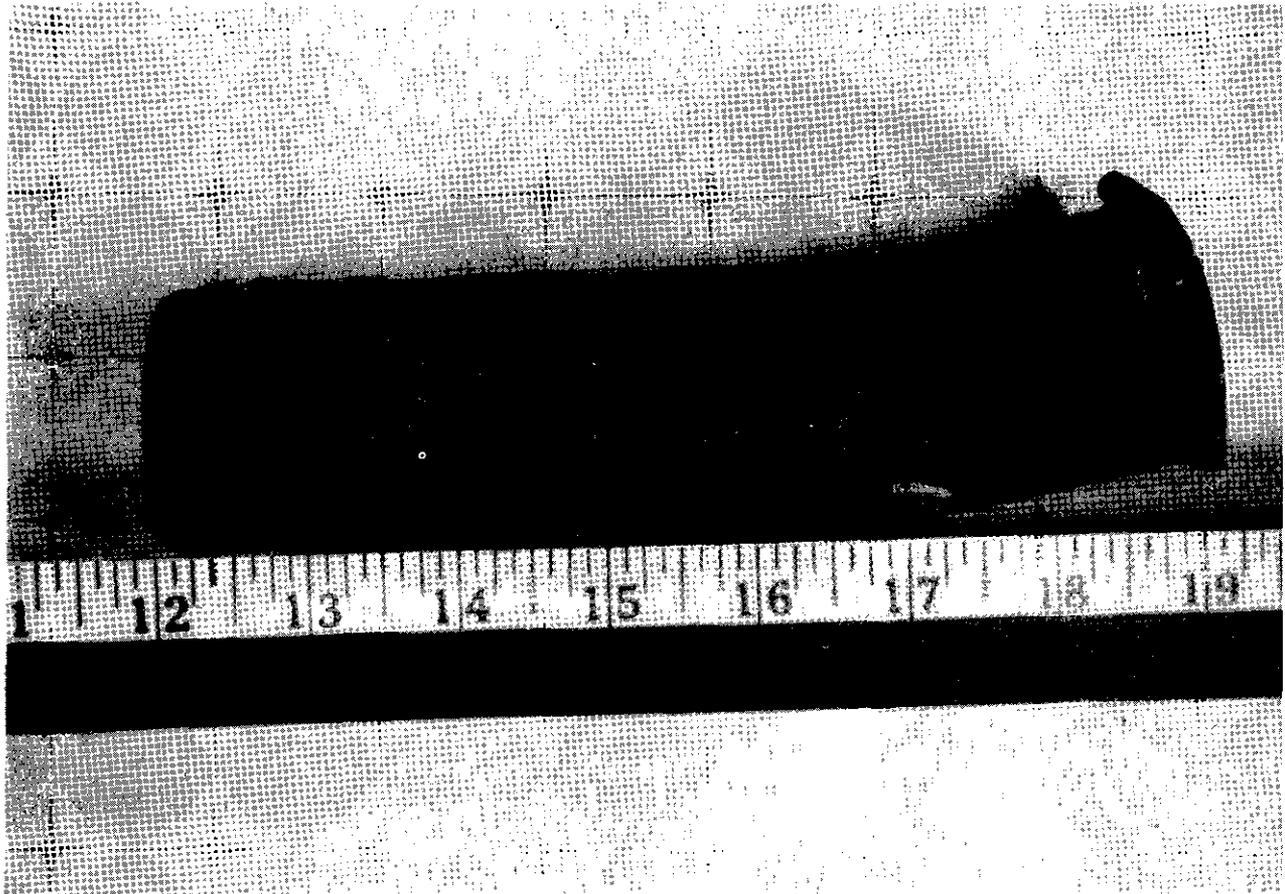
Figure 11.--Center pin remnant removed from truck bolster of EJ&E 4712. Fracture face mushroomed by battering from upper remnant over a prolonged period.
