ILLINOIS CENTRAL GULF
RAILROAD COMPANY
FREIGHT TRAIN DERAILMENT
HAZARDOUS MATERIAL RELEASE
AND EVACUATION
MULDRAUGH, KENTUCKY
JULY 26, 1980

NTSB-RAR-81-1

**ILLINOIS CENTRAL GULF RAILROAD COMPANY
FREIGHT TRAIN DERAILMENT
HAZARDOUS MATERIAL RELEASE
AND EVACUATION
MULDRAUGH, KENTUCKY
JULY 26, 1980**

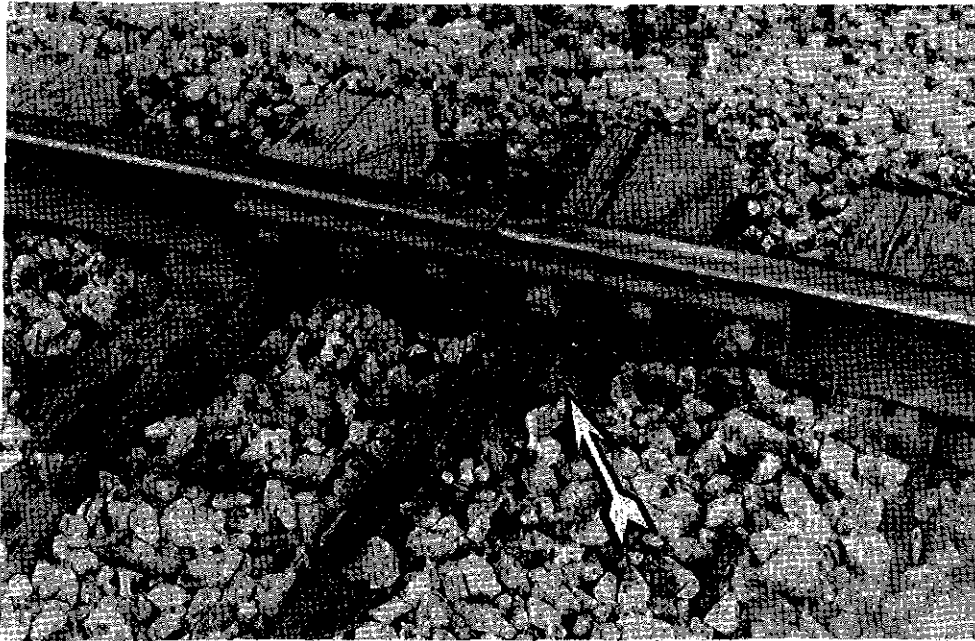
Postderailment inspection disclosed defects in crossties, tie plates, and spiking in the approach to and beyond the point of derailment. (See figures 2, 3, 4, and 5.) A defective crosstie, marked by the ICG with a yellow dot prior to the December 14, 1979, FRA geometry car inspection, was found in the middle location at a supported insulated joint on the east rail about 216 feet south of the point of derailment. (See figure 2.) The ICG joint was supported by three crossties. The track safety standards (49 CFR 213.109(d)) require a minimum of one nondefective crosstie at each joint of Class 3 track, and a nondefective crosstie in a supported joint must be in the middle location. The yellow dot on the crosstie is a carrier-used method of indicating that the crosstie must be removed. A tie plate was also missing at this joint.

Figure 2.—Defective crosstie marked by yellow dot (arrow) 216 feet before the point of derailment.

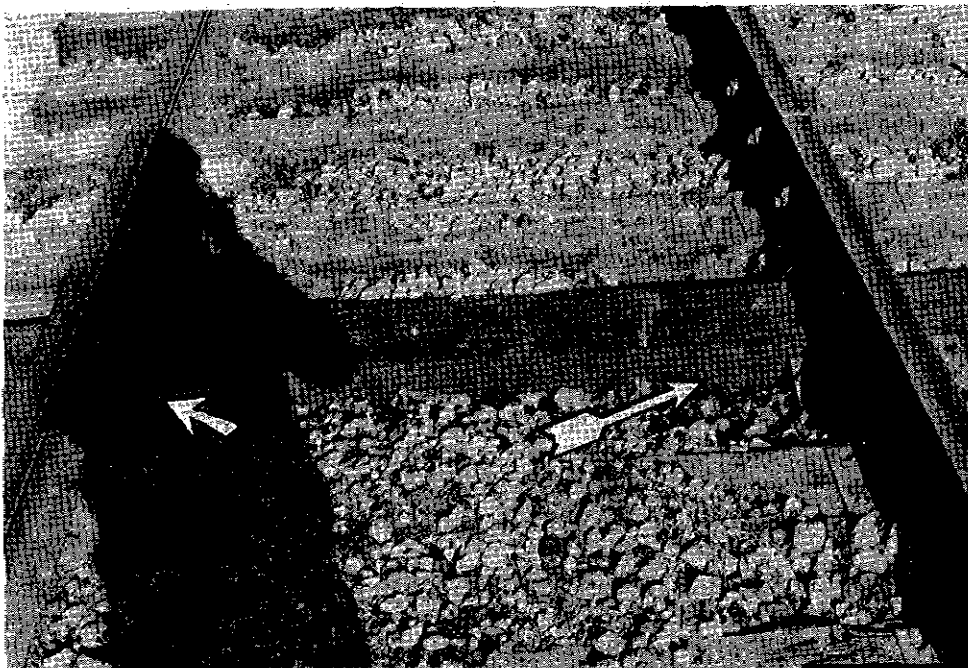
An unspiked new crosstie was found at a location about 300 feet south of the point of derailment. (See figure 3.) Because of the absence of spikes in a number of the new crossties, many tie plates were not properly positioned under the rail base. (See figure 4.) Federal regulations require that tie plates having shoulders must be placed so that no part of the shoulder is under the base of the rail.

Figure 3.—Unspiked new crosstie about 300 feet south of the point of derailment.

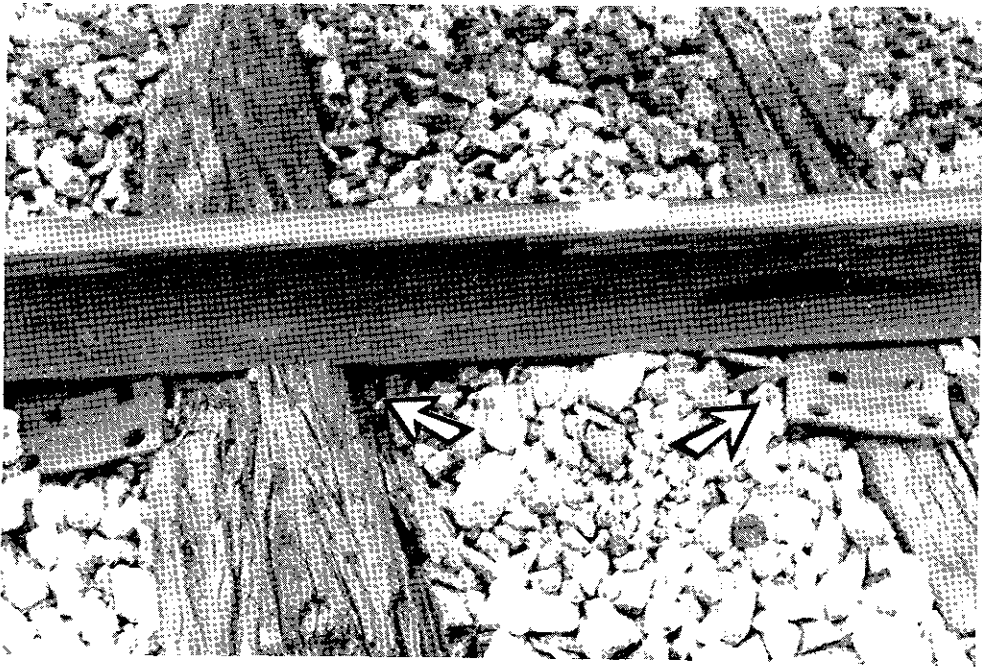
Figure 4.--Improperly installed and unspiked tieplates in derailment area.

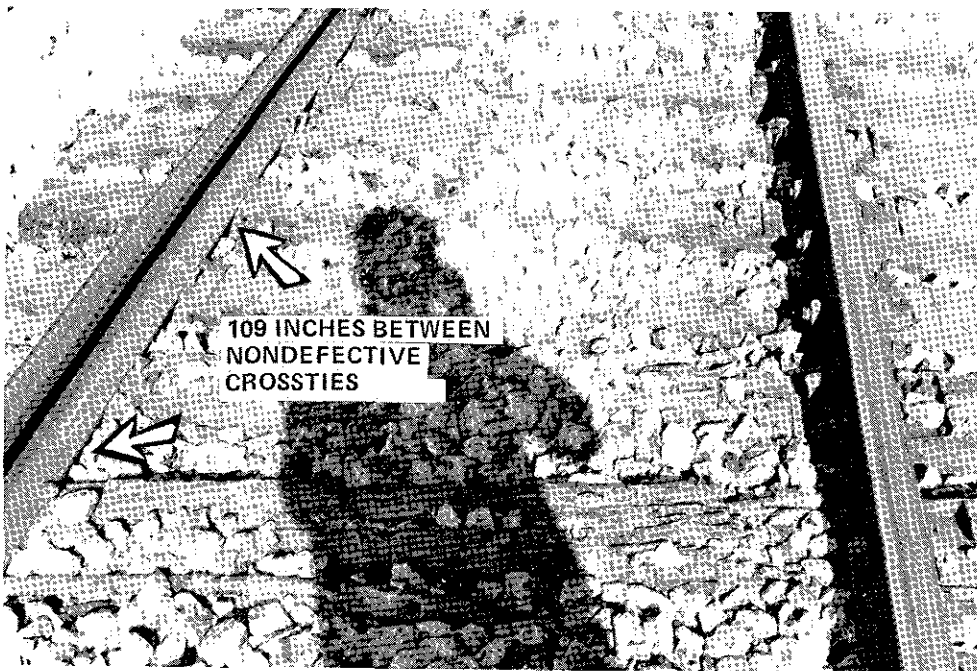
Four adjacent defective crossties--two were split and two were missing spikes--were found at the accident site, leaving a space of 109 inches between nondefective crossties. (See figure 5.) This exceeded the 70 inches maximum for nondefective crosstie spacing for Class 3 track allowed by the track safety standards (49 CFR 213.109(c)).

Figure 5.--Four adjacent defective cross-ties at the accident site.

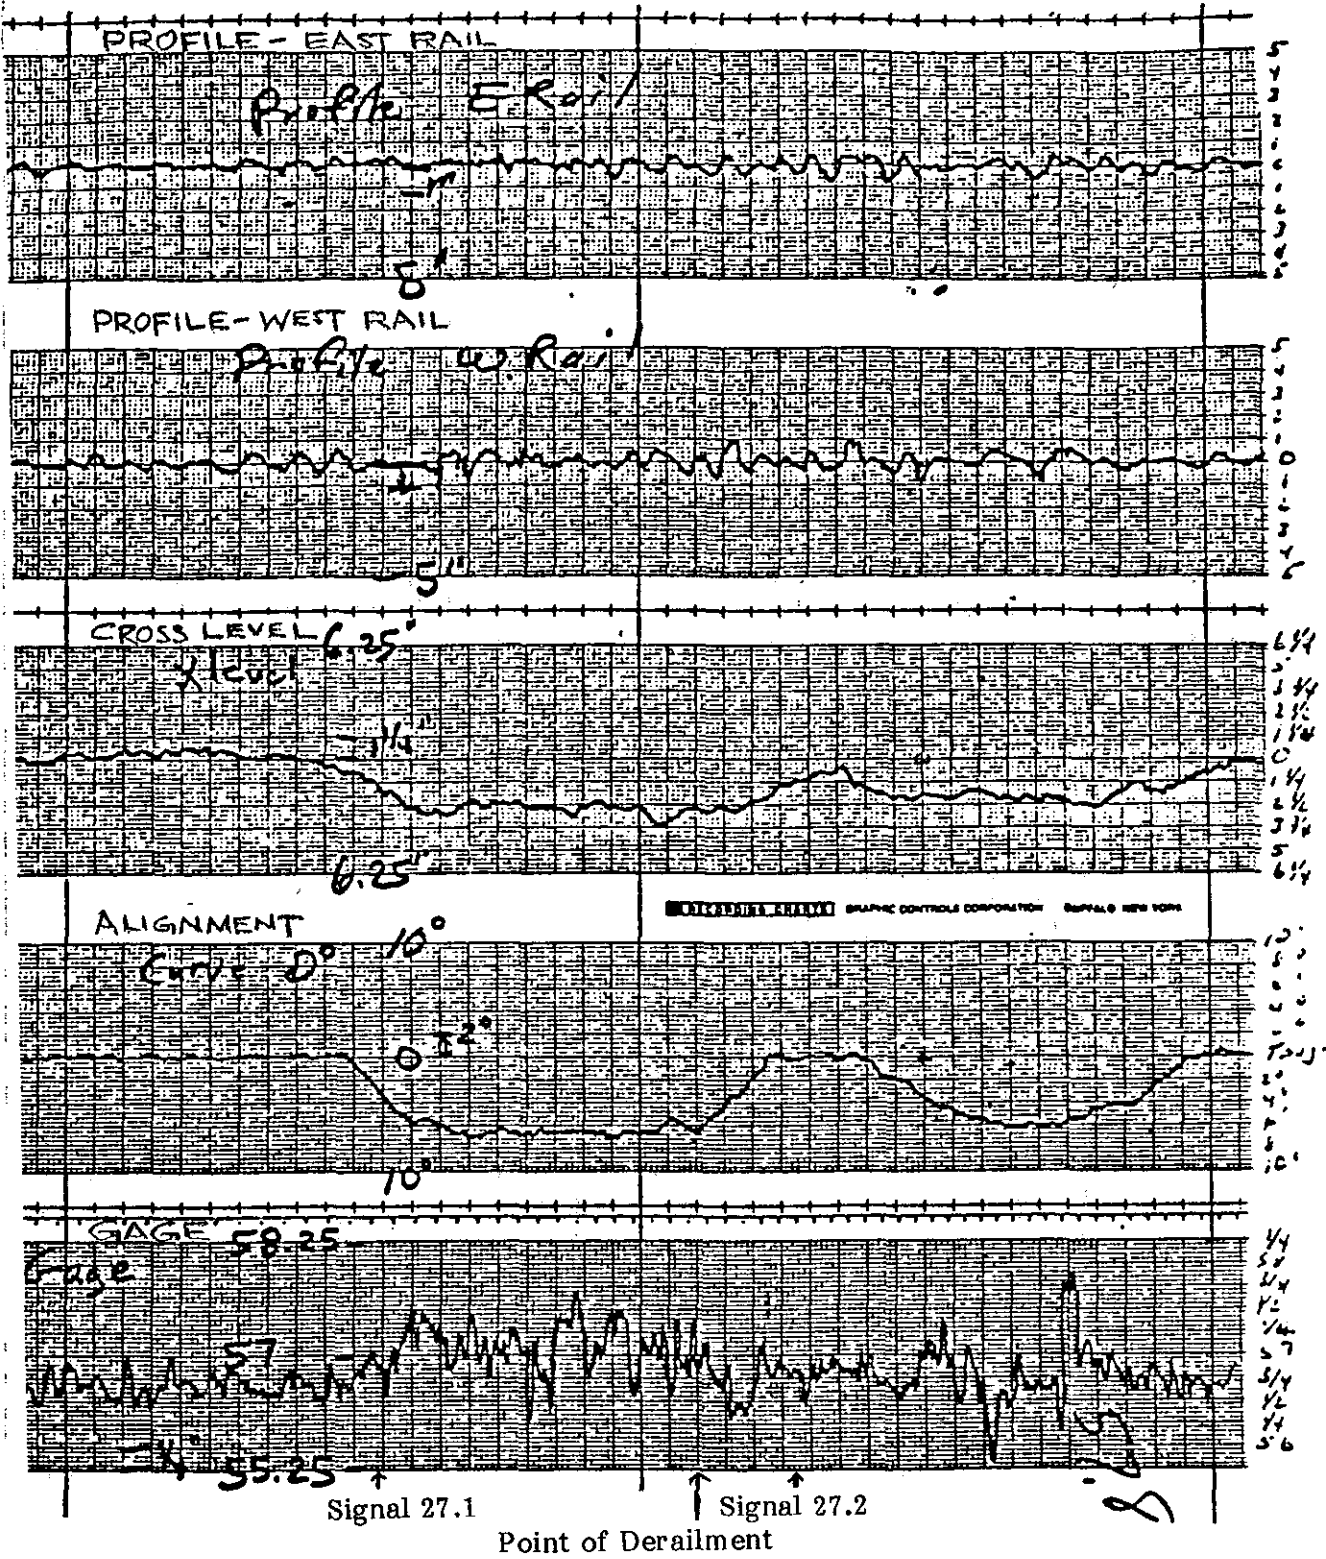
APPENDIX D
FRA GEOMETRY TAPE,
DECEMBER 14, 1979
ICG TRACK, MP 27 TO 28

measurements of the track made by the FRA geometry car revealed abrupt changes in curvature and superelevation for a distance of about 84 feet at the beginning of the 6° curve. The variations of the 6° curve alignment from 5°30' to as much as 7° would have produced additional lateral forces on the outside rail of the curve as a train moved around the curve. Abrupt changes in the superelevation also would have produced unequal lateral forces. Even though these measurements were made about 6 months before the accident, there is no record that the repairs were made to correct these conditions before the accident occurred. Separately, these defects were not in violation of the standards for Class 3 track. However, constant traffic would, in all likelihood, have made the deviations greater than when originally measured. The increased possibility of derailment because of the combination of these deteriorating track conditions should have been recognized by inspectors.

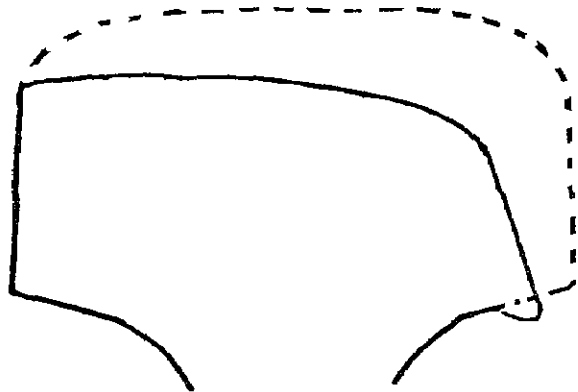
A postaccident inspection revealed that the gage side of the head of the outside rail of the 6° curve was reduced between 28 to 44 percent of its surface. (See appendix E.) The ICG inspector who made the July 24, 1980, inspection said he noticed flange marks on the top of joint bars at milepost 27.5. He said he attributed the flange marks to railhead wear and curve-worn rail on the high side of the curve which would permit the flanges of the wheels to contact the joint bars. He did not note these conditions on the inspection report.

Many excessively curve-worn rails were found throughout the derailment area. The approximate 28- to 44-percent reduction in the cross section of the rail would have substantially lowered the rail's ability to withstand bending stresses. ^{3/} This worn condition would have made the rail more prone to breakage under the strain of the increasingly heavy loads carried by today's trains. ^{4/} A 44-percent reduction of cross section also would have made the rail more prone to tipping because the resultant force of the vertical and lateral component forces of the wheel on the rail could have been beyond the outside edge of the rail base. The use of such curve-worn rails is left to the discretion of the carrier. Neither the ICG nor the FRA have promulgated rules or regulations to limit wear for rails that are used in mainline trackage. The Safety Board believes that the use of such excessively worn rails should not be used on main or side tracks.

WEST RAIL, STA 30+71
28% WEAR

Establish and implement track maintenance standards which designate the limit of acceptable rail wear and which require rail removal when worn beyond the acceptable limits. (Class II, Priority Action) (R-81-33)

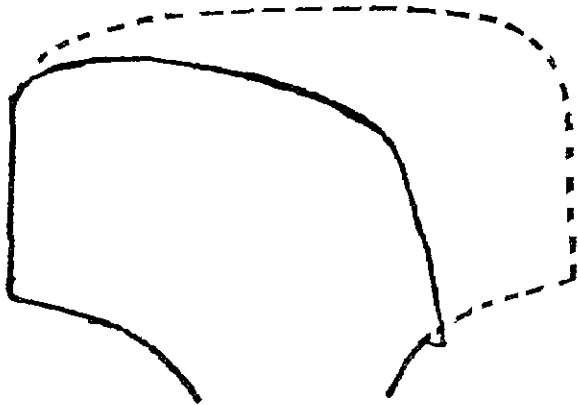
WEST. RAIL, STA 34+27
44% WEAR
