# NATIONAL TRANSPORTATION SAFETY BOARD

COLLISION OF  
AMTRAK PASSENGER TRAIN NO. 301  
ON ILLINOIS CENTRAL GULF RAILROAD  
WITH MARQUETTE MOTOR SERVICE TERMINALS, INC.  
DELIVERY TRUCK  
WILMINGTON, ILLINOIS  
JULY 28, 1983

✓  
NTSB/RHR-84/02,

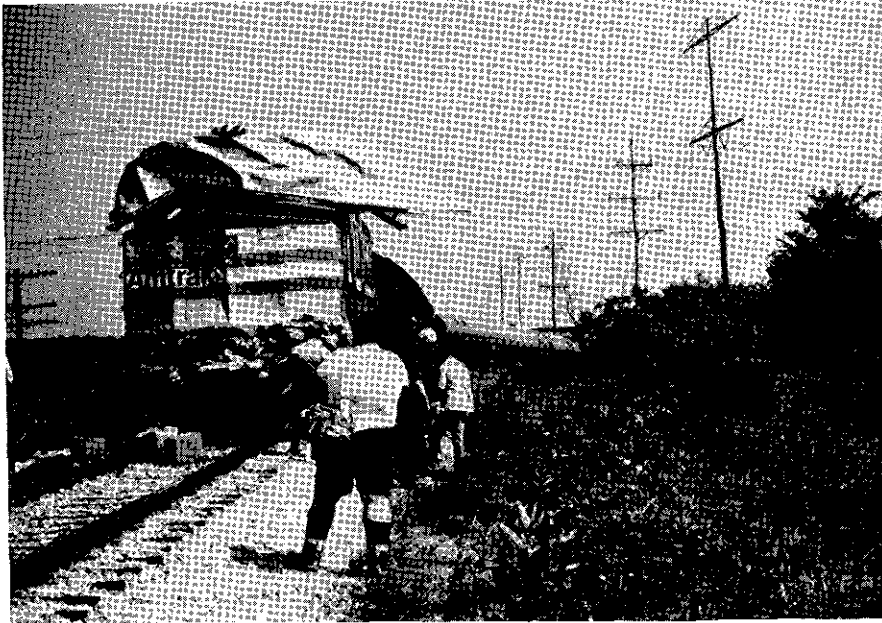
As a result of the collision, the locomotive unit derailed, and upon exiting the crossing its lead truck turned over and displaced the east rail from the track structure. The displaced rail caused the train's cars to derail as they passed over the crossing. The couplers between cars did not separate. The locomotive unit remained upright on the track structure and came to a stop about 800 feet south of the crossing. The lead car remained in line with the locomotive unit but was tilted about 45 degrees to the left (east). The second car came to a stop diagonally to the track with its left side against the east embankment. The rear car was diverted laterally from the track structure down an embankment into a deep ditch east of the track grade, where it came to a stop on its left side. (See figure 3.)

Figure 1.--View north of derailed train No. 301.

The locomotive unit sustained considerable front-end damage as a result of the collision, with both halves of the windshield shattered and the running gear damaged as a result of the postcollision derailment. The bodies and underframe equipment of the two rear cars were damaged extensively. The underfloor batteries and other apparatus of the emergency lighting system were damaged. Microwave ovens and other equipment and supplies were ejected from wall stowage locations in the food service car and caused considerable interior damage. About 700 feet of track was damaged.

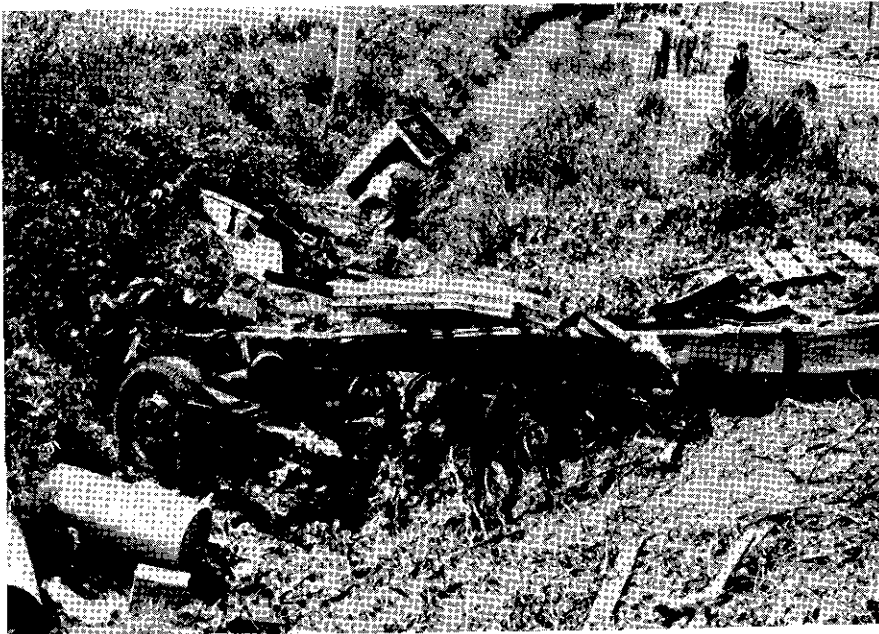
A two-axle, cargo van truck, operated by Marquette Motor Service Terminals, Inc., (MMS), was moving east on New River Road en route to deliver merchandise to a factory about 1 mile east of the crossing. The driver was alone in the truck. The engineer and fireman of the train stated that the truck closely followed an automobile onto the crossing and appeared to be traveling about 40 to 50 mph. The fireman applied the train's brakes in emergency when he realized that the truck was not going to stop and that a collision was imminent. The locomotive unit struck the van cargo area of the truck behind the cab, separating it from the chassis. One side of the van cargo area became wrapped around the windshield of the locomotive. (See figure 1.) The truck's chassis and cab also were separated, both coming to rest in a ditch in the southeast quadrant of the crossing. Other parts of the truck and its lading were scattered east of the crossing. (See figure 2.)

Figure 2.--View south of truck chassis and cab.

The truck and its lading were destroyed.

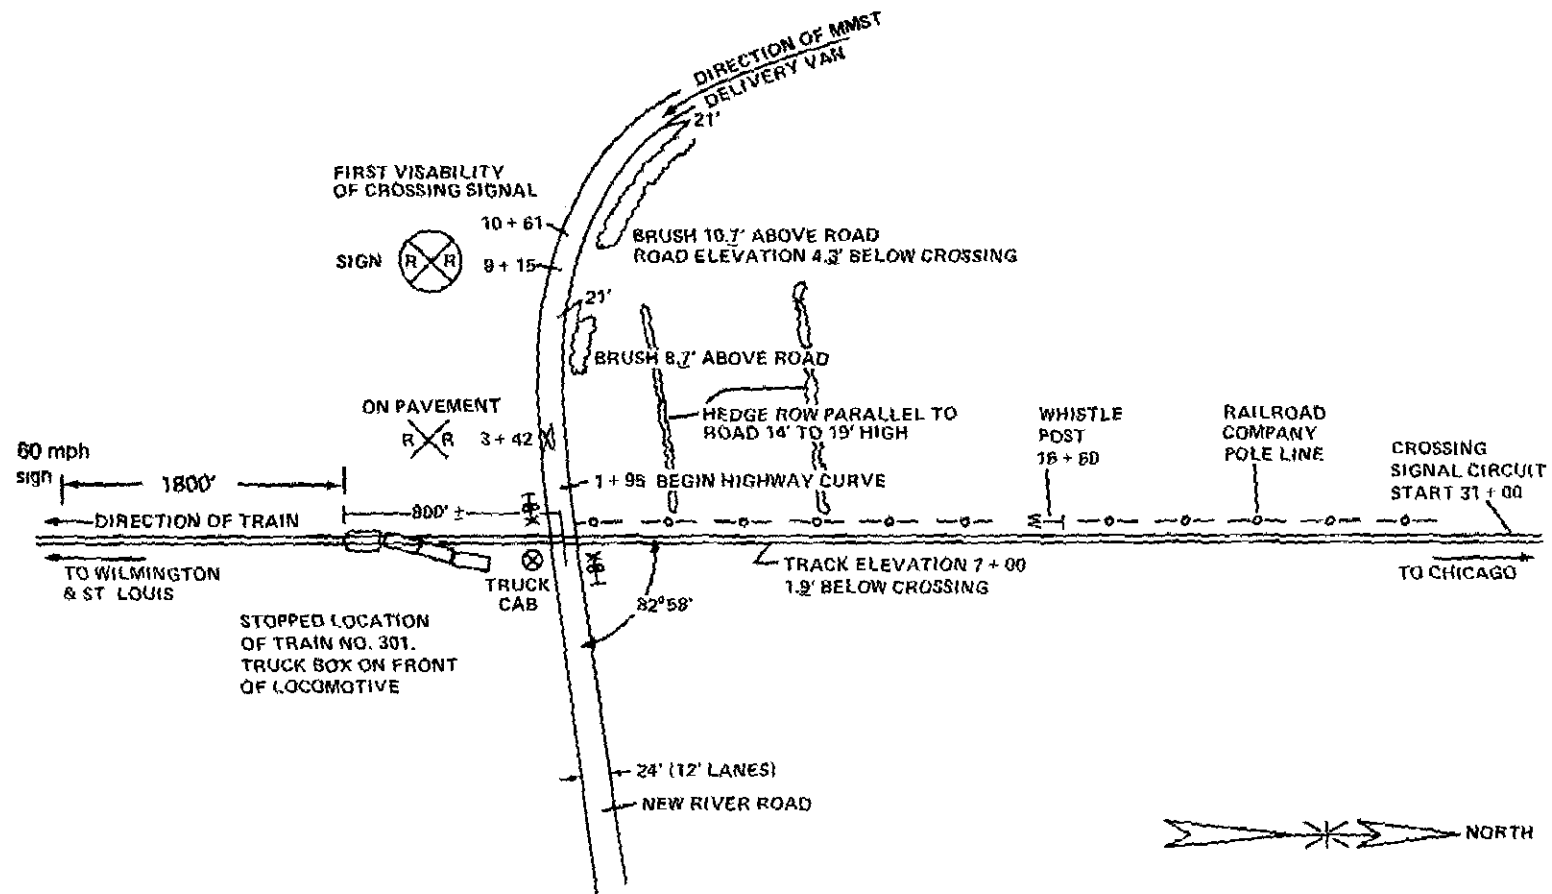
Figure 3.--Plan view of accident site.

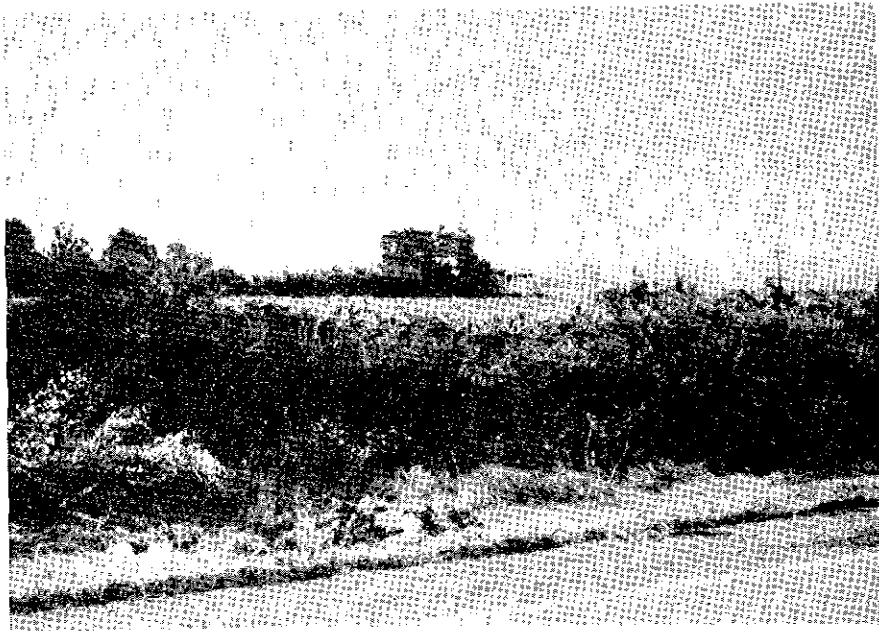
Figure 4.--View east along New River Road.

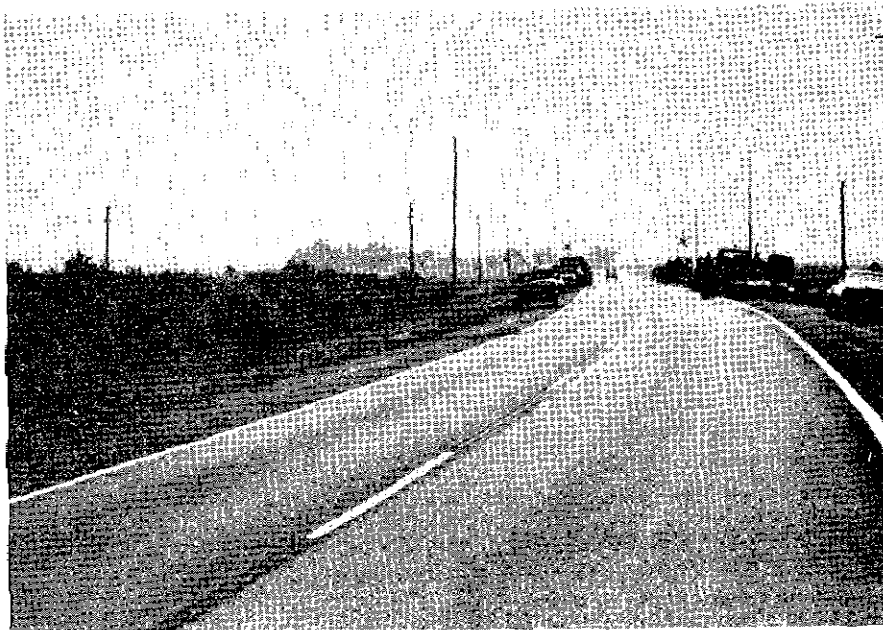
Figure 5.--View of track across northwest quadrant.
