## INTERSTATE COMMERCE COMMISSION

REPORT OF THE DIRECTOR OF THE BUREAU OF SAFETY CONCERNING AN  
ACCIDENT AT THE INTERSECTION OF THE TRACKS OF THE ILLINOIS  
CENTRAL RAILROAD AND THE CHICAGO AND EASTERN ILLINOIS  
RAILWAY AT MARION, ILL., ON AUGUST 3, 1933.

December 6, 1933.

Inv. No. 1841  
Illinois Central RR  
Chicago & Eastern Illinois Ry  
Marion, Ill.  
August 3, 1933.

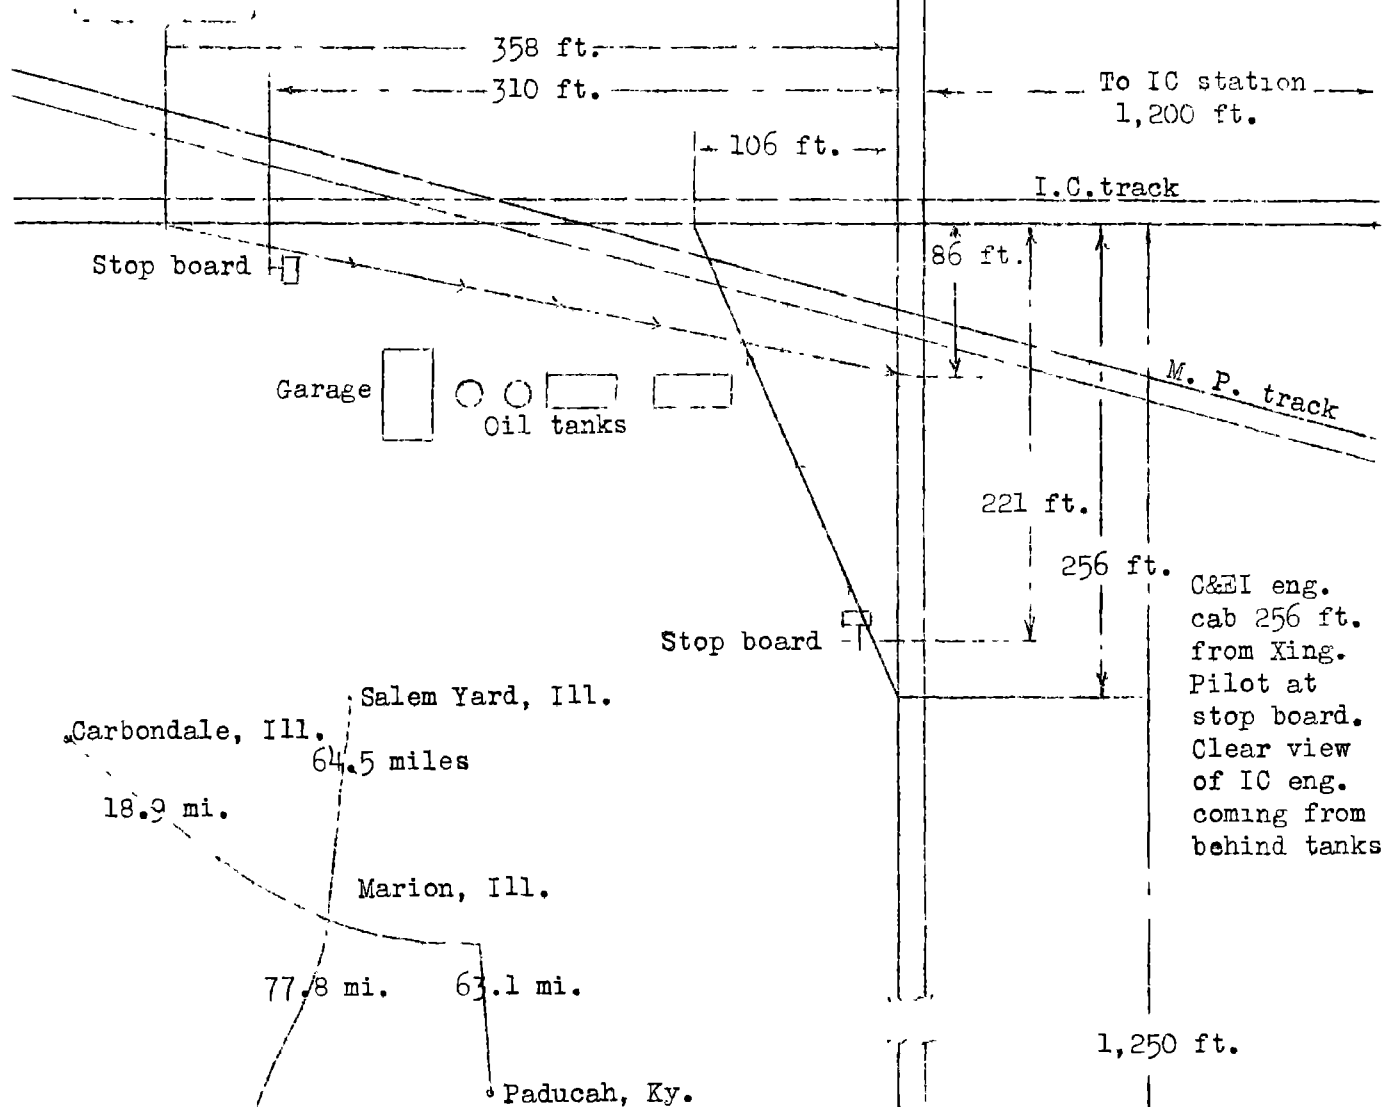
IC eng. cab 358 ft. from  
Xing. Pilot at stop  
board. Clear view  
of C&EI engine 86 ft.  
from crossing.

C&EI eng.  
cab 256 ft.  
from Xing.  
Pilot at  
stop board.  
Clear view  
of IC eng.  
coming from  
behind tanks

Due to buildings and oil tanks of the Mid-Continent Oil Company being located in the southwest corner of the crossing, the views had by the engineman of a south-bound IC train and the fireman of a north-bound C&EI train are considerably restricted. When an engine of an IC train is at the stop board 310 feet from the crossing, the engineman is unable to see a north-bound C&EI train until that train reaches a point 86 feet south of the crossing; with the engine of a C&EI train at the stop board 221 feet from the crossing, the fireman is unable to see a south-bound IC train until it reaches a point 106 feet west of the crossing. As each train approaches the crossing the view of the other track gradually lengthens.

The view is considerably obstructed when approaching this crossing on both of the intersecting tracks; no signal or interlocking protection is provided and safety of operation over the crossing depends upon engineman knowing that the track is clear. Had Fireman Hatfield maintained a constant look-out from his side of the cab after advising Engineman Deffenbaugh that the way was clear he could have discovered that the opposing train was approaching the crossing and have warned his engineman in time to avert the accident. Engineman Deffenbaugh should have seen to it that his fireman was maintaining a proper lookout. From the evidence, and the fact that neither train could stop before reaching the crossing, it is apparent that neither engineman was approaching the crossing under such control that he was prepared to stop unless the track was clear, as required by the rules and in accordance with the provision of the state law which requires that before proceeding an engineman must positively ascertain that the way is clear and that his train can safely resume its course.
