REPORT OF THE DIRECTOR
BUREAU OF SAFETY

ACCIDENT ON THE
ILLINOIS CENTRAL RAILROAD
AND THE
CHICAGO, MILWAUKEE, ST. PAUL & PACIFIC RAILROAD

CHARLES CITY, IOWA

INVESTIGATION NO. 2329

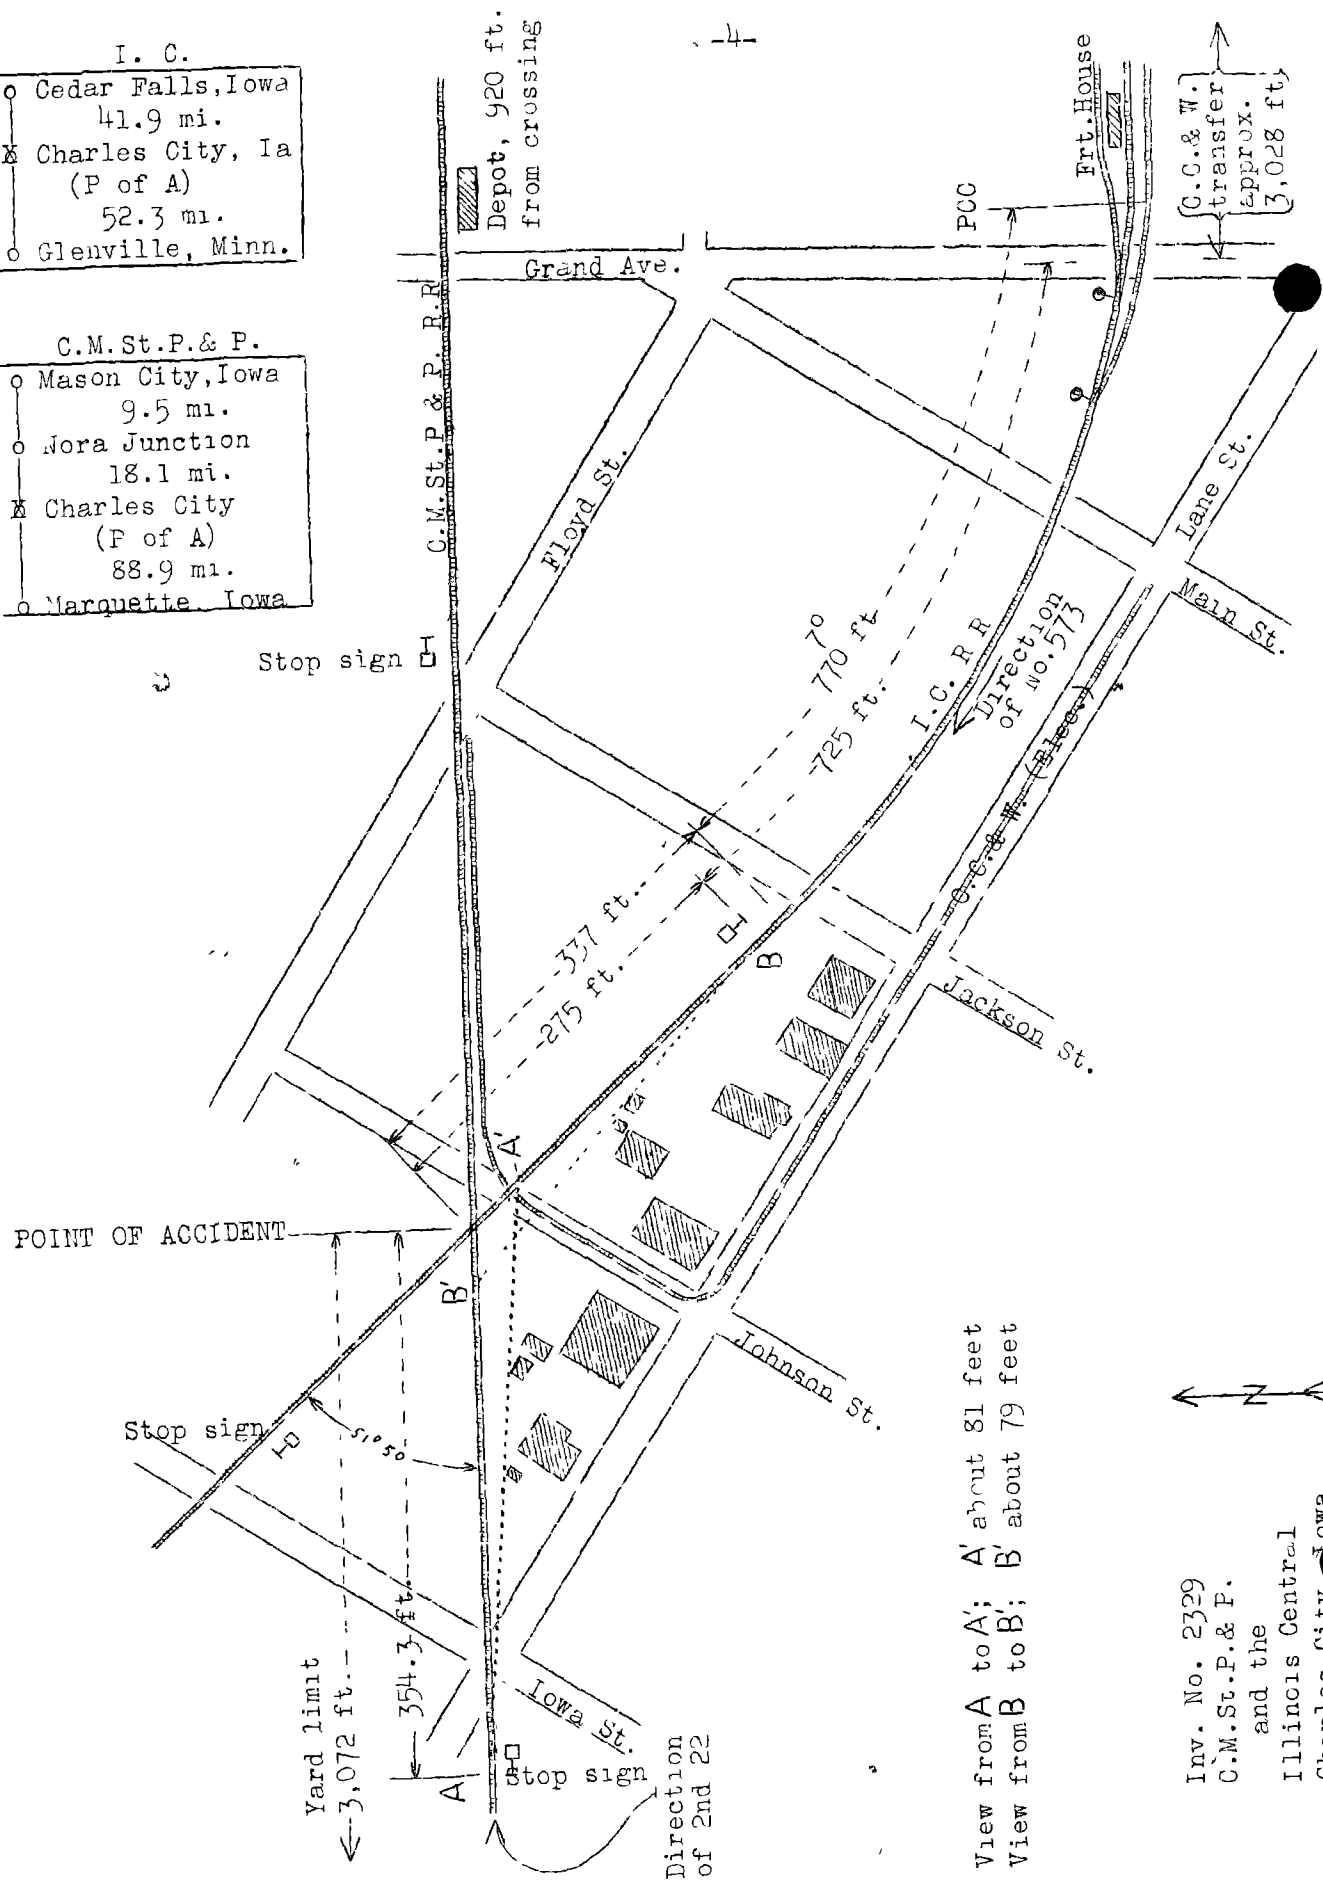
Inv. No. 2329
 C.M. St. P. & P.
 and the
 Illinois Central
 Charles City Iowa
 February 9, 1909

View from A to A'; A' about 81 feet
 View from B to B'; B' about 79 feet

The crossings are situated in a residential section and buildings restrict the view from the fireman's side of an I.C. engine, with its pilot opposite the I.C. stop board, to a distance of 78.5 feet west of the center-line of the C.M.St.P.& P. crossing, and the view from the engineman's side of a C.M.St.P. & P. east-bound engine standing with its pilot opposite the C.M. St.P.& P. stop board is restricted to 81 feet east of the center-line of the crossing on the I.C. track.

Because of buildings near the crossing, the view on the engineman's side of an east-bound C.M.St.P. & P. train and the view on the fireman's side of a west-bound I.C. train were materially restricted. From the stop board on the C.M.St.P. & P. an engineman can see a distance of only 81 feet east of the crossing on the I.C. track and must reach a point within 100 feet of the crossing before he can see as far as the I.C. stop board; also, a fireman on a west-bound train at the I.C. stop board can see only about 79 feet of the C.M.St.P. & P. track west of the crossing and the engine must reach a point about 51 feet from the crossing before the fireman can see as far as the C.M.St.P. & P. stop board. According to the evidence, the fireman of the I.C. train first saw the reflection of the headlight of the other train when his own engine was about 71 feet from the crossing but he did not call his engineman's attention to this fact although they were moving slowly and could have stopped; when his train had advanced about 20 feet farther he saw the headlight of the other train which he thought was closely approaching its stop board, and he thought it would stop at that point; however, the engine of this train already had passed the stop board. About the time the I.C. train reached the crossing the I.C. engineman saw the reflection of the headlight of the C.M.St.P. & P. engine on the second pair of drivers of his engine and called to his fireman to inquire what was to the left of the engine. The C.M.St.P. & P. engineman said he was maintaining a lookout but did not see the I.C. train until he was only two or three car lengths from the crossing; he applied the brakes in emergency but was unable to stop short of the crossing. The headlights of both engines were burning brightly and it is apparent that had a proper lookout been maintained someone on each engine would have observed the presence of the other train in time to have averted the accident.

It is recommended that responsible officials of both railroads involved give immediate consideration to the necessity for increased protection for train movements over the crossing involved in this accident.
