INVESTIGATION NO. 2687  
THE ILLINOIS CENTRAL SYSTEM  
REPORT IN RE ACCIDENT  
AT 63rd STREET STATION,  
CHICAGO, ILL., ON  
MARCH 27, 1943

Railroad: Illinois Central  
Date: March 27, 1943  
Location: 63rd Street Station, Chicago, Ill.  
Kind of accident: Rear-end collision  
Trains involved: Passenger : Passenger  
Train numbers: 2 : 8  
Engine numbers: 2449 : 2434  
Consist: 18 cars : 11 cars  
Speed: Standing : 8-12 m. p. h.  
Operation: Automatic block-signal system  
Track: Eight tracks; tangent; 0.08 per-  
cent descending grade northward  
Weather: Clear  
Time: About 9:10 p. m.  
Casualties: 145 injured  
Cause: Accident caused by failure properly  
to enforce flagging rule, and by  
failure to operate following train  
in accordance with signal indication

Accident at 63rd Street Station, Chicago, Ill., on March 27, 1943, caused by failure properly to enforce flagging rule, and by failure to operate following train in accordance with signal indication.

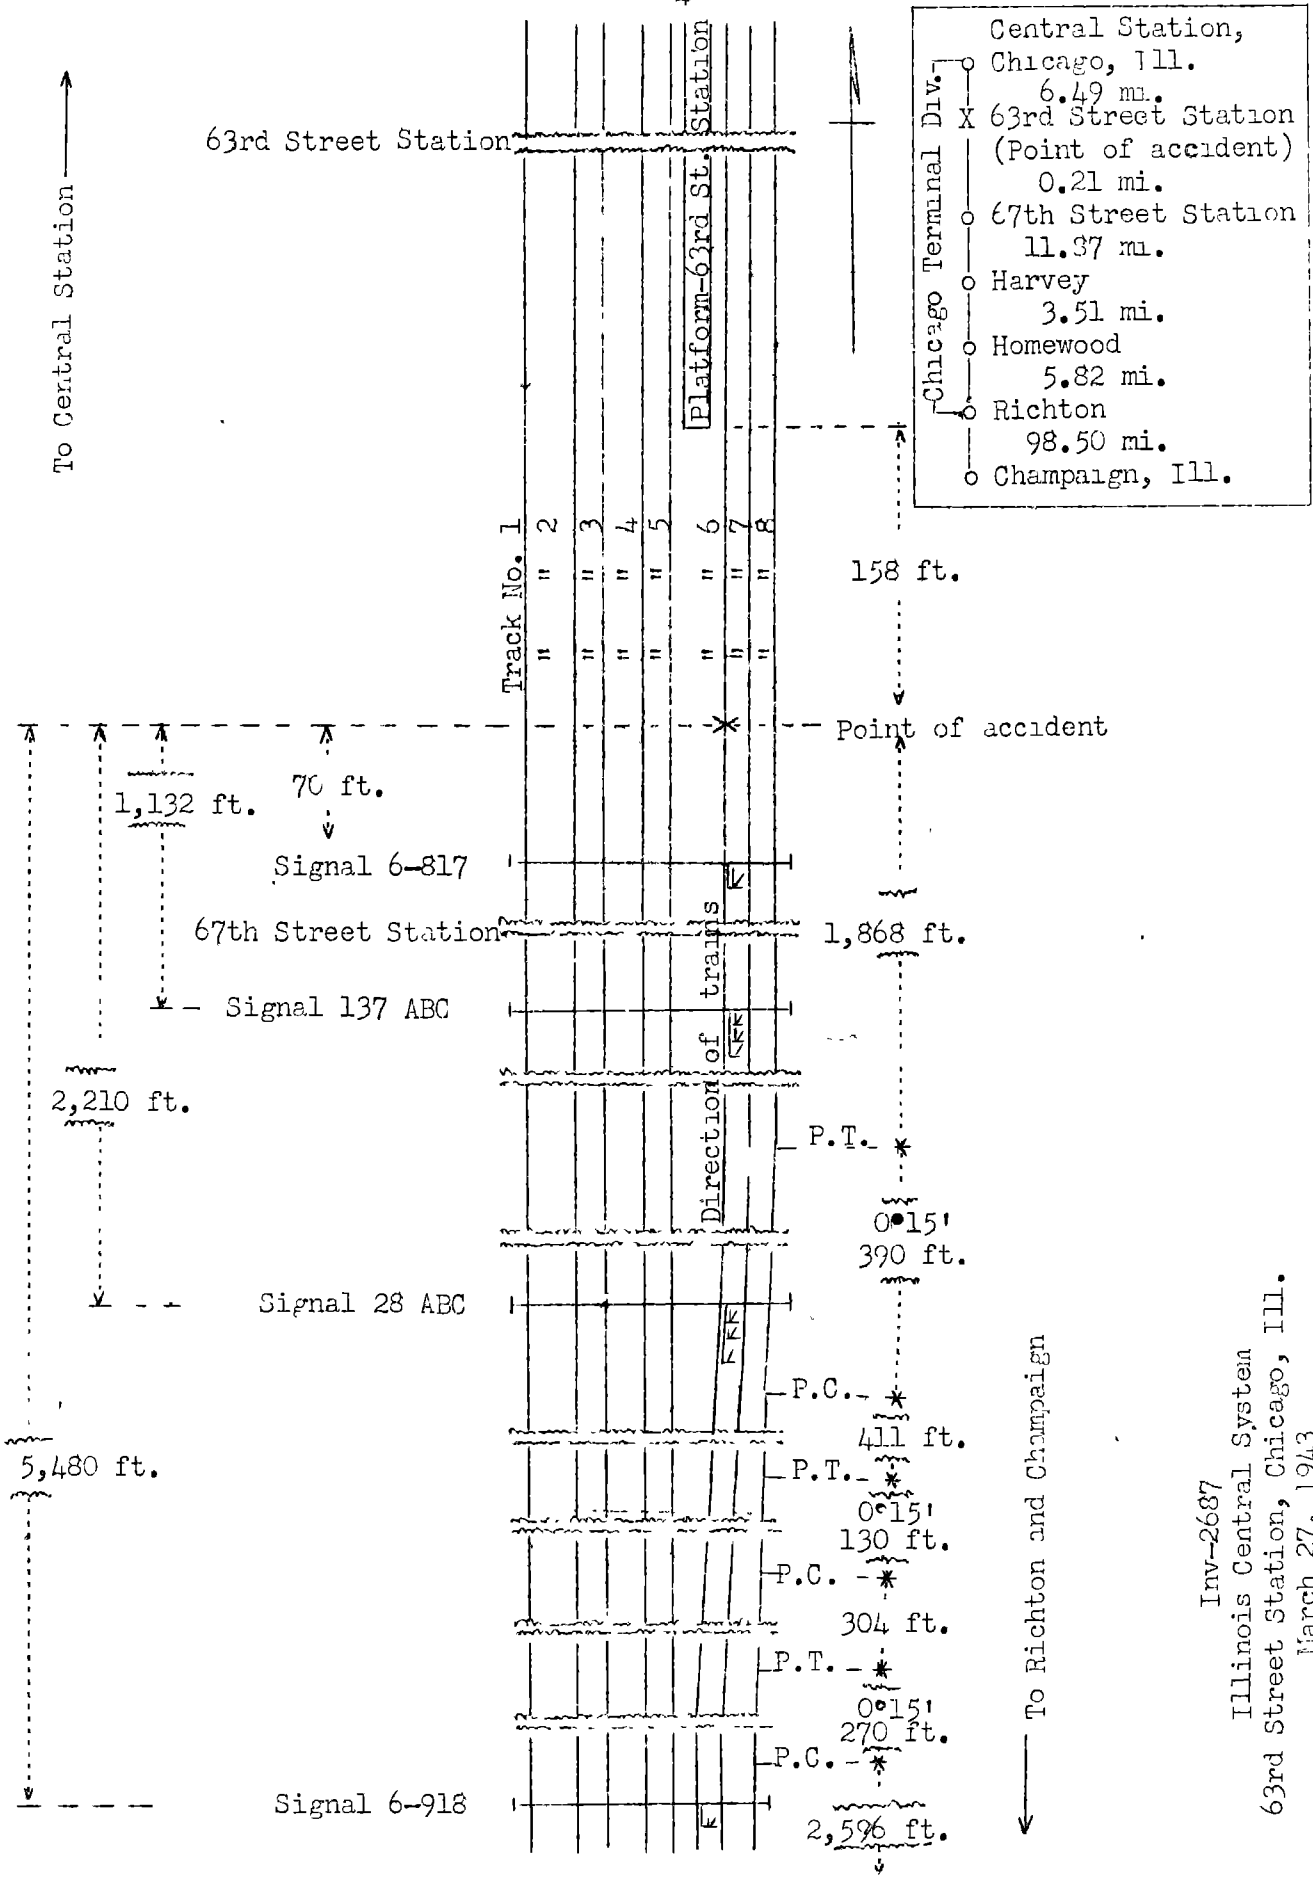
Inv-2687  
 Illinois Central System  
 63rd Street Station, Chicago, Ill.  
 March 27, 1943

Automatic signal 6-918, semi-automatic signals 28 ABC and 137 ABC at 67th Street interlocking, and automatic signal 6-817, which govern north-bound movements on track No. 6, are mounted on signal bridges located, respectively, 5,480, 2,210, 1,132 and 70 feet south of the point of accident. These signals are of the color-light type, and are continuously lighted. The involved aspects and corresponding indications and names of these signals are as follows:

No. 2, a first-class train, was due to leave 63rd Street Station, a regular stop, at 9:10 p. m. This train stopped at 63rd Street about 9:07 p. m., with the rear end standing 70 feet north of signal 6-817. About 9:10 p. m. the rear end was struck by No. 8.

When No. 8 was about 1.15 miles south of the point where the accident occurred, the speed was about 65 miles per hour, the throttle was open, the headlight was lighted and the engineer were maintaining a lookout ahead. Brake-pipe pressure of 90 pounds was being maintained. The engineer observed from a distance of about 800 feet that signal 6-918 was displaying advance-approach, and he made a brake-pipe reduction of 7 pounds. As soon as the brake-pipe exhaust ceased he made a further reduction of 8 pounds. This brake application reduced the speed to about 30 miles per hour and, when the engine was a short distance north of signal 6-918, the engineer released the brakes and partially closed the throttle. When the engine was about 1,200 feet south of the point of accident he made another 7-pound brake-pipe reduction, which was not released, and the speed was reduced to about 20 miles per hour as the engine passed signal 137 ABC. When the engine was about 350 feet south

of signal 6-817, the enginemen observed simultaneously the lighted markers of No. 2 showing red to the rear, and a fusee which had just become ignited. The engineer immediately moved the brake valve to emergency position and closed the throttle, but he could not stop his train short of No. 2. The speed was from 8 to 12 miles per hour at the time of the collision. The first the members of the train crew knew of anything being wrong was when the brakes were applied in emergency. The brakes of this train had been tested and had functioned properly en route.
