INTERSTATE COMMERCE COMMISSION  
WASHINGTON

REPORT OF THE DIRECTOR  
BUREAU OF SAFETY

ACCIDENT ON THE  
ILLINOIS CENTRAL RAILROAD

INVESTIGATION NO. 2308

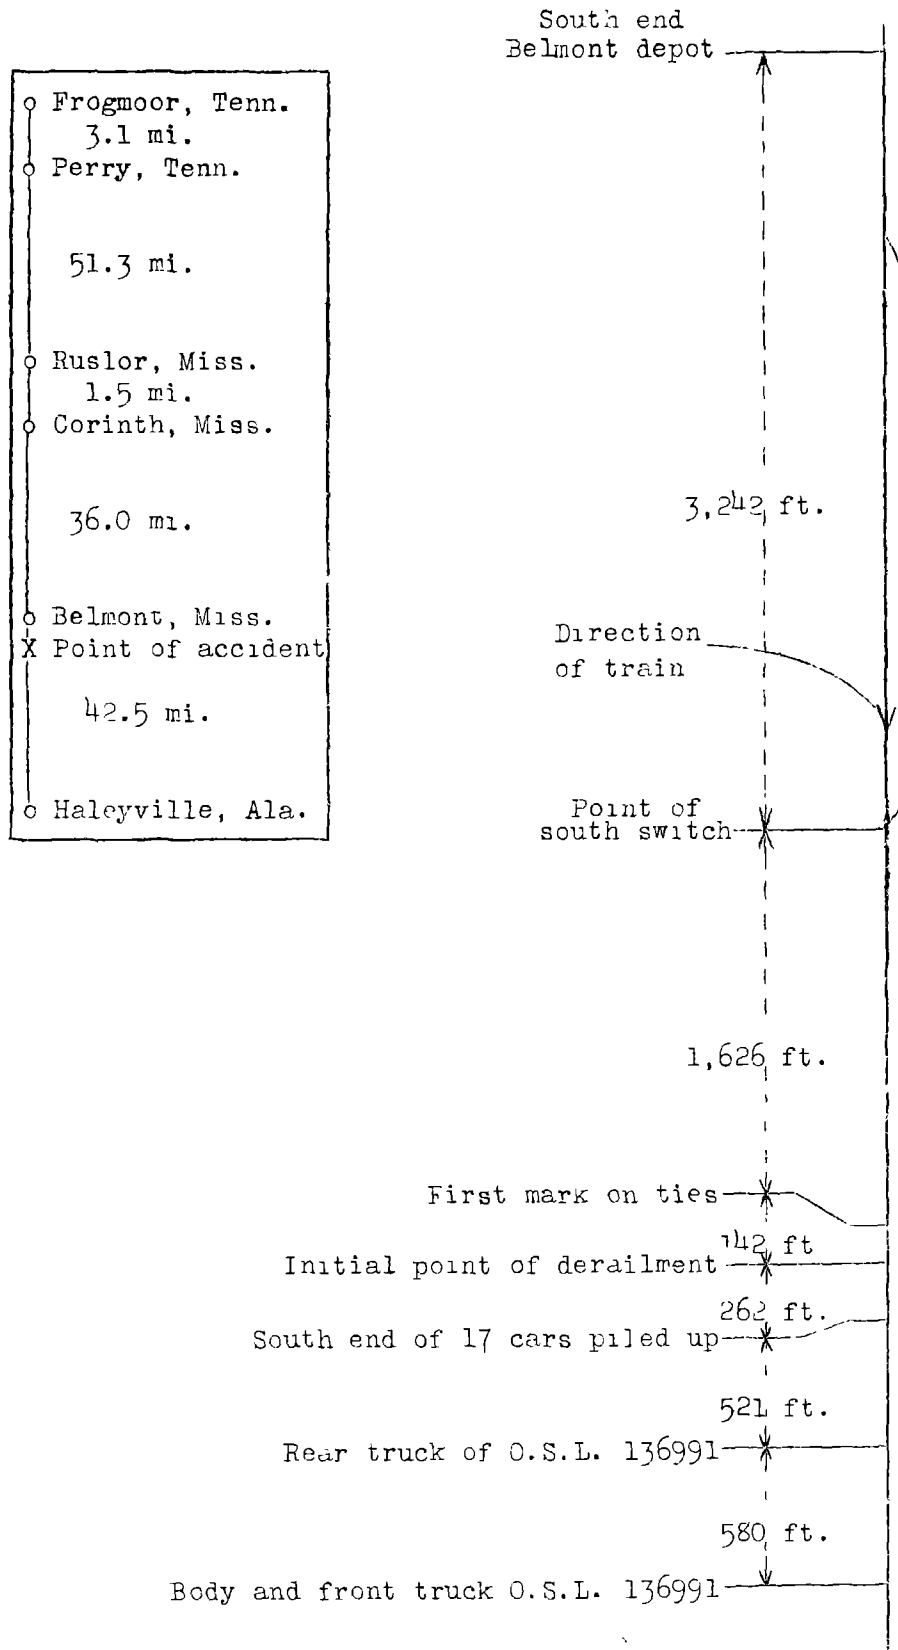
Inv. No. 2308  
Illinois Central R.R.  
Belmont, Miss.  
Nov. 9, 1938.

He stated that the analysis corresponds with cast steel in such castings. He further reported that the frame broke in the "T" section approximately  $8\frac{1}{2}$  inches inside of the axle center and 4 inches below the crown of the box opening where the frame rested on the box. A concealed progressive fracture started from the inner side of the frame, in the lower side of the "T" section, where a series of blow and shrink holes so weakened the section as to result in over-stressing the casting. In his opinion this failure was due to a very poor casting, the defects of which were not visible.

O.S.L. 136991; this was a progressive oxidized fracture and a series of blow and shrink holes appeared on the inside of the lower "T" of the lower arch at a point about  $8\frac{1}{4}$  inches from the journal box center line. The broken truck side-frame bore the following marks: A S F 6650, Pat. 5 3 10,  $5\frac{1}{2}$  x 10, Dr, 7 - 14. U P. R R CCS 694.

The evidence is to the effect that the twelfth car in the train, O.S.L. 136991, a composite-body steel-underframe box car loaded with copper bullion, was the first car to become derailed; this was caused by a defect in the lower side of the "T" section of the truck side-frame on the east side of the rear truck of the car. The car in question was not overloaded and had been inspected in the train by a car inspector at Frogmoor and by members of the train crew at Corinth. The air brakes were tested and they functioned properly en route. According to the evidence neither speed nor track conditions had any bearing on the accident. Examination of the failed truck side-frame and report of the engineer of tests disclosed that a progressive fracture had started from the inner side of the frame in the lower side of the "T" section, where a series of blow and shrink holes so weakened the section as to result in overstressing the casting. This fracture did not extend through to the outside and it could not be seen in ordinary inspections.
