ACCIDENT ON THE
ILLINOIS CENTRAL RAILROAD

CHAMPAIGN, ILL.

DECEMBER 3, 1936

INVESTIGATION NO. 2125

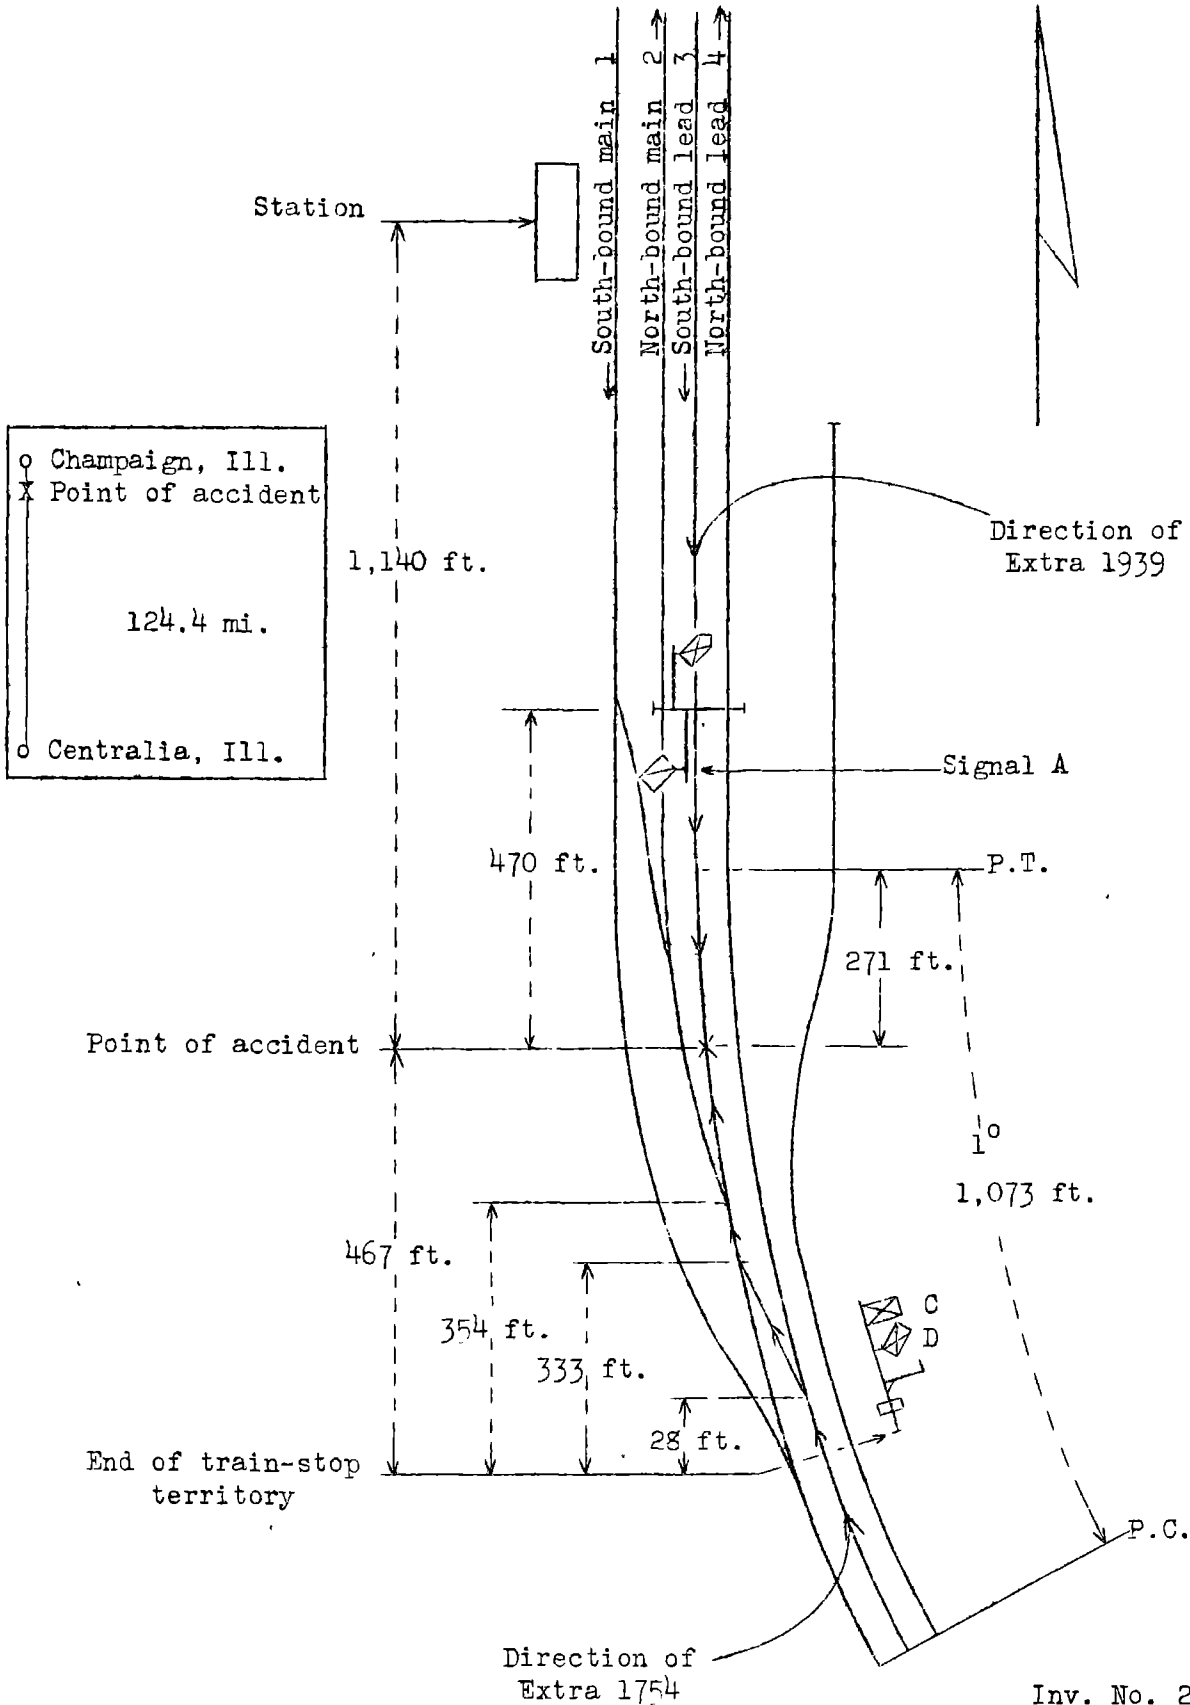
Inv. No. 2125
 Illinois Central
 Champaign, Ill.
 Dec. 3, 1936

The automatic signal involved, located at the point where the two freight lead tracks converge with the main tracks, 467 feet south of the point of accident, is a 2-arm, 3-position signal of the upper quadrant semaphore type; signal C, the top arm, governs through movements over the north-bound main and normally displays a stop indication. Signal D, the lower arm, governs movements from the north-bound main to the north-bound freight lead track and normally displays an approach indication; forty-five or ninety degree positions of the arm govern the route to the interlocking signal located 2,715 feet to the north. Night indications

are green, yellow and red. This signal location, C and D, also marks the northern end of automatic train-stop territory. The switches in the immediate vicinity are of the low-stand, hand-operated type, normally set and locked for the north-bound and south-bound freight leads. It is necessary to line three switches at this point for a continuous route over the north-bound main track, these switches being located 28 feet, 333 feet, and 354 feet respectively, north of the signal. When the first switch located just north of the signal is reversed, signal D displays a stop indication; all three switches must be lined for a through movement over the north-bound main track before signal C will display a proceed indication.

Automatic signal A, located on a signal bridge 470 feet north of the point of accident, governs movements from the south-bound freight lead to the south-bound main track; this signal is a 2-position, upper-quadrant semaphore signal, and normally displays an approach indication.
