INVESTIGATION NO. 3097
ILLINOIS CENTRAL RAILROAD COMPANY
REPORT IN RE ACCIDENT
NEAR CHAMPAIGN, ILL., ON.
APRIL 19, 1947

Accident near Champaign, Ill., on April 19, 1947, caused by a train entering a crossover at a high rate of speed, as a result of approach and home signals of an interlocking displaying false proceed indications.

Inv. No. 3097
Illinois Central Railroad
Champaign, Ill.
April 19, 1947

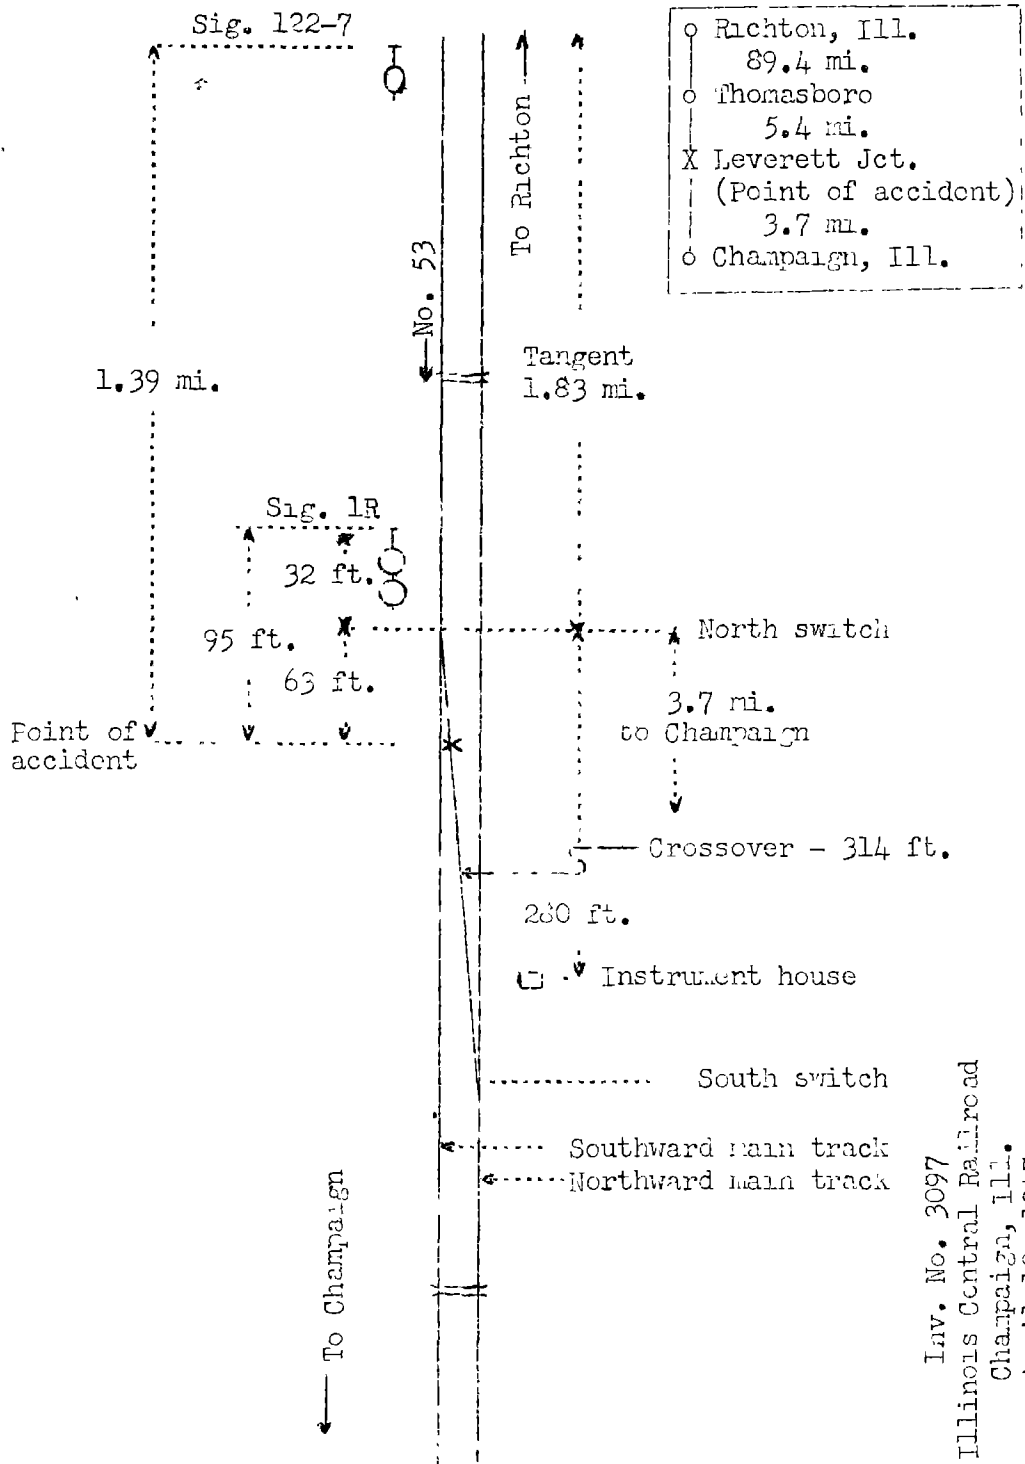
This accident occurred on that part of the Illinois Division extending between Richton and Champaign, Ill., 98.5 miles, a double-track line in the vicinity of the point of accident, over which trains moving with the current of traffic are operated by timetable, train orders and an automatic block-signal system. Within interlocking limits at Leverett Jct., 94.8 miles south of Richton, a facing-point crossover 314 feet long connects the southward and the northward main tracks. The north switch of this crossover is 3.7 miles north of the station at Champaign. The derailment occurred on the turnout of the north crossover-switch, at a point 63 feet south of the switch. The main tracks are tangent throughout a distance of 1.83 miles immediately north of the north crossover switch and a considerable distance southward. The grade is practically level.

No. 53, a south-bound first-class passenger train, consisted of Diesel-electric engine 4000, a single-unit type, one baggage-dormitory car, two coaches, one dining car, two coaches and one lounge-tavern-observation car, in the order named. All cars were of light-weight all-steel construction. This train passed Thomasboro, the last open office, 5.4 miles north of Leverett Jct., at 9:50 a. m., on time, passed signals 122-7 and 1R, which displayed proceed, and while moving on the southward main track at an estimated speed of 70 miles per hour it entered the crossover at Leverett Jct. at the north switch, which was lined for entry to the crossover, and was derailed.

The engine stopped practically upright, across the main tracks and at an angle of about 60 degrees to them, with the front end 978 feet south of the north crossover switch. The first car stopped on its left side, across the southward

main track and at an angle of about 75 degrees to it, with the roof against the side of the engine. The second to seventh cars, inclusive, stopped practically upright and in various positions across the main tracks and in line with them. The engine and the first car were badly damaged, and the remainder of the equipment was considerably damaged.
