INVESTIGATION NO. 2546
THE ILLINOIS CENTRAL RAILROAD COMPANY
REPORT IN RE ACCIDENT
NEAR CORINTH, MISS., ON
NOVEMBER 23, 1941

Accident near Corinth, Miss., on November 23, 1941, caused
by broken rail, as result of presence of transverse
fissure.

Inv-2546
 Illinois Central Railroad
 Corinth, Miss.
 November 23, 1941

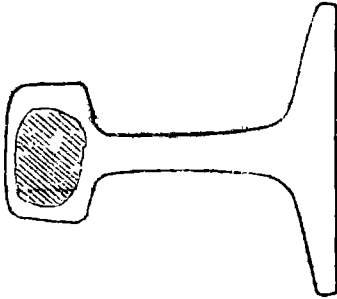
Transverse fissure involved covered covered about 75 percent of the cross-sectional area of the head of the rail.

Soon after the accident occurred, a rail on the east side of the track was found broken into numerous pieces, 34 of which were recovered and constituted about 29 feet of the 33-foot rail section. The first break occurred between two ties at a point 25-1/4 inches north of the receiving end of the rail and 10 inches north of the bonding connection. This piece of rail remained in its normal location. A transverse fissure covering about 75 percent of the cross-sectional area of the head was found at the first break. Wheel marks at this break indicated that the derailment occurred at this point. Four other transverse fissures, each of which covered about 10 percent of the cross-sectional area of the head, were found in the broken rail. All breaks except the first appeared to have occurred during the derailment. Apparently, the rail became broken when the train was passing over it.

On the day prior to the day of the accident, the track at the point involved had been inspected twice by the section gang and no defective condition was found. The fissure at the first break had not progressed to the surface at any point and prior to the accident its presence could not be detected by visual inspection. A detector car was last operated over the track involved on February 7, 1941, at which time four defective rails were found but none was within a distance of 1 mile of the point where the accident occurred.
