NTSB-RAR-70-2

RAILROAD ACCIDENT REPORT

ILLINOIS CENTRAL RAILROAD COMPANY

DERAILMENT AT

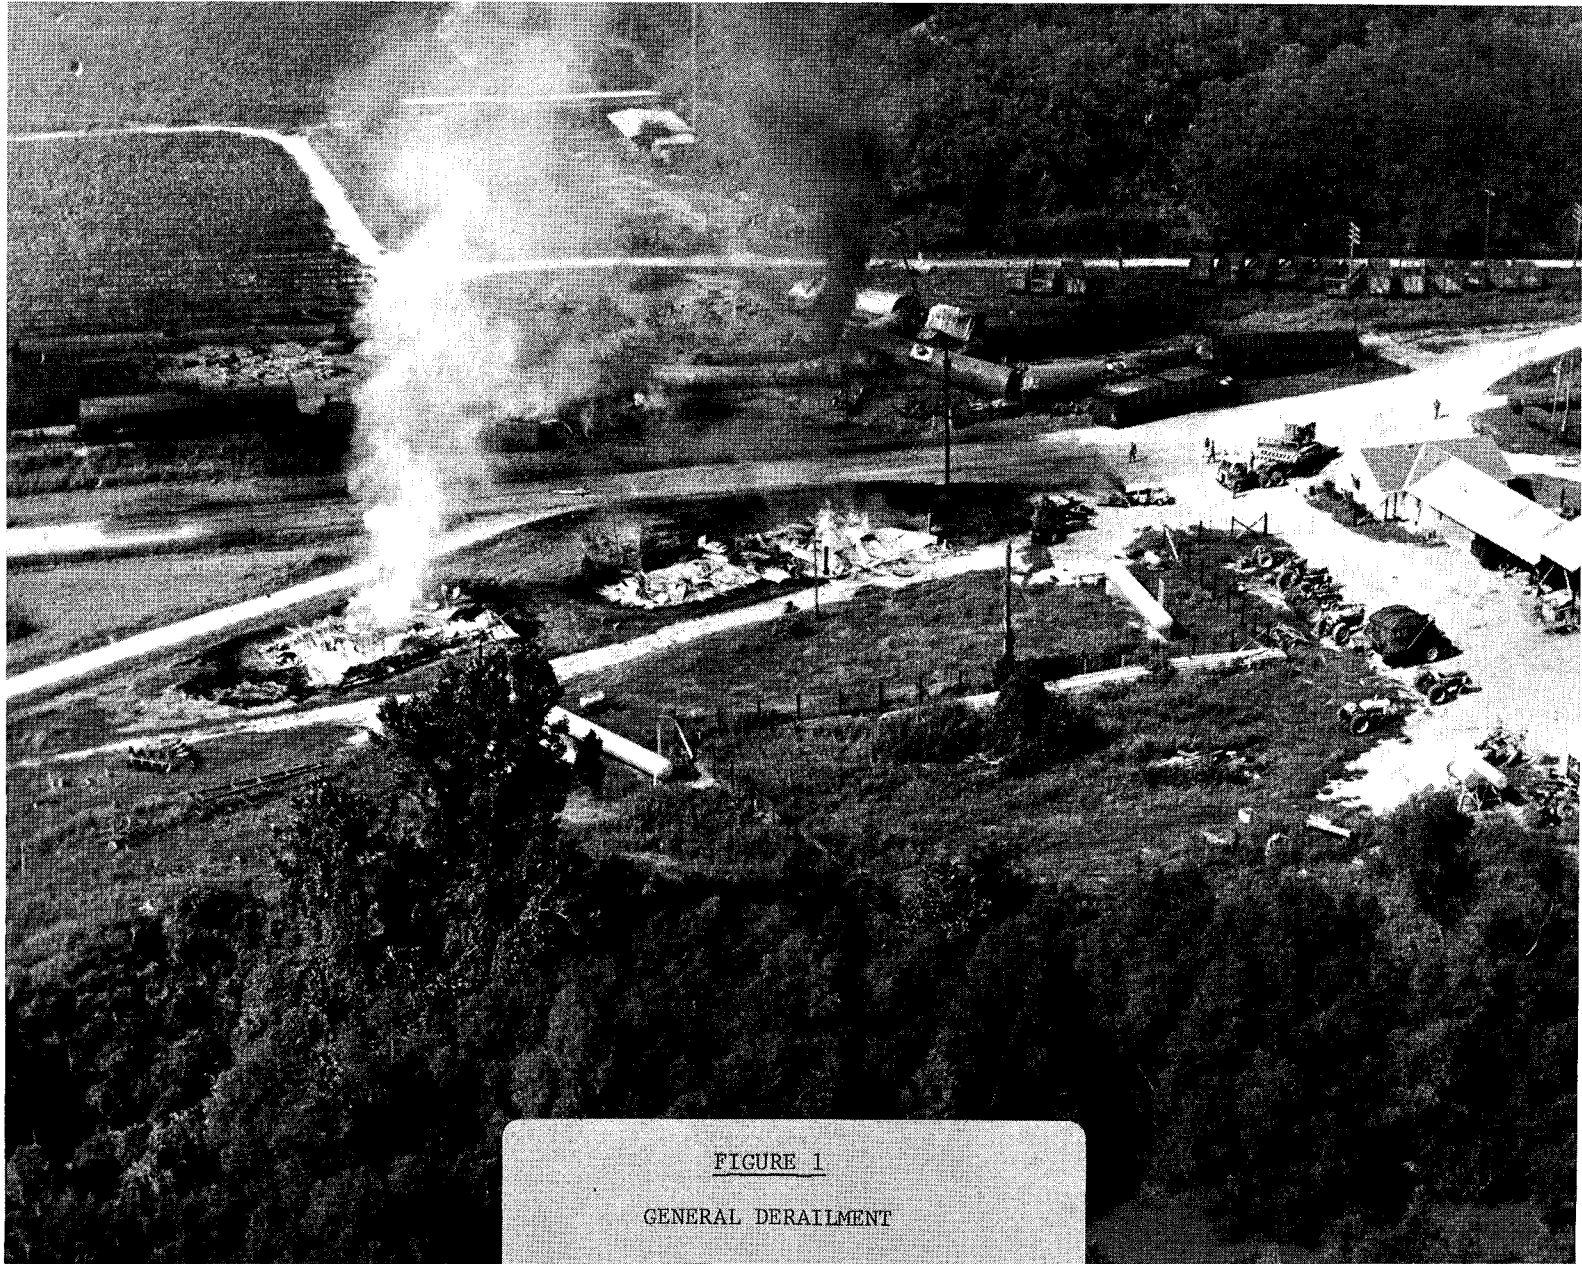
FIGURE 1
GENERAL DERAILMENT

Based on the evidence, there is no question that the deraillment resulted when the boxcar buckled. The absence of interlocking couplers allowed the cars to separate and jackknife. A disengaged coupler punctured the tank and allowed the spillage of the vinyl chloride which ignited. Had the cars remained coupled and in line with the track, they would not have jackknifed and piled up in a jumbled mass. Once the vinyl chloride vapor ignited, the fire impinged on the other tanks.

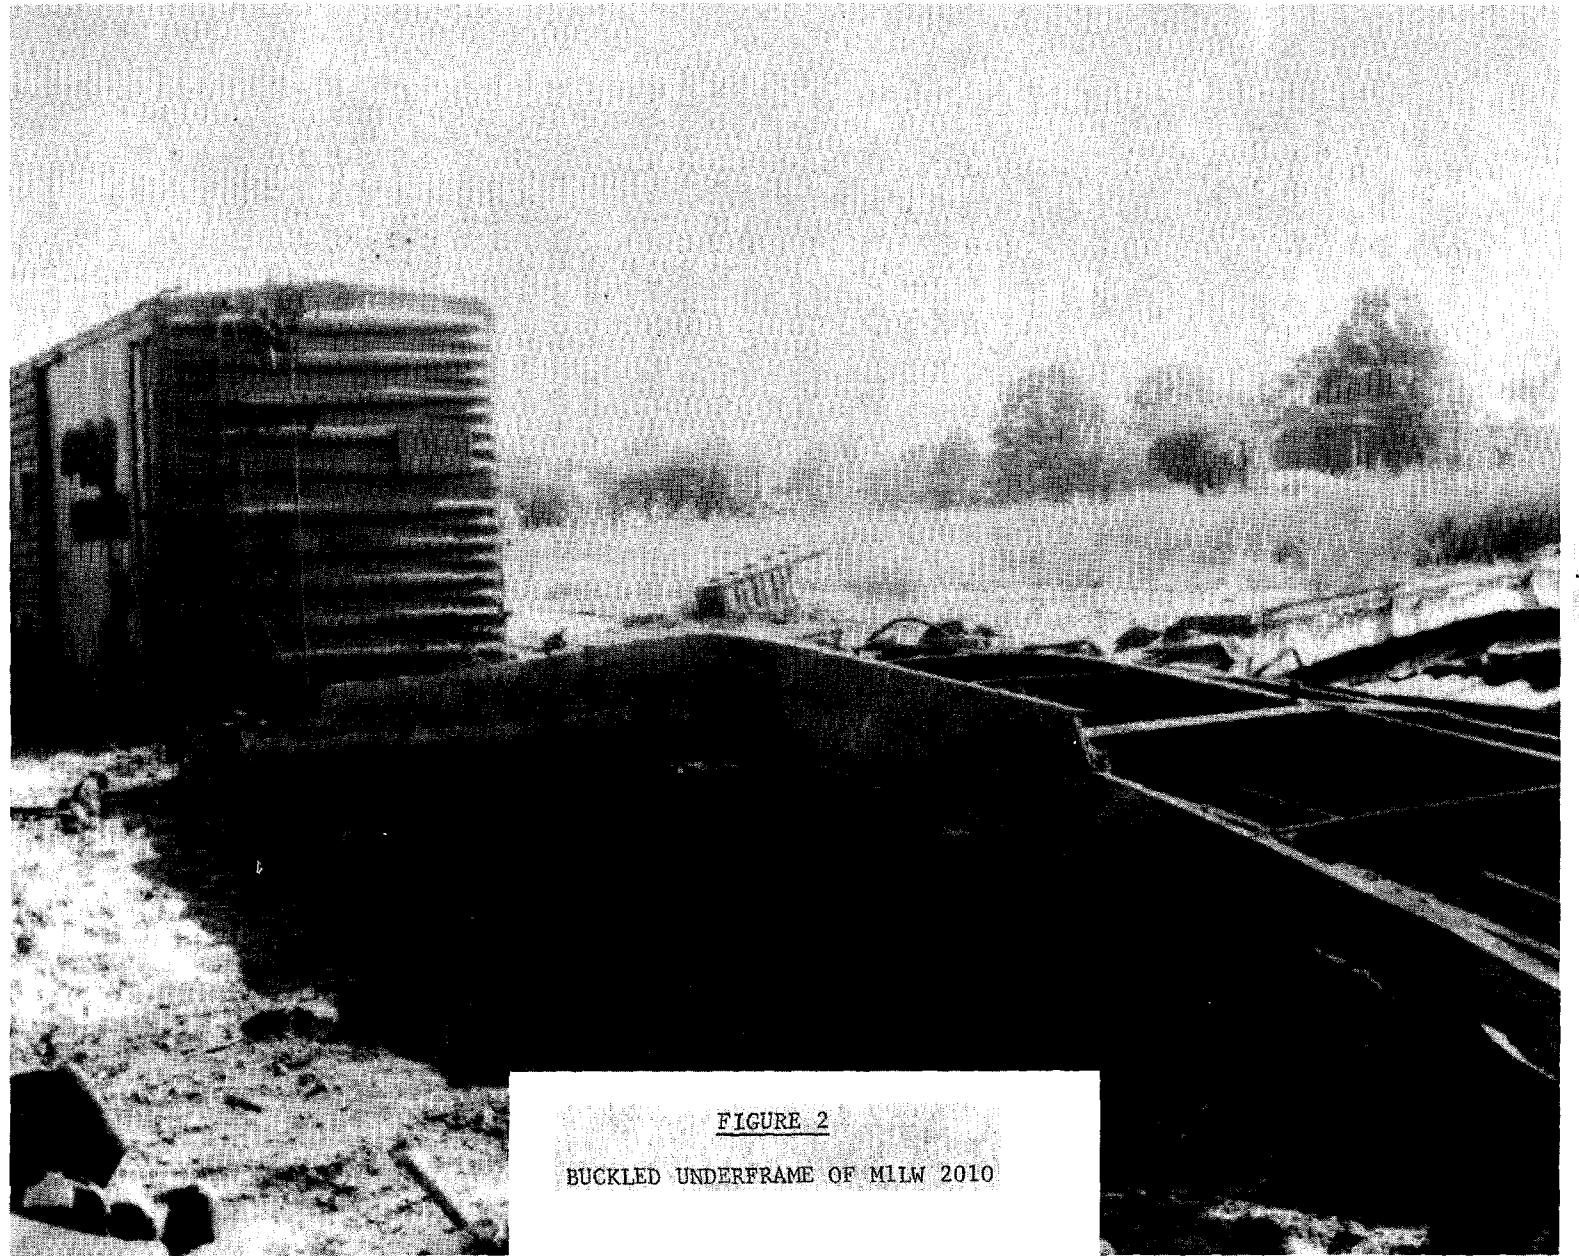
FIGURE 2
BUCKLED UNDERFRAME OF MLW 2010

A witness described seeing a box car buckle upward immediately after the emergency brake application and before the train stopped. This car was identified as Milwaukee car 2010, the 108th car in the train. (See Figure 2, page 7) This car was thrown out of the train, landing on one end and reversing itself. Fourteen additional cars, including 10 cars of hazardous materials, derailed. None of the equipment ahead of the 106th car in the train derailed. The 106th car stopped upright and in line with the track structure, with the north trucks derailed. The 107th to 119th cars, inclusive, derailed and stopped in various positions on both sides of the track, as shown in Appendix 2. The 120th car stopped upright and in line with the track, with the north trucks derailed.

The nature of the failure indicates that the car was subjected to compressive forces that exceeded the strength of the structure. This type of failure of empty cars, involving severe braking, has been documented in many past accidents. Under normal emergency braking, full braking power is developed successively by the locomotive and each car behind it until the rear car attains full braking. This lag may require up to 18 seconds before the rear car receives full braking power.

4. The empty MILW car buckled because of undue pressure resulting from uneven braking of the train under full emergency conditions. The front part of the train decelerated at a rate greater than the rear part.

- (a) capable of providing shorter stopping distances which nearly approach the theoretical limit under all conditions of loading and length of trains;
- (b) capable of stopping a train in the emergency applications now required by regulations without internal collisions, train separations, or damage to the train or its lading;
- (c) capable of propagating brake application, both service and emergency, throughout the length of a train more expeditiously and surely;
- (d) capable of more rapid application of the full intended stopping force to the rails at each car after the application signal is received at each car.
