RAILROAD/HIGHWAY ACCIDENT REPORT

ILLINOIS CENTRAL RAILROAD COMPANY

Train No. 1 Collision With Gasoline
Tank Truck At
South Second Street Grade Crossing
Loda, Illinois

Report Number: NTSB-RHR-71-1

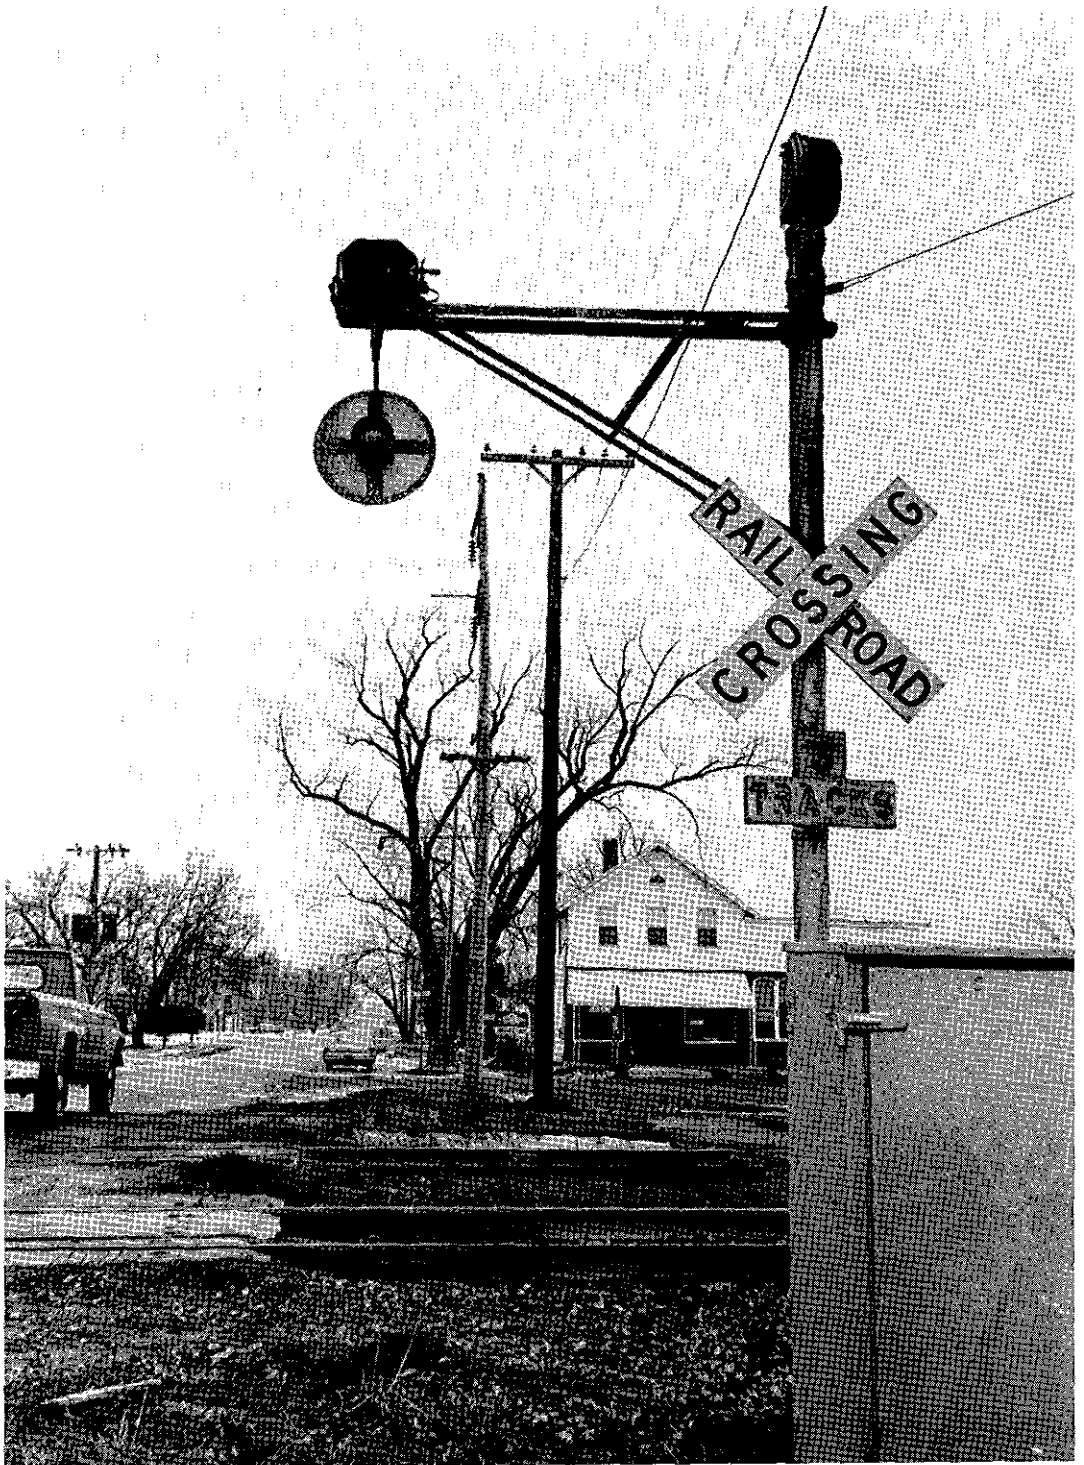
FIGURE 2

crossarm, and it was located in the northeast quadrant of the crossing, 11 feet north of the paved surface of the roadway. A warning bell was mounted on top of the mast. A multiple-track sign and a crossbuck warning sign were attached to the mast, 6 feet 11 inches, and 9 feet 11 inches, respectively, above the ground. A wig-wag banner, 20 inches in diameter, was suspended from the crossarm. The banner, a white, circular, metal disc with a black cross and border, was located 10 feet 11 inches above the ground and swung in an arc 30 inches in length parallel with the tracks. A light contained between two red lenses, 6-3/8 inches in diameter, was mounted in the center of the banner. This light illuminated the red lenses and could be seen on each side of the crossing. (See Figure No. 2) The signal was installed April 9, 1927.

An inspection made of the automatic warning device the day following the accident disclosed that the light between the red lenses in the center of the banner was so dim that one had to look closely during daylight hours to determine whether the light was lighted. It was observed that the paint on the banner was worn and faded. When operating, the movement of the banner through its 30-inch swing appeared short and was above the normal line of sight of the driver. The alarm bell was not loud and if there had been any distracting noise such as a running engine it would have been difficult to hear in an enclosed motor vehicle.

The design and worn condition of the automatic warning device was such that when the signal was operating during daylight hours it would not effectively attract the attention of an approaching motorist. Typical modern warning signals, used at other grade crossings and having bright alternately flashing red lights positioned at the level of the motorist's line of vision, are much more effective in providing attention-getting warning than the device described in this accident.

4 The Illinois Central Railroad and the town of Loda, Illinois, improve the grade crossing involved in this accident. Improvements should include an effective warning device capable of drawing the attention of highway drivers and conveying a warning of the approaching train, improved condition of crossing surface, and improved vision of track to approaching drivers.

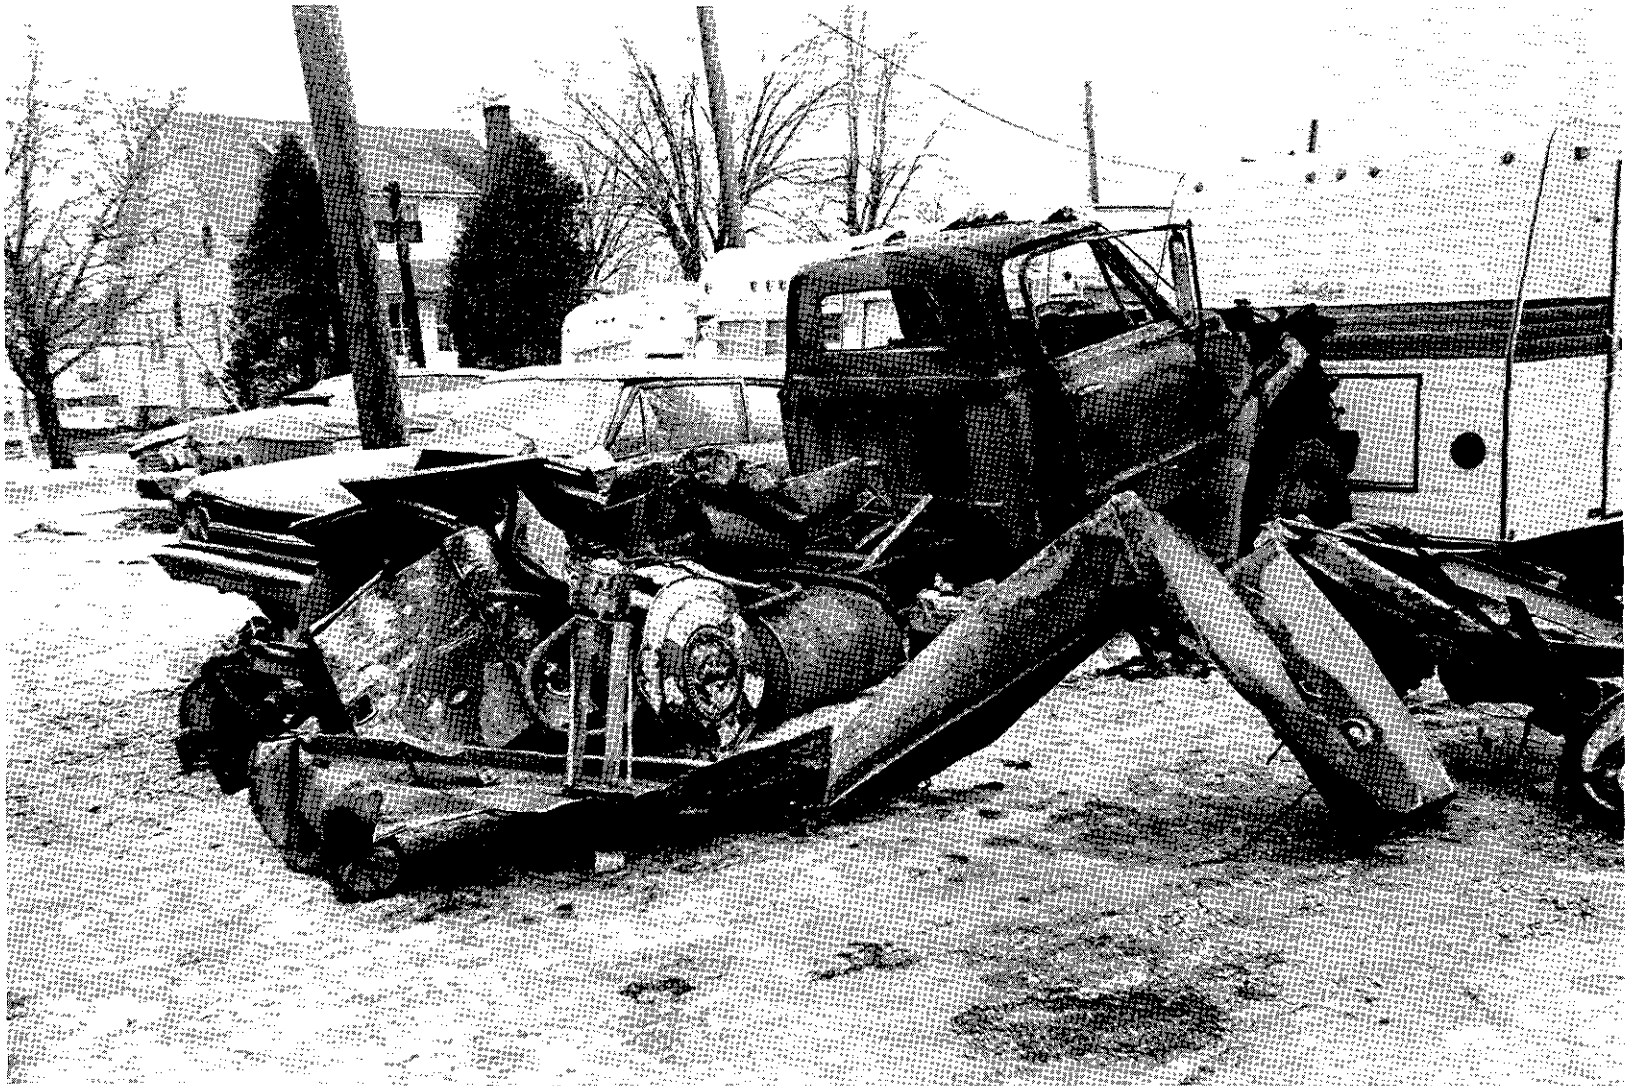
FIGURE 3

The locomotive struck the right side (north side) of the truck at about the center of the tank. The motortruck cab and part of the chassis were either carried, or hurled by the forces of the impact, to a point 85 feet south of the point of the collision. They came to rest along the west side of the business track. The motortruck rear wheels and cargo tank were separated from the chassis and were carried, or propelled by the force of the explosion and impact, south of the crossing and stopped along the west side of the business track. The rear wheels and axle and the cargo tank stopped 245 feet and 265 feet, respectively, south of the collision point. The motortruck and tank were completely demolished. (See Figure No. 3.)

Photo showing right side of motortruck after it had been moved from accident point.

The design of the vehicle did contribute to the severity of the injuries to the driver and to the occupants of the locomotive. The tank ruptured on impact and separated from the vehicle. Large quantities of fuel were propelled through the rupture and sprayed over the truck cab and the locomotive. The tank was not provided with material to limit the flow of a commodity in the event of a container rupture. Such techniques as filling tanks with special reticulated foam are technically effective in preventing the rapid discharge of liquid from a ruptured tank. The locomotive struck the truck at about the center of the tank which completely destroyed the tank and the rear portion of the vehicle. The force of the impact caused the front of the truck to turn northward and strike the locomotive. The structural integrity of the cab, however, was not violated by the collision. (See Figure No. 3)

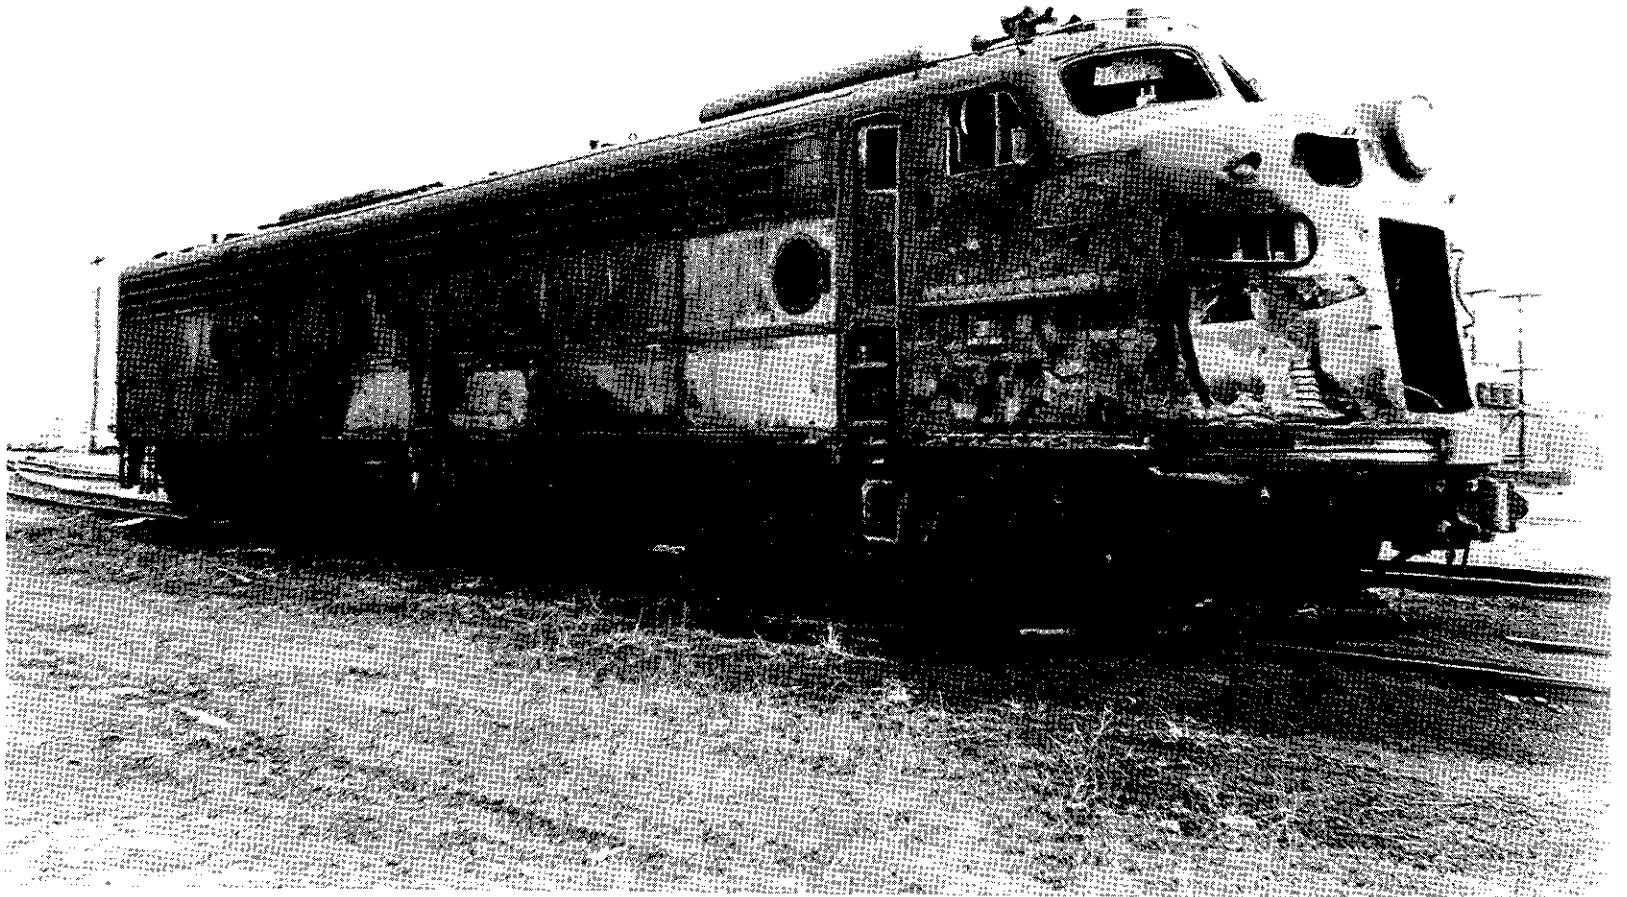
FIGURE 4

The locomotive unit has two headlights. One is a sealed beam, 250-watt, fixed headlight mounted above the nose compartment door.

about 7 feet 10 inches above the top of the rail. The other headlight has rotating red and white lights, and it is located about 10 feet 10 inches above the top of the rail. The carrier's operating rules² require that the fixed headlight must be displayed to the front of trains by day and night; the white oscillating light must be displayed at night and during the day when weather conditions seriously impair visibility, and the red oscillating light must be displayed both day and night when a train is disabled or stopped suddenly by an emergency application of brakes, or when the engineer or conductor finds it necessary to stop trains under conditions whereby adjacent tracks may be fouled.

“10 The Safety Board recommends that the Federal Railroad Administration study the visual effectiveness of the white, fixed, sealed-beam headlights on locomotives in contrast with the bright daylight as compared with an oscillating or gyrating headlight unit, a flashing strobe light or other high-intensity type light, possibly of a more contrasting color.”
