RAILROAD ACCIDENT INVESTIGATION

ILLINOIS CENTRAL RAILROAD COMPANY

MT PULASKI, ILL

Accident at Mt. Pulaski, Ill., on June 1, 1958, caused by the explosion of a tank car loaded with nitromethane.

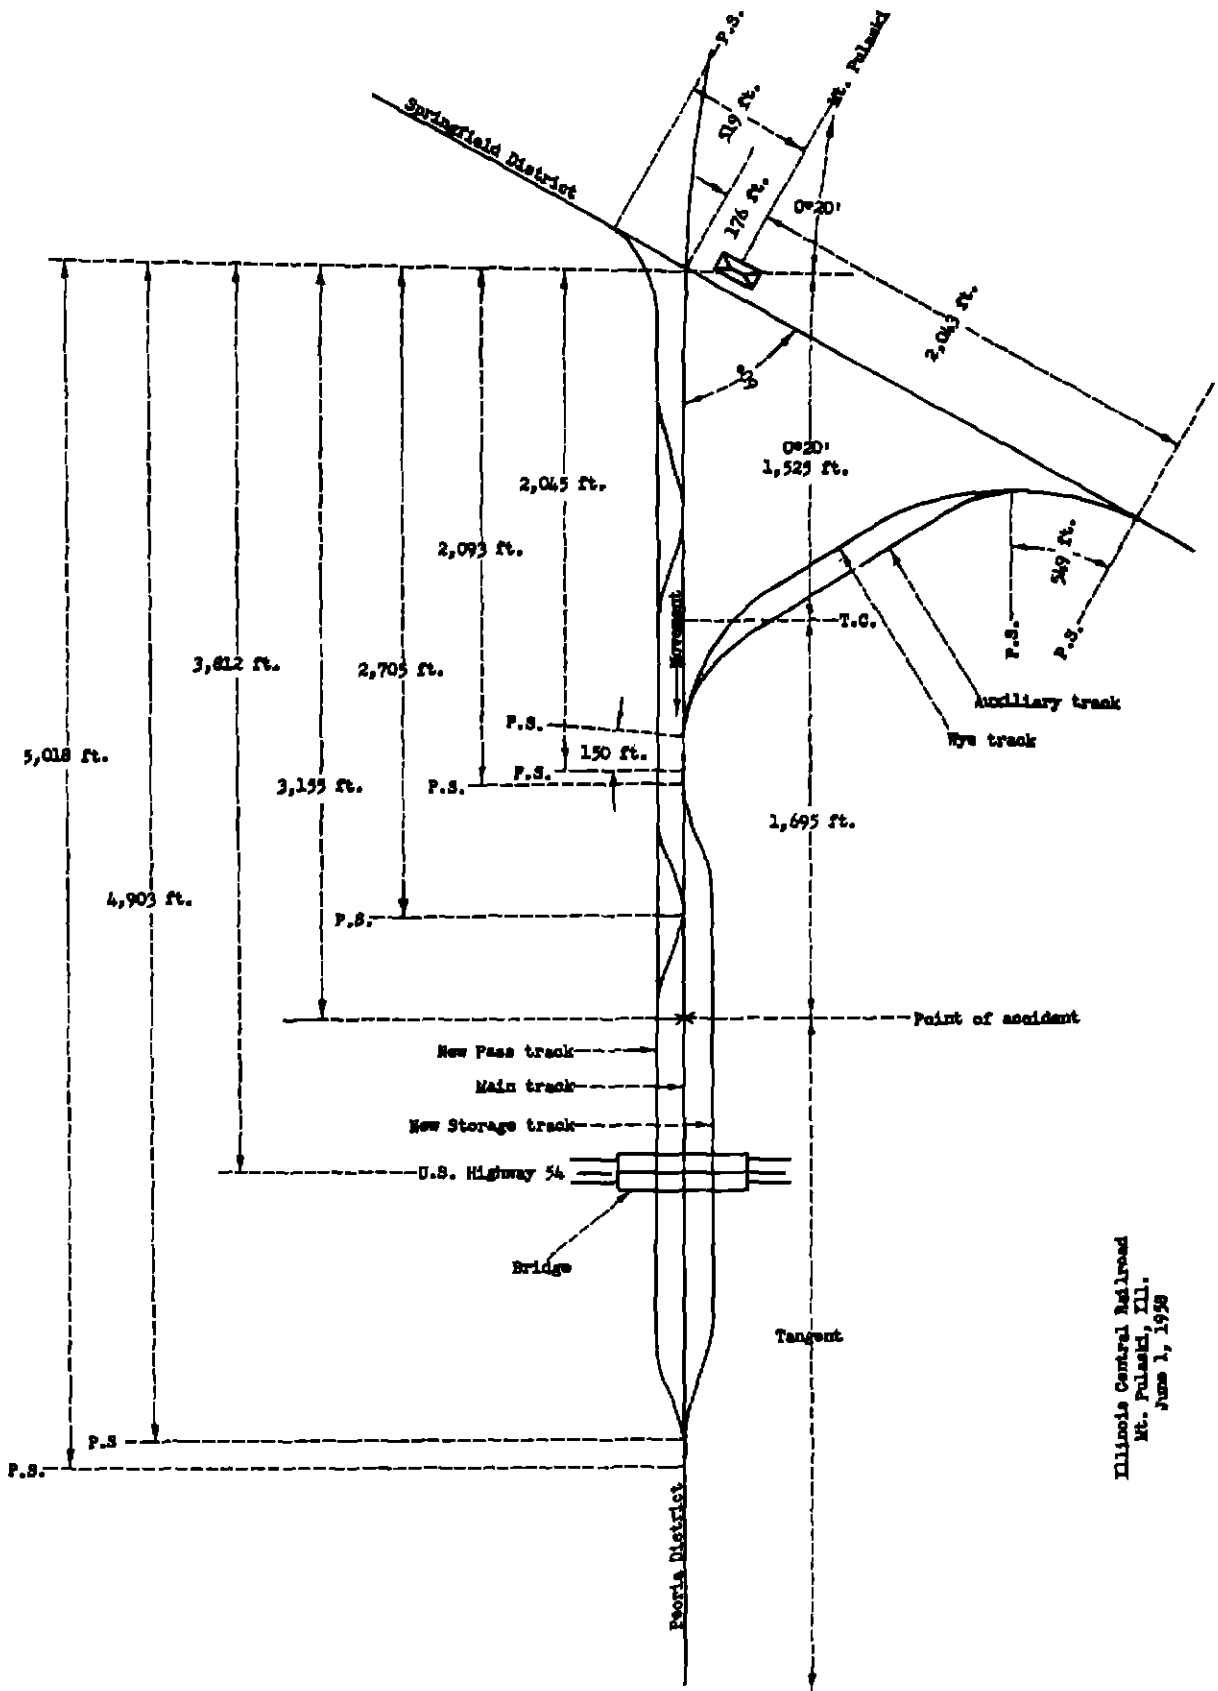
Illinois Central Railroad
 Mt. Pleasant, Ill.
 June 1, 1938

Location of Accident and Method of Operation

This accident occurred on that part of the Springfield Division designated as the Peoria District and extending between Mattoon and I C Junction, Ill., 110.0 miles. This is a single-track line over which trains are operated by timetable, train orders, and an automatic block-signal system. At Mt. Pulaski, Ill., 63.8 miles north of Mattoon, a single-track line of the Springfield District crosses the main track at grade at an angle of 60°. Geographic directions are approximately east and west on the Peoria District, and north and south on the Springfield District. Timetable directions are north and south on both districts. Timetable directions on the Peoria District, except as indicated, are used in this report. The station at Mt. Pulaski is located in the north-east angle of the crossing at a point 176 feet east of the crossing. A wye track diverges to the east from the main track. The switch of this track, which is facing-point for northbound movements, is located 2,045 feet south of the station. This track connects with the main track of the Springfield District at a point 2,043 feet east of the station. An auxiliary track parallels the wye track on the south. The west switch of this track is located 150 feet north of the west wye-track switch, and the east switch is located 549 feet west of the east wye-track switch. An auxiliary track, designated as the New Storage Track, parallels the main track on the east. The north and south switches of this track, connecting the track with the main track, are located, respectively, 2,093 feet and 4,903 feet south of the station. An auxiliary track, designated as the New Pass Track, parallels the main track on the west. The south switch of this track, connecting the track with the main track, is located 5,018 feet south of the station. This track diverges to the west in the vicinity of the crossing and connects with the Springfield District main track at a point 519 feet west of the station. Four crossovers connect the main track with the New Pass Track. The north switch of the most southerly crossover, which is facing-point for southbound movements on the main track, is located 2,705 feet south of the station. U. S. Highway 54 spans the railroad on a steel and concrete bridge. The centerline of the bridge is located 3,812 feet south of the station. The accident occurred within yard limits on the main track at a point 3,155 feet south of the station. From the south on the main track there are, in succession, a tangent throughout a considerable distance to the point of accident and 1,695 feet northward, and a 0°20' curve to the right 1,525 feet to the crossing and a considerable distance northward. The grade is level at the point of accident.

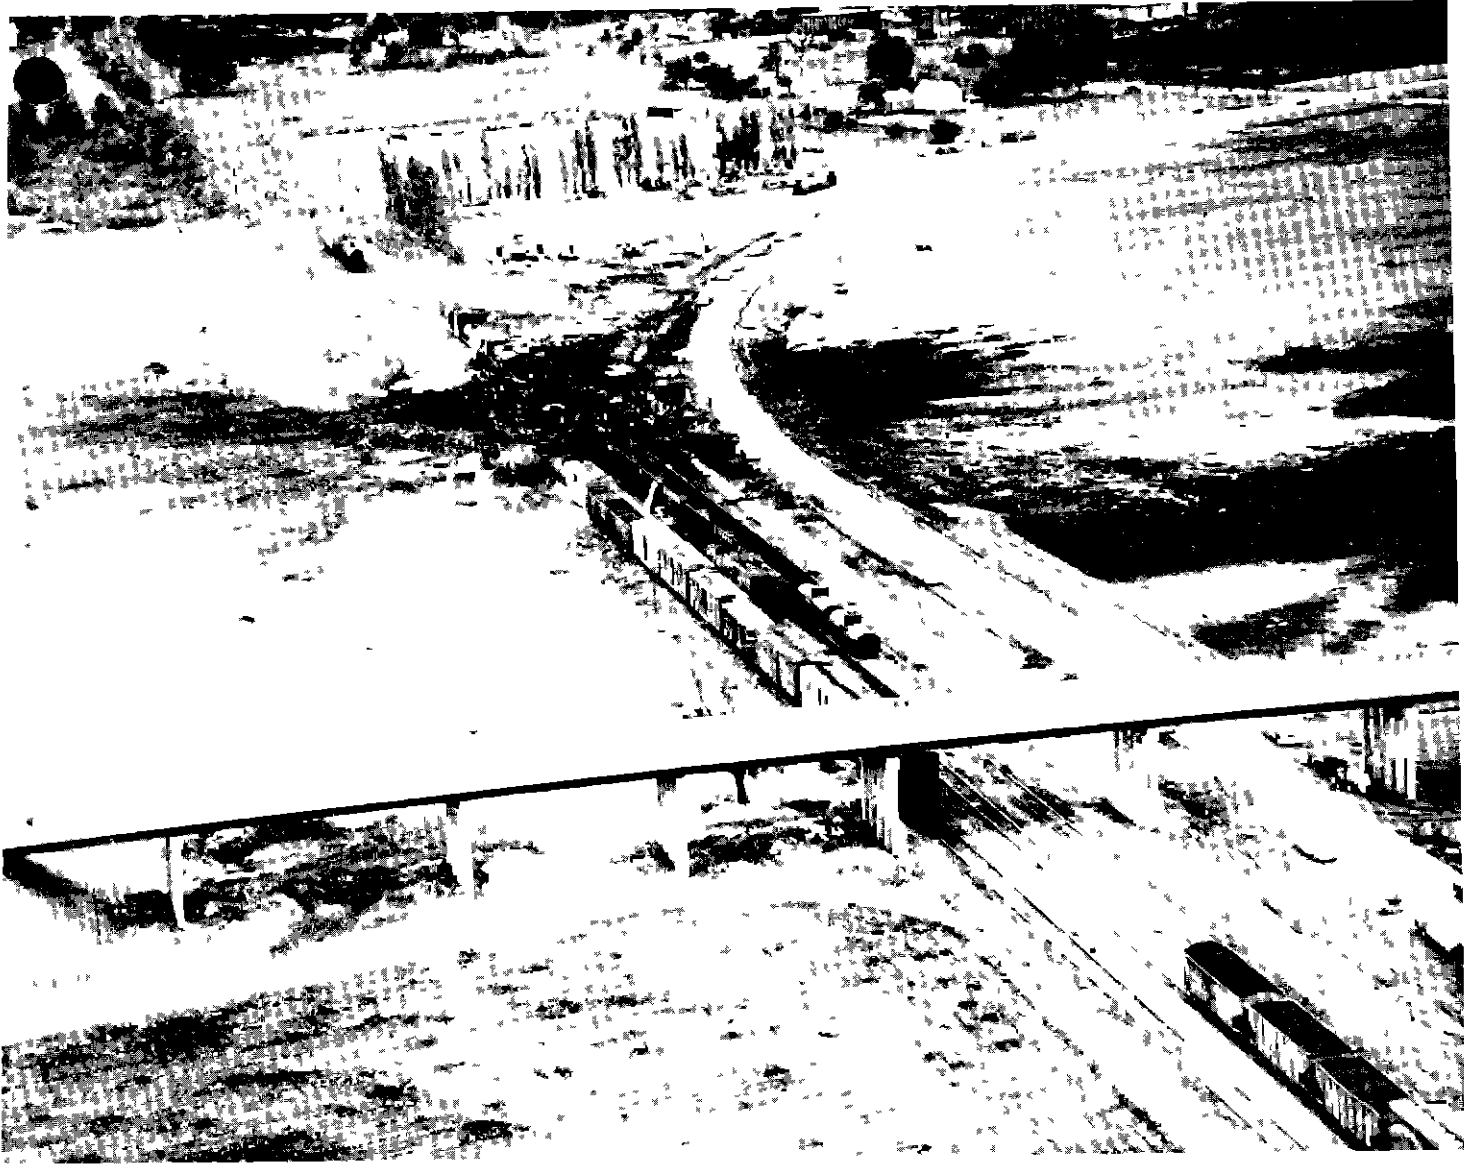
The explosion blasted a crater approximately 100 feet in diameter and 36 feet deep. The track structure in the immediate vicinity of the crater was destroyed. Cars standing on the main track, the New Storage Track, and the New Pass Track were plow from the tracks. Two cars stopped in the vicinity of the highway bridge and east of the tracks. Another car stopped approximately 300 feet south of the point of accident and 250 feet east of the tracks. The other derailed cars stopped within a radius of 250 feet of the point of accident. GATX 29633 and 17 other cars were destroyed. Twelve cars were heavily damaged by the explosion and some of these cars were further damaged by fire resulting from the explosion. Six other cars were somewhat damaged. The explosion scattered fragments of wreckage over a wide area. Considerable damage was caused to buildings in Mt. Pulaski by the fragments and by concussion. The highway bridge was damaged slightly.

Since car GATX 29633 and its lading were destroyed by the explosion, the cause of the explosion could not be determined. The car was standing and a coupling was not being made to either end of the cut of cars containing the car when the explosion occurred. Records indicate that the car was last loaded with 2-nitropropane before being loaded with the lading involved in the accident. The Chief Chemist testified that 2-nitropropane would act as an inhibitor and tend to prevent the explosion of nitromethane. An official of the United States Department of Commerce Weather Bureau witnessed the explosion. He said in a statement that he did not hear thunder or observe lightning at any time during the afternoon of the day of the accident.

1. The cause of the accident was the explosion of a tank car loaded with nitromethane.
2. The cause of the explosion could not be determined from the facts developed in this investigation.
3. Under certain conditions nitromethane can become a dangerous explosive.

In view of these findings we recommend that the Bureau of Explosives of the Association of American Railroads continue the investigation of the properties of nitromethane in order that adequate regulations can be formulated for the classification and preparation for transportation of other than bulk shipments of the material in tank cars and in tank motor vehicles when transported by common contract, or private carriers by motor vehicles.
