**RAILROAD ACCIDENT INVESTIGATION**

REPORT NO 4094

**ILLINOIS CENTRAL RAILROAD COMPANY**

**MAY 31, 1966**

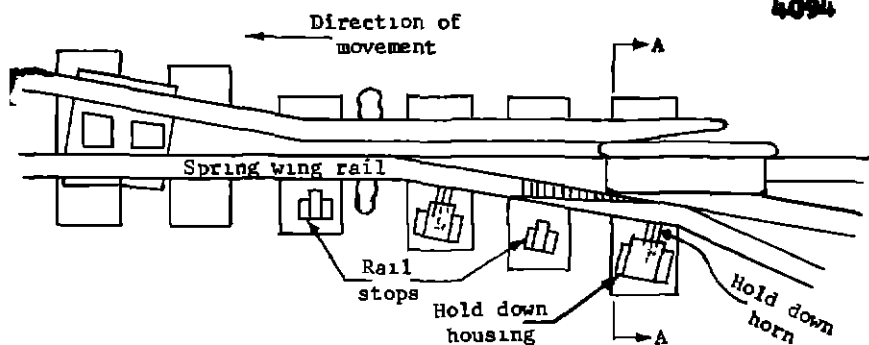
The spring wing rail of the frog was provided with hold downs 7 inches and 42 inches south of the frog point. The hold-down horns were riveted to the west side of the web of the spring wing rail. The flanges of the hold-down housings had their diagonal corners riveted to the frog plates and their outer edges welded to the frog plates. In addition, at the two remaining corners of each hold-down housing, spikes had been driven through the flanges and the frog plates into the switch ties. Examination of the frog after the derailment disclosed that the south hold-down horn was fractured at its outer end, and the three rivets securing the south end of the reinforcing bar to the spring wing rail were loose. At each hold-down housing the southwest corner was broken at the rivet. The weld along the south side of the housing and the flange on the north side of the housing were also broken. These defective conditions permitted independent vertical movements between the spring wing rail and the long point rail of the frog in excess of the maximum allowable one-eighth inch. The worn and polished appearance of the fractures of the broken pieces indicated that they had been broken and loose for a considerable time.

It is apparent that the south hold-down horn and both hold-down housings of the spring frog assembly had been broken a considerable time, indicating that the spring frog assembly had been inadequately maintained.

Sketch of frog showing position of wheel where a dangerous condition existed, due to defective hold downs, as shown in Section A-A

It is recommended that the Illinois Central Railroad Company take such action as is necessary to insure thorough inspection and adequate maintenance of spring frog assemblies.

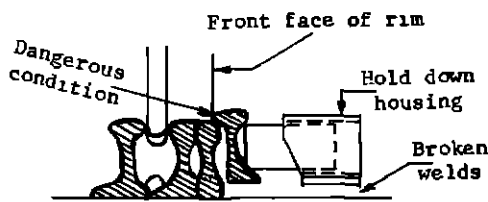
Section A-A  
Defective hold down

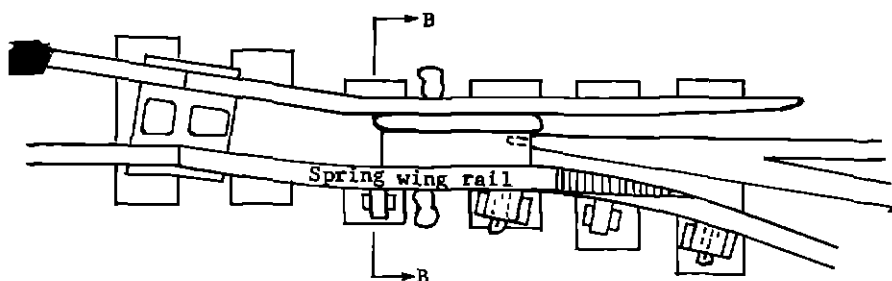
northern portion of this rail was deflected downward and the southern portion rocked upward. The front face of the rim of the following wheel then engaged the gage side of the raised spring wing rail and forced it outward as the wheel continued northward and dropped off the frog point into the throat of the frog. Some of the trailing wheels rerailed between the toe of the frog and the second straight closure rail. Apparently the northern end of the first straight closure rail was forced westward sufficiently to break loose from the rail joint and allow some of the wheels to rerail at the receiving end of the second closure rail. After being heavily battered by derailed wheels, the second closure rail broke 14-1/2 feet from the south end. The remaining 24-1/2 feet received considerable batter at the broken end and apparently was displaced by the 9th car, and resulted in the derailment of both trucks of the 9th to 12th cars, inclusive.

Sketch of frog showing wheel derailed after engaging spring wing rail and forcing it out of position, as shown in Section B-B

Section B-B  
Wheel derailed after passing  
over point of frog
