RAILROAD ACCIDENT INVESTIGATION

REPORT NO. 4163

ILLINOIS CENTRAL RAILROAD

SEPTEMBER 26, 1969

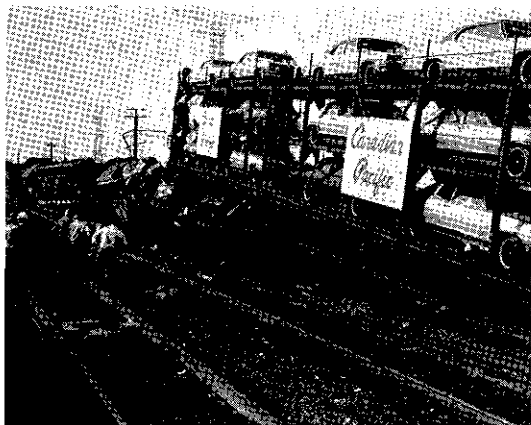
PLATE NO. 2

Ninth car of Extra 1214 North on top of first diesel-electric unit of Extra 5055 North.

The three diesel-electric units stopped upright, in leaning positions, on and in line with the structure of track No 4 (See Photo, Plate No 2). The control compartment at the front of the first unit was demolished as a result of the rear end of the 10th car of Extra 1214 North over-riding the underframe at the front of the unit, striking the control compartment, and stopping on top of the unit after also striking the engine compartment.

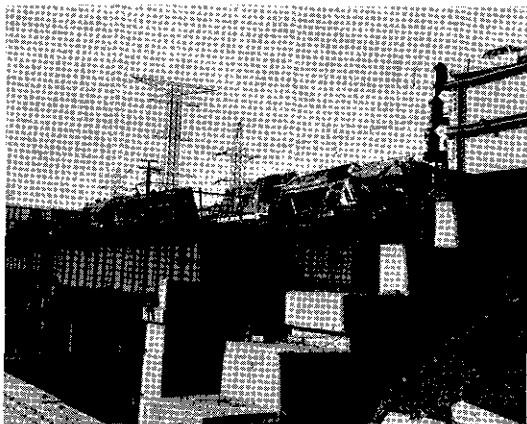
Locomotive units of Extra 5055 North on the Little Calumet River bridge. First unit is on the right.

This train stopped with the front of the first diesel-electric unit on the Little Calumet River bridge and 553 feet north of the collision point. All three diesel-electric units and the first 66 cars were derailed, some as a result of buckling action. The derailed cars stopped in various positions on that portion of the main tracks extending from the center of the bridge spanning the PC and B&O Railroads to the south end of the bridge over the Little Calumet River. All six main tracks were blocked by the wreckage. The bridge over the PC and B&O Railroads was heavily damaged, and some wreckage and spilled coal fell onto the PC tracks, blocking that railroad.

The first diesel-electric unit was destroyed, and the other two were damaged considerably. Of the 66 derailed cars, 65 were destroyed and one was somewhat damaged.
