RAILROAD ACCIDENT REPORT
ILLINOIS CENTRAL RAILROAD COMPANY
AND
INDIANA HARBOR BELT RAILROAD COMPANY
COLLISION BETWEEN
YARD TRAINS AT
RIVERDALE, ILLINOIS
ON SEPTEMBER 8, 1970

NATIONAL TRANSPORTATION SAFETY BOARD
Washington, D. C. 20591
REPORT NUMBER: NTSB-RAR-71-3

ADOPTED: NOVEMBER 24, 1971

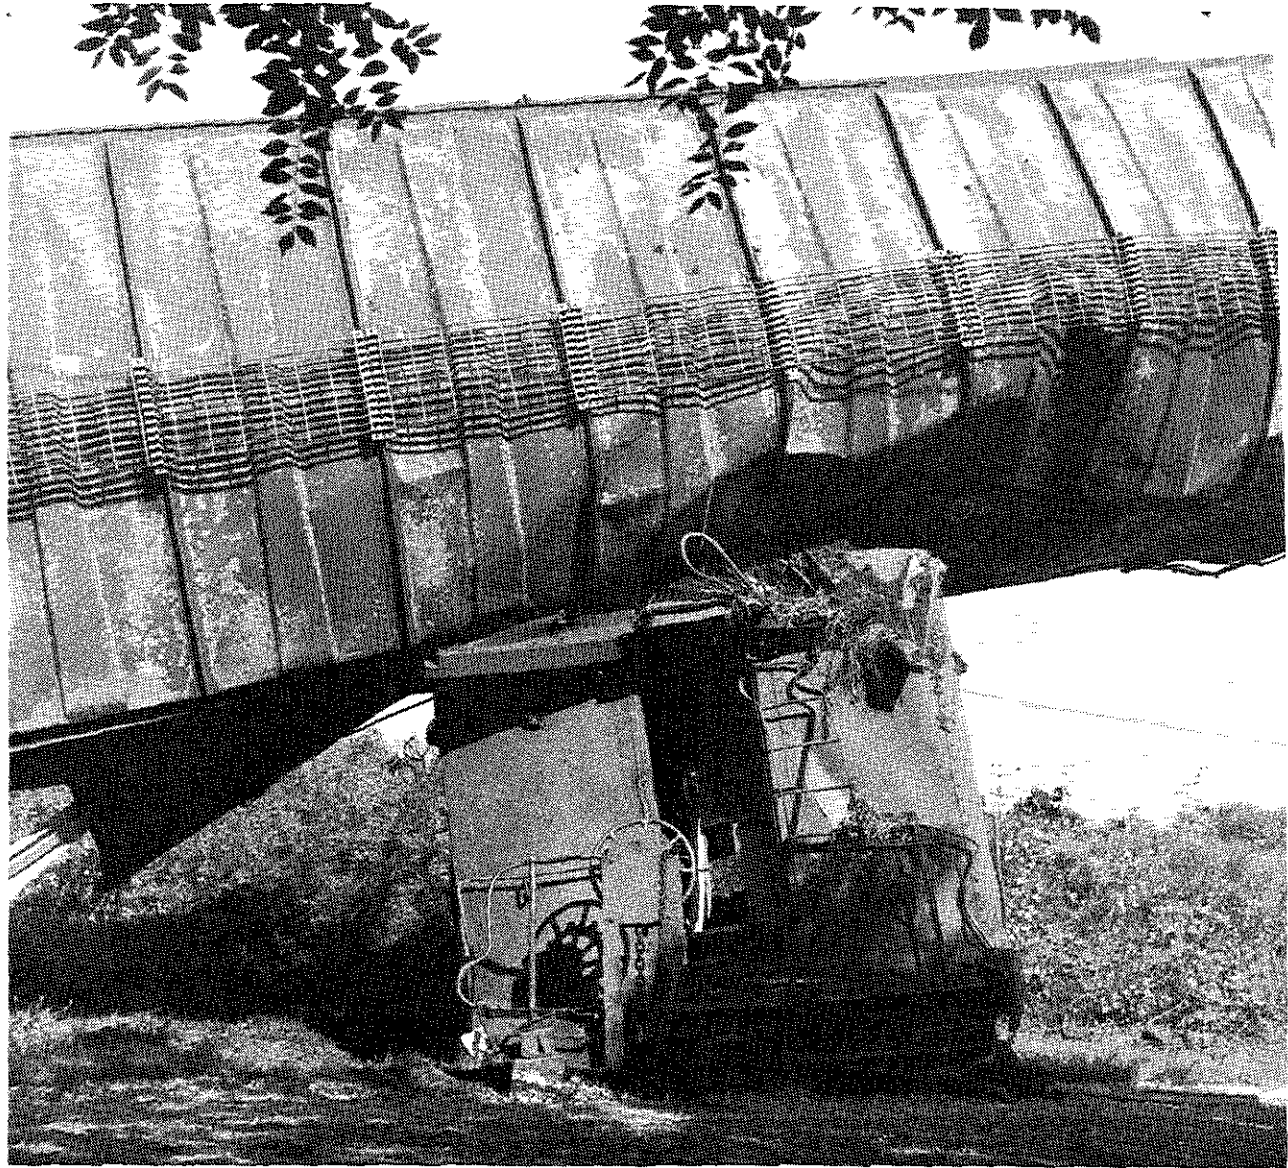
Figure 4 – The Collision End of IC
Caboose No. 9636

The collision caused the IC caboos to override the heavy underframe of the locomotive, initiating the demolition of the control

motive. Figure 5 shows the trailing end, and what originally was the west side, of the caboose. The interior of the caboose was cluttered with dislodged and overturned furniture and appurtenances. The IC estimated the damage to the caboose to be \$5,000.

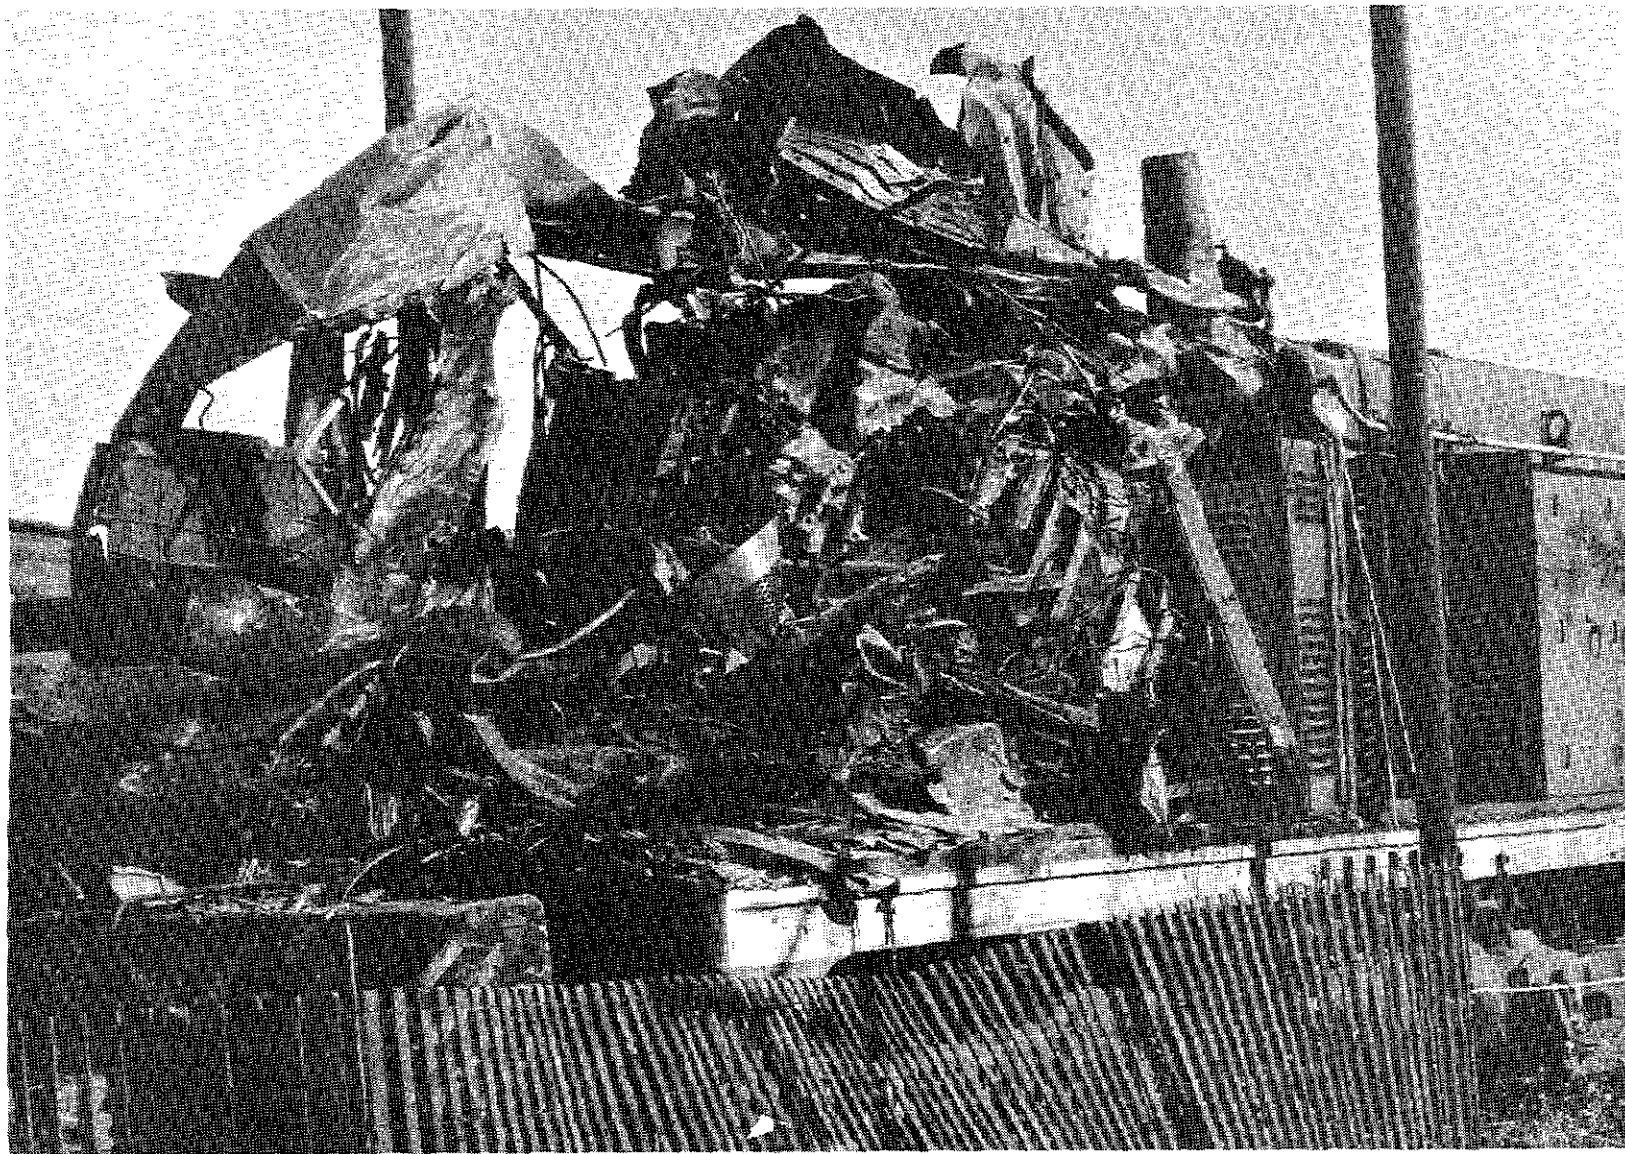
Figure 6 – The Right Side or Engineer's Side
Of IHB Locomotive No 8717

The cab of the IHB locomotive was demolished, with the exception of a small area where the front brakeman was located. Figure 6 shows the engineer's side of the locomotive. Figure 7 shows the opposite side of the locomotive. The structural underframe of the locomotive appeared to be relatively undamaged. The IHB estimated the damages to the locomotive to be \$75,000.

Modifications in locomotive design definitely are required. It does not appear logical to place a control compartment on the end of a massive locomotive where it is exposed to all collision hazards without providing protection for the occupants of that compartment. The caboose in this accident survived the dynamics of the collision relatively intact structurally. The critical vertical structural supports at the end of the caboose consisted of two cornerposts, which were 5- by 5-inch angles one-half inch thick. Intermediate supports included two 3-inch Z-sections, one-quarter inch thick, and two 6- by 6-inch-wide flange sections having a flange thickness of three-eighths inch and a web thickness of one-quarter inch. By contrast, the vertical struc-
