INVESTIGATION NO. 3053
ILLINOIS CENTRAL RAILROAD COMPANY
REPORT IN RE ACCIDENT
NEAR RUDDOCK, LA., ON
DECEMBER 27, 1946

Accident near Ruddock, La., on December 27, 1946, caused
by a broken rail.

Inv. No. 3053
 Illinois Central Railroad
 Ruddock, La.
 December 27, 1946

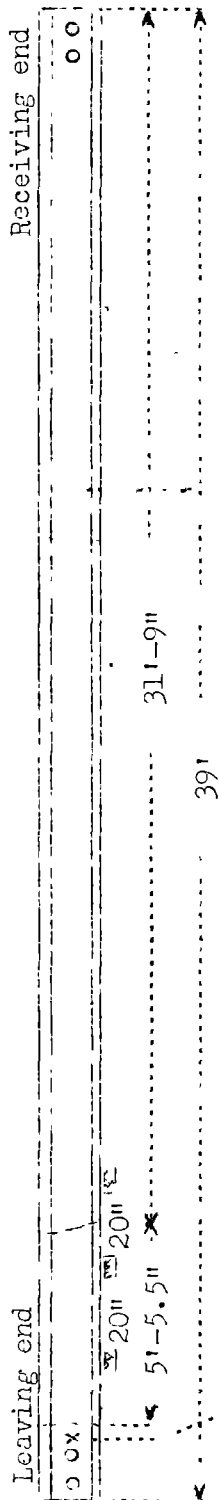
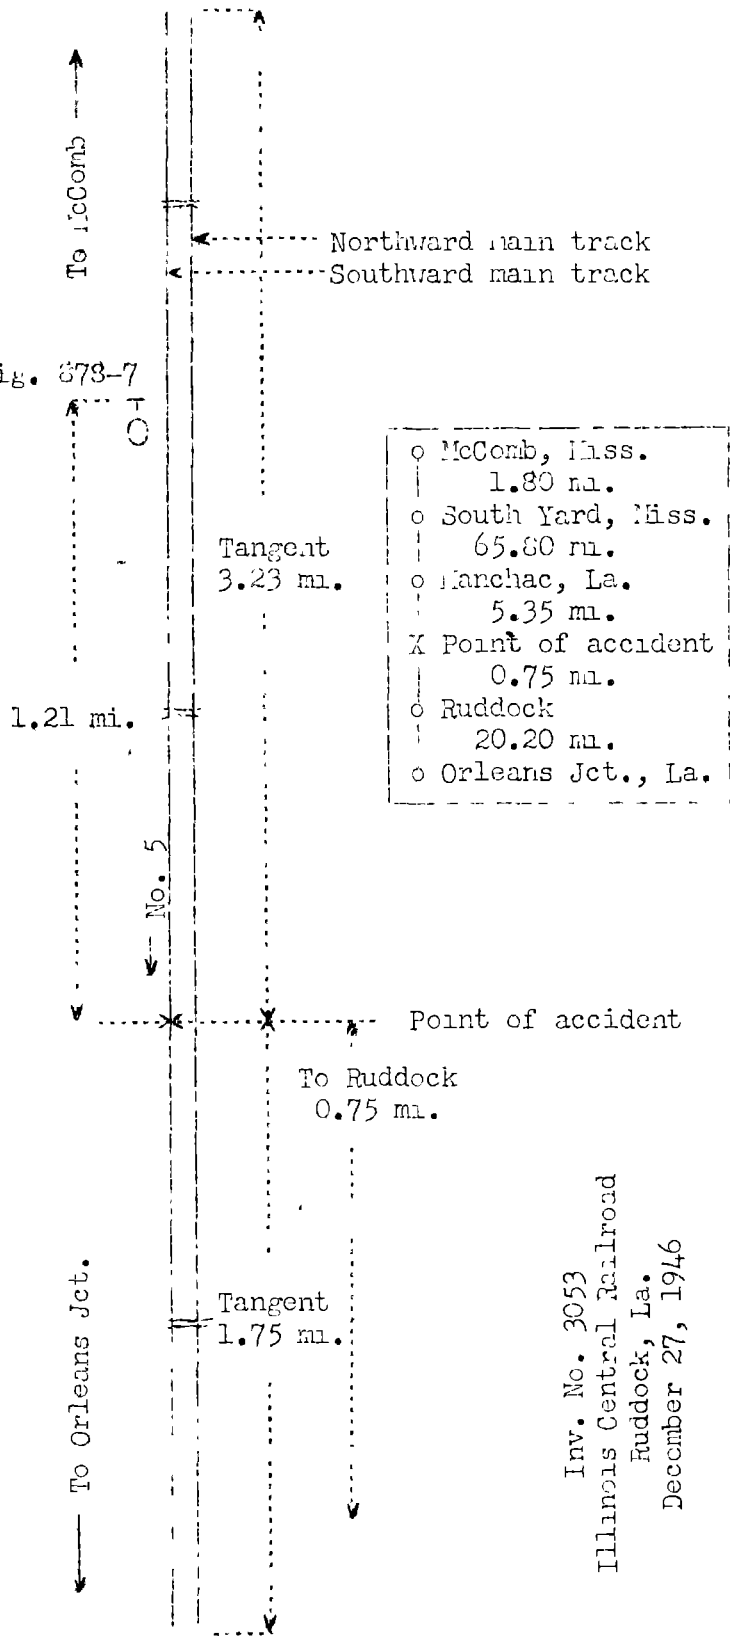
Sketch showing broken rail - west side of southward main track

After the accident a broken rail was found on the west side of the southward main track. This rail was broken into three pieces. The first break occurred between two ties at a point 31 feet 9 inches south of the receiving end of the rail. The adjacent ends of the pieces at the first break were considerably battered. The second break occurred between two ties at a point 5 feet 5.5 inches south of the first break.

The receiving end of the third piece of rail was battered downward about 15 degrees. Both breaks occurred north of the north ends of the bond wires and the angle bars at the leaving end of the rail. At both breaks there were progressive detail fractures covering about 50 percent of the cross-sectional area of the head of the rail. The metal at these areas was darkened by oxidation, which condition indicated that the rail had been defective for some time prior to the accident. The remainder of the breaks through the head, and the breaks in the web and the base of the rail were new. The breaks through the head of the rail were square, but were slightly angular downward through the remainder of the rail. Both fractures occurred beneath rail burns caused by the slipping of driving wheels. At these points the top surface of the rail had shelled out, and the detail fractures had progressed downward in the head. Flange marks appeared on the west side of the web of the piece of rail extending between breaks Nos. 1 and 2.

A south-bound passenger train passed over this track about 14 minutes before the derailment occurred, and the crew did not observe any abnormal condition of the track. Since the first automatic block signal north of the point of derailment displayed proceed for No. 5, it is probable that the complete failure of the rail occurred when the front portion of this train passed over it, then the piece between the breaks became displaced and the general derailment followed.
