REPORT NO. 3574  
ILLINOIS CENTRAL RAILROAD COMPANY  
IN RE ACCIDENT  
AT SHREVEPORT, LA., ON  
MAY 14, 1954

Accident at Shreveport, La., on May 14, 1954, caused by  
a bus occupying a rail-highway grade crossing  
immediately in front of an approaching transfer  
movement.

Report No. 3574  
 Illinois Central Railroad  
 Shreveport, La.  
 May 14, 1954

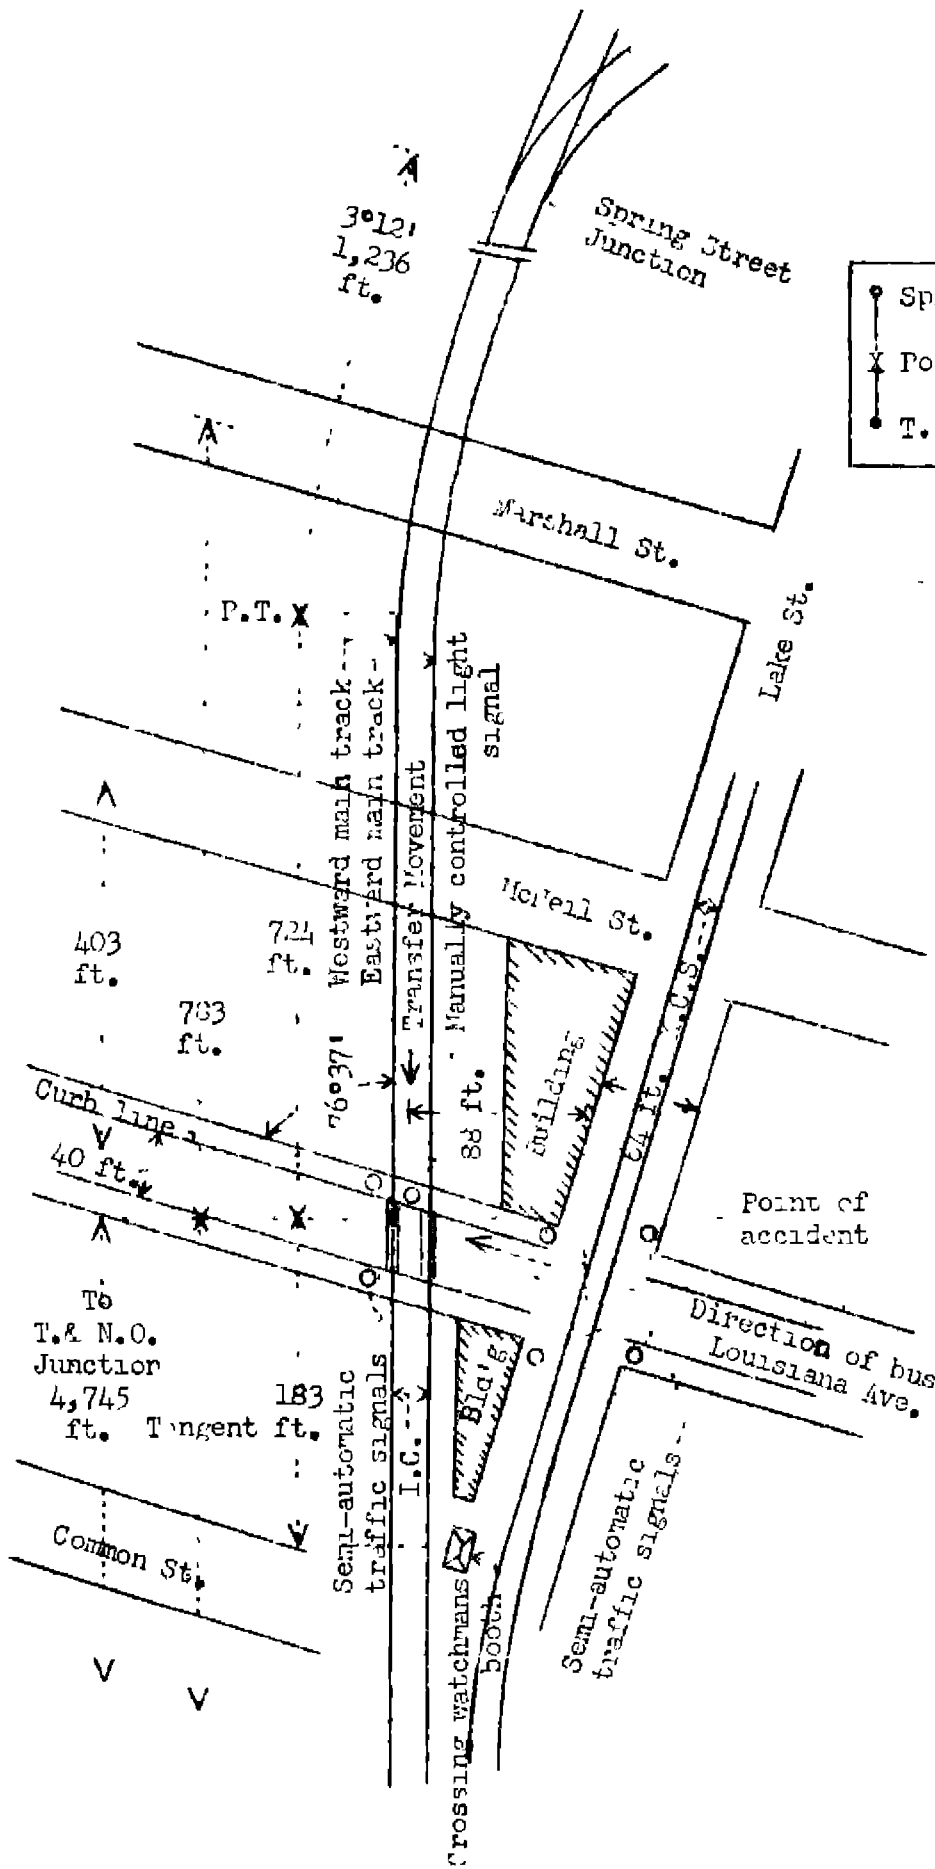
Location of Accident and Method of Operation

• Spring Street Jct., La.  
 0.40 mi.  
 X Point of accident  
 0.87 mi.  
 • T. & N. O. Junction, La.

This accident occurred on that part of the Vicksburg Division extending between Spring Street Junction and T. & N.O. Junction, 1.27 miles. Both of these points are located within the corporate limits of Shreveport, La. This is a double-track line, over which trains moving with the current of traffic are operated by timetable and operating rules. There is no block system in use. Trains and engines of the St. Louis Southwestern Railway regularly are operated over this portion of the Illinois Central Railroad. The accident occurred within yard limits, on the westward main track, at a point 1,960 feet west of Spring Street Junction, where the railroad is crossed at grade by Louisiana Avenue. From the east on the railroad there are, in succession, a 3°12' curve to the left 1,236 feet in length and a tangent 724 feet to the point of accident and a considerable distance westward. The grade for west-bound movements averages 0.90 percent ascending throughout a distance of 1,000 feet immediately east of the crossing. Louisiana Avenue intersects the railroad at an angle of 76°37'. This avenue is 40 feet wide between curbs and is surfaced with bituminous material. It is tangent for a considerable distance on each side of the crossing. The grade for north-bound vehicles averages 2.00 percent ascending a distance of 150 feet immediately south of the crossing and is practically level over the crossing. The crossing is approximately 65 feet wide. A 4-inch by 10-inch timber is secured to the ties on each side of each rail, and the remaining area of the crossing is surfaced with bituminous material to the approximate level of the tops of the rails. The main tracks are laid on 14.1-foot centers at this point.
