INVESTIGATION NO. 3228
ILLINOIS CENTRAL RAILROAD COMPANY
REPORT IN RE ACCIDENT
NEAR WICKLIFFE, KY., ON
JANUARY 18, 1949

Accident near Wickliffe, Ky., on January 18, 1949, caused
by the sinking of a fill.

Inv. No. 3223
 Illinois Central Railroad
 Wickliffe, Ky.
 January 13, 1949

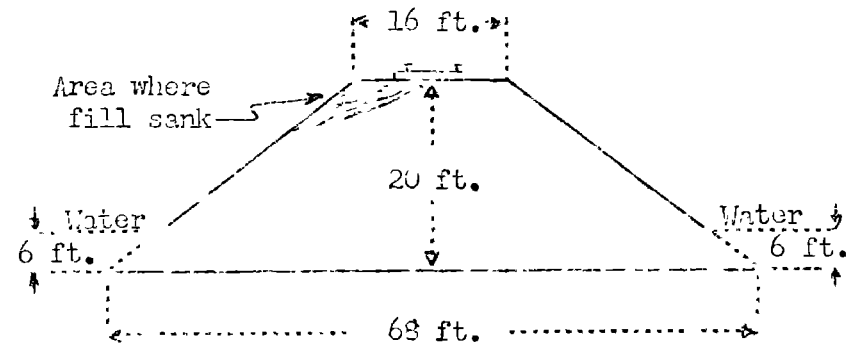
Cross section of fill at point of accident

Examination after the accident disclosed that a section of the fill about 85 feet in length on the west side of the track had sunk. At the point of accident the maximum depth was about 4 feet at the shoulder and it extended under the ties to about the center-line of the track. The track south of the point of accident was in normal alinement and there was no indication of dragging equipment.

The fill in question was an earthen fill. In 1937 a part of the fill was washed away by a flood. This portion was replaced with earth and slog, and rip-rap was placed at the base of the fill. It had rained steadily throughout a period of several hours prior to the time of the accident. At that time backwater from the Ohio River and the Mississippi River had risen about 6 feet above the bottom of the fill. The engineer of maintenance-of-way of this carrier said that backwater frequently rises on this fill to a height in excess of 6 feet but a sinking of the fill had not occurred at this location prior to the time this accident occurred. Apparently, the earth in the bottom of the fill was softened by water to such an extent that the combined weight of the upper part of the fill and the engine of Extra 1569 North forced the bottom portion of the fill outward and the upper portion downward.
