REPORT NO. 80-1
ILLINOIS TERMINAL RAILROAD COMPANY
COLLINSVILLE, ILLINOIS
AUGUST 6, 1978

✓ RAILROAD ACCIDENT INVESTIGATION

~~ACCIDENT~~ REPORT, NO. 80-1, 80-2.

ILLINOIS TERMINAL RAILROAD COMPANY

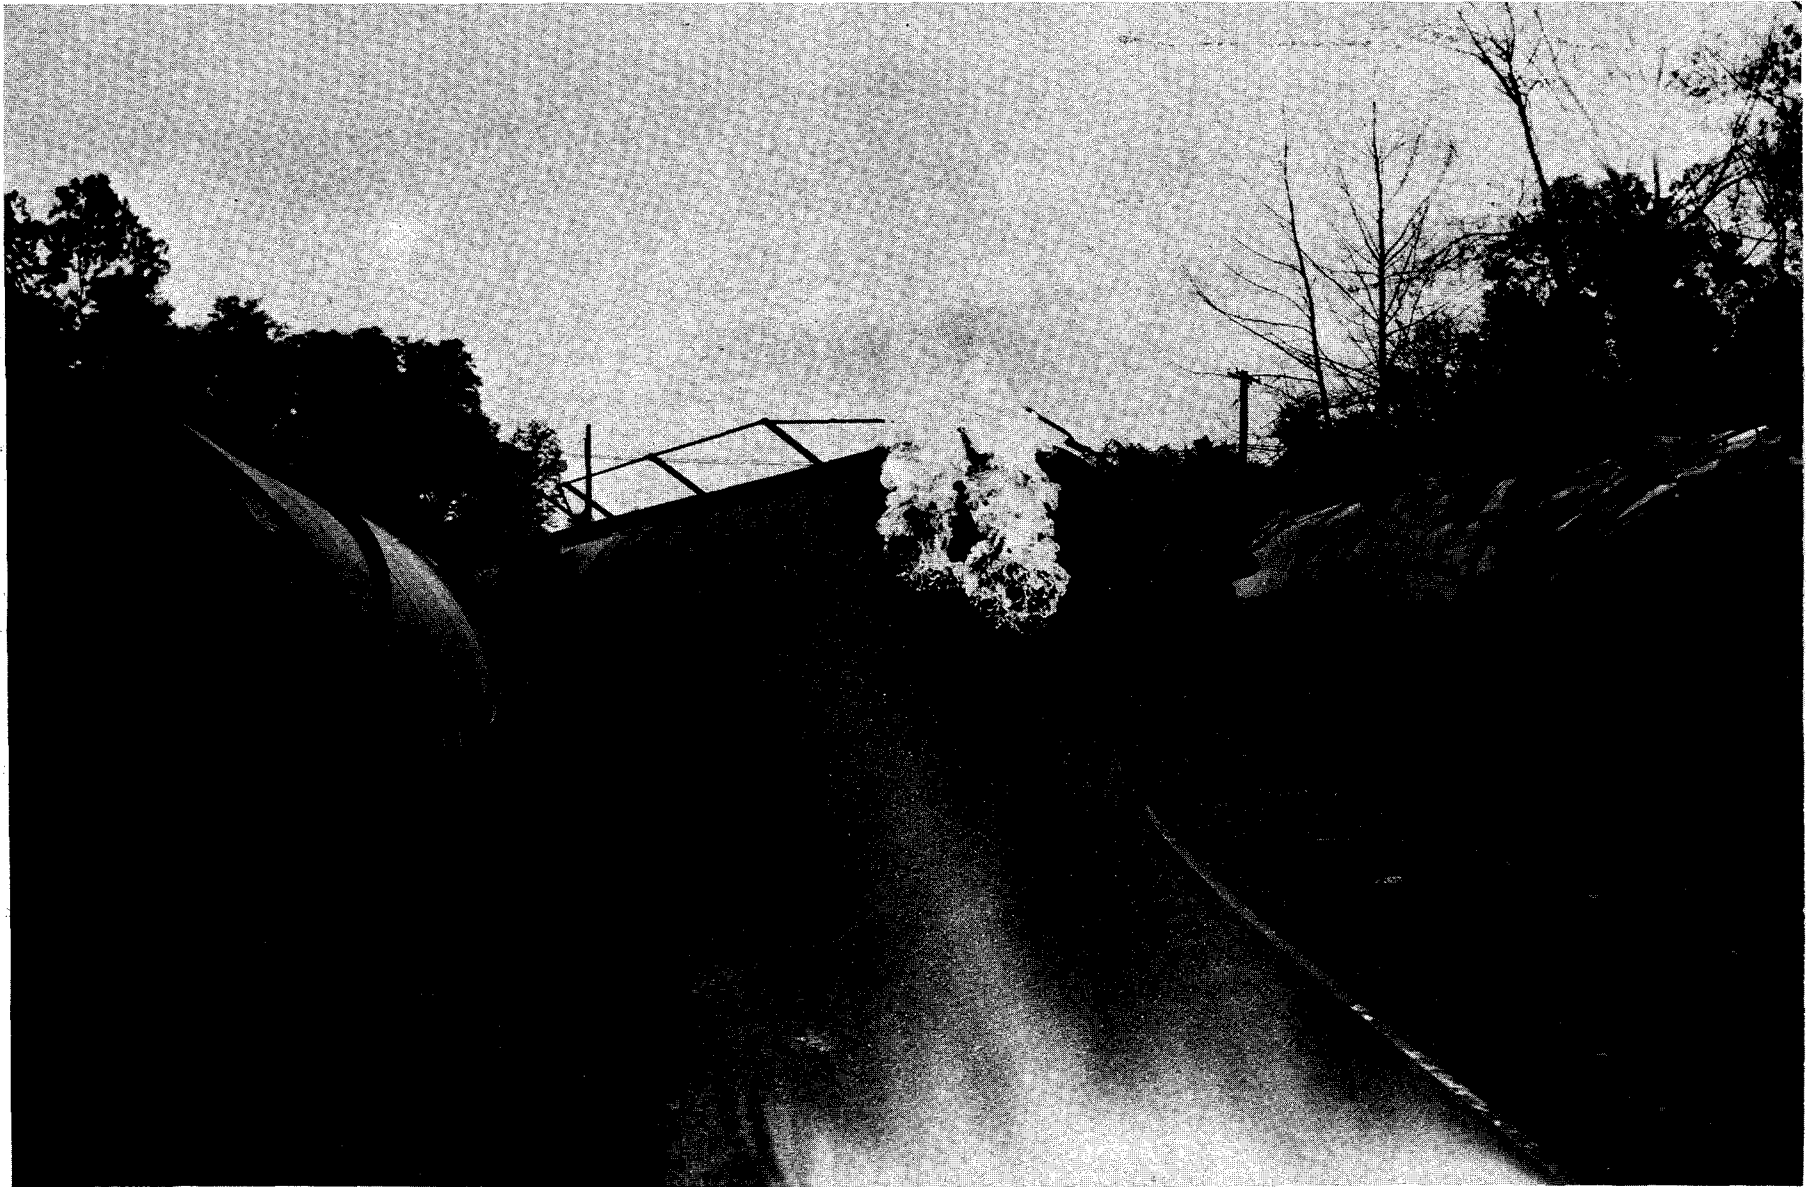
The initial derailment had occurred 20.5 feet south of a 116.8 foot bridge at Mile Post 22.8. At this point, a lift-off of the wheels on the leading truck of the 21st car caused the tank car to derail over the high rail of the curve. This car, with one set of derailed trucks, traveled 1.2 miles south to the Keebler siding track's south switch where the general derailment occurred. The 21st through the 26th cars in the train subsequently derailed. The 27th car derailed only the south trucks as it stopped on the North Keebler Street crossing. The derailed cars were all "jumbo" tank cars containing liquefied petroleum gas. One of the derailed tank cars was punctured and ruptured, releasing the gas which exploded.

VIEW OF BURNING TANK CAR

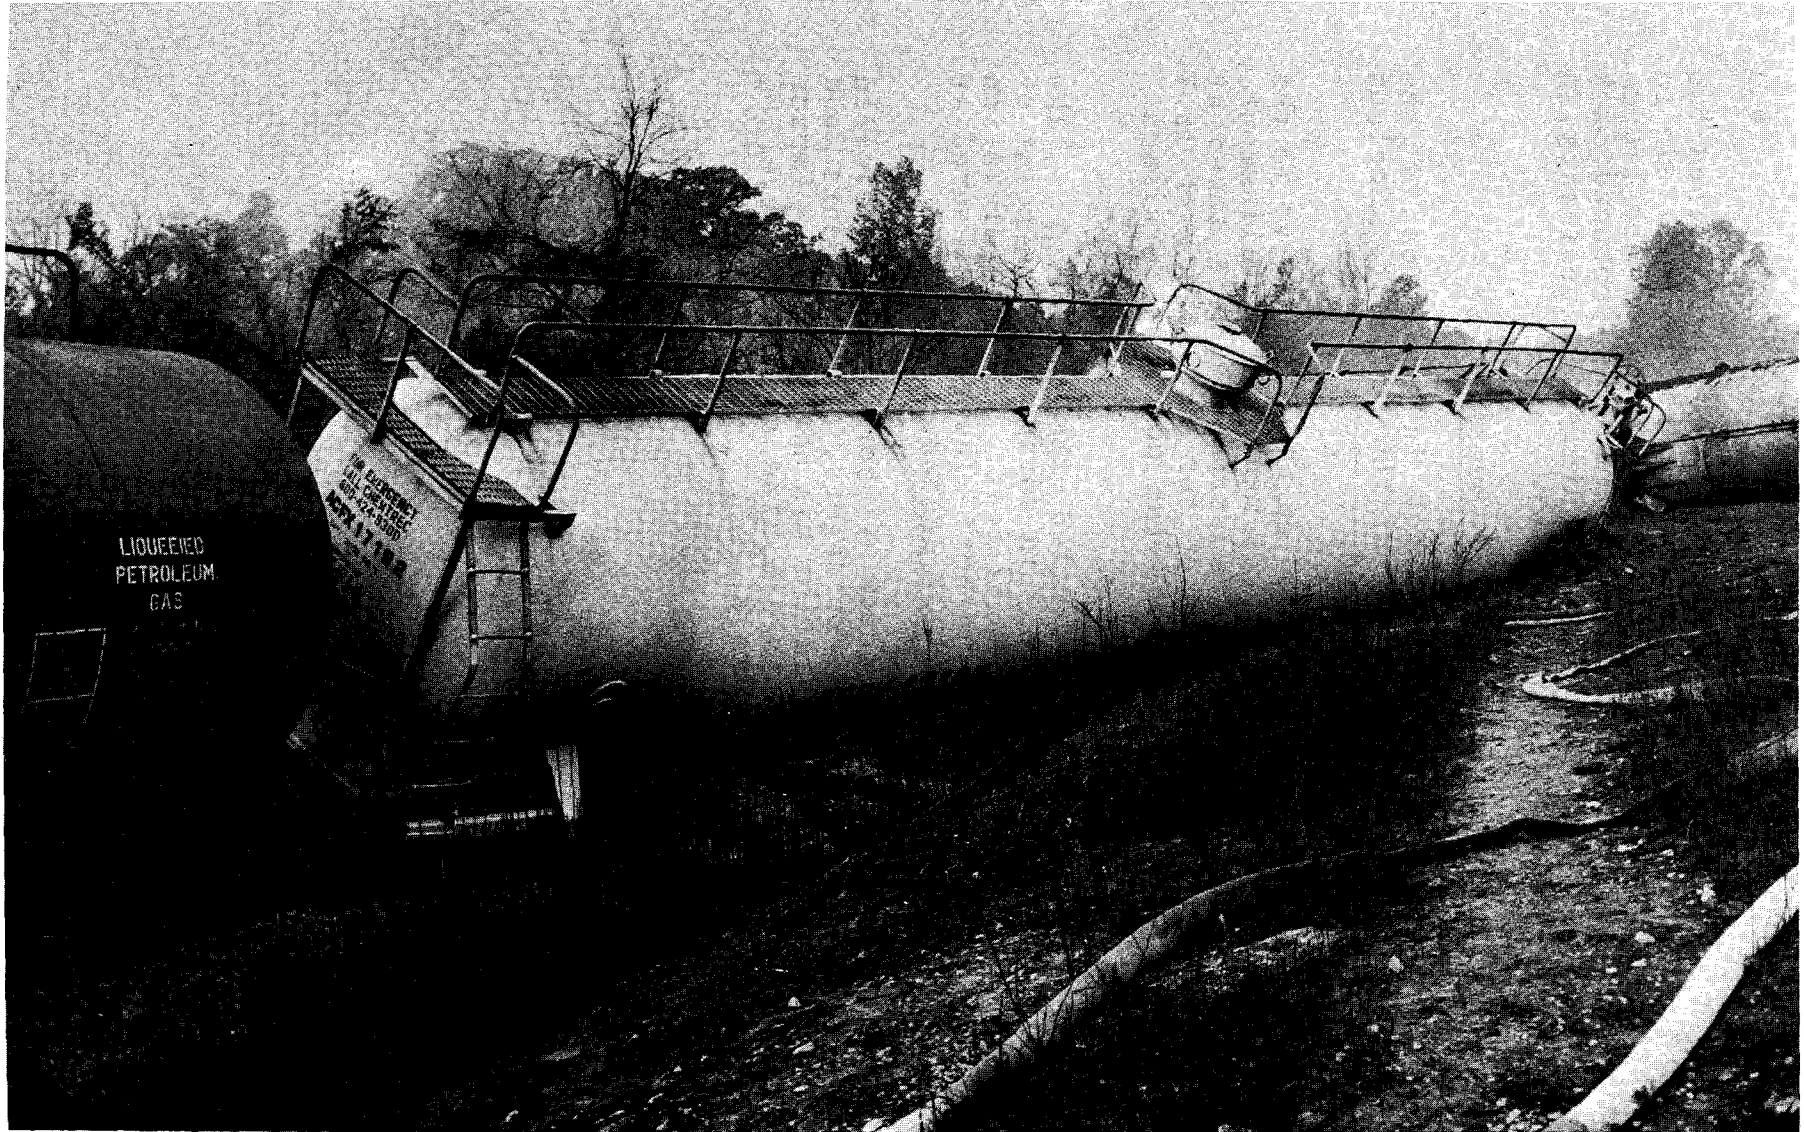
VIEW OF DERAILED CARS; THE DARKER CAR, GATX 91452 WAS EQUIPPED WITH SHELF COUPLERS.

The fifth car, ACFX 17192, specification 112A340-W with type E couplers, the sixth car, GATX 91452, specification 112T340-W with jacketed insulation and type E shelf couplers, and the seventh car, NATX 32151, specification 112A340-W with type E couplers, remained coupled together, upright and in line with the track structure. Only the lead truck of the seventh car derailed.
