REPORT OF THE DIRECTOR  
BUREAU OF SAFETY

ACCIDENT ON THE  
INDIANA HARBOR BELT RAILROAD

BROADVIEW, ILL.

INVESTIGATION NO. 2452

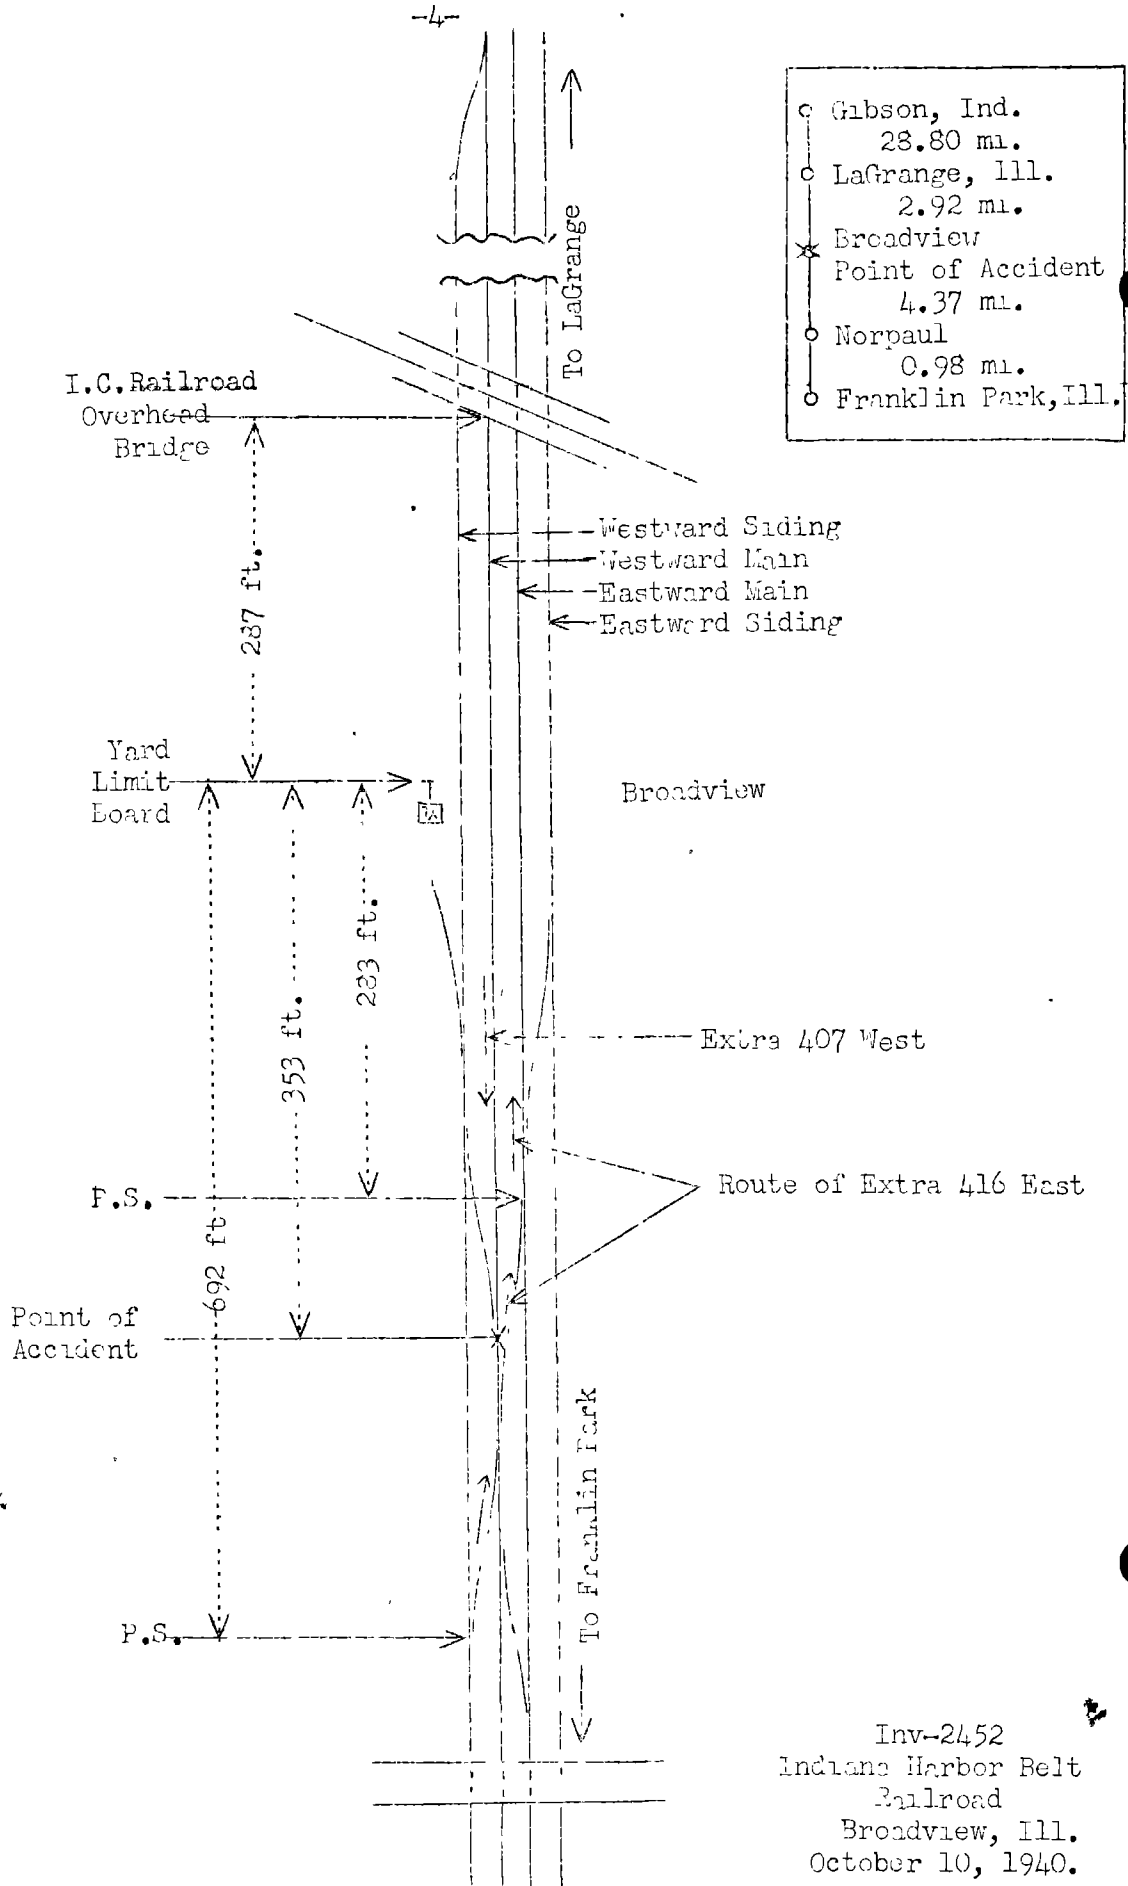
Inv-2452  
 Indiana Harbor Belt  
 Railroad  
 Broadview, Ill.  
 October 10, 1940.

- Gibson, Ind. 28.80 mi.
- LaGrange, Ill. 2.92 mi.
- ✱ Broadview Point of Accident 4.37 mi.
- Norpaul 0.98 mi.
- Franklin Park, Ill.
