INVESTIGATION NO. 2693

THE INDIANAPOLIS UNION RAILWAY COMPANY  
AND  
THE CLEVELAND, CINCINNATI, CHICAGO & ST. LOUIS  
RAILWAY COMPANY

REPORT IN RE ACCIDENT

APRIL 12, 1943

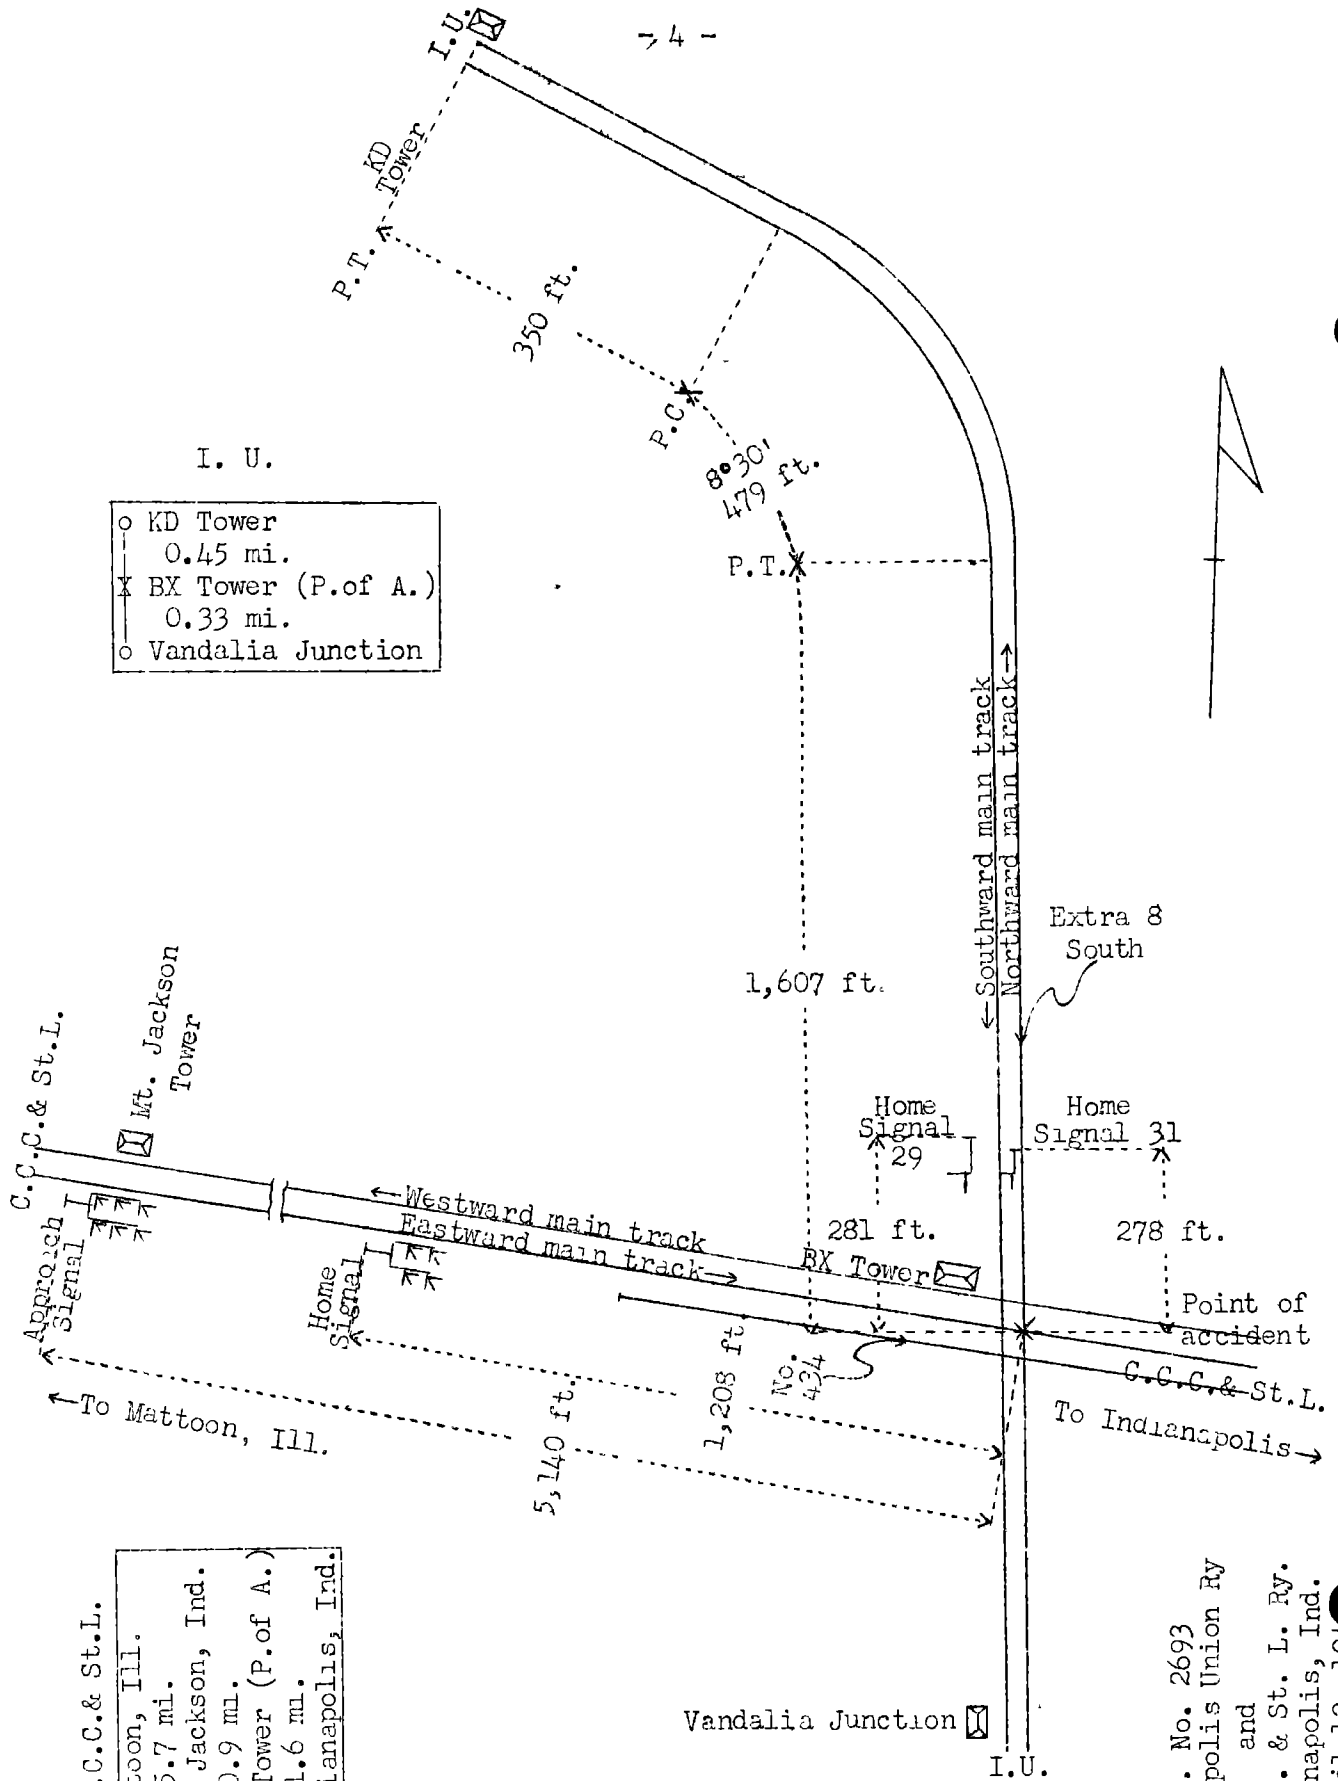
Location of Accident and Method of Operation

- KD Tower
- 0.45 mi.
- ✕ BX Tower (P. of A.)
- 0.33 mi.
- Vandalia Junction

- Mattoon, Ill.
- 125.7 mi.
- Mt. Jackson, Ind.
- 0.9 mi.
- ✕ BX Tower (P. of A.)
- 1.6 mi.
- Indianapolis, Ind.

Inv. No. 2693  
 Indianapolis Union Ry  
 and  
 C. C. C. & St. L. Ry.  
 Indianapolis, Ind.  
 April 12, 194
