INTERSTATE COMMERCE COMMISSION

REPORT OF THE DIRECTOR OF THE BUREAU OF SAFETY CONCERNING AN
ACCIDENT ON THE INTERNATIONAL-GREAT NORTHERN RAILROAD
AT BLACK BRIDGE, TEXAS, ON DECEMBER 27, 1933.

March 1, 1934.

Inv. No. 1879
International - Great Northern RR
Black Bridge, Texas
Dec. 27, 1933

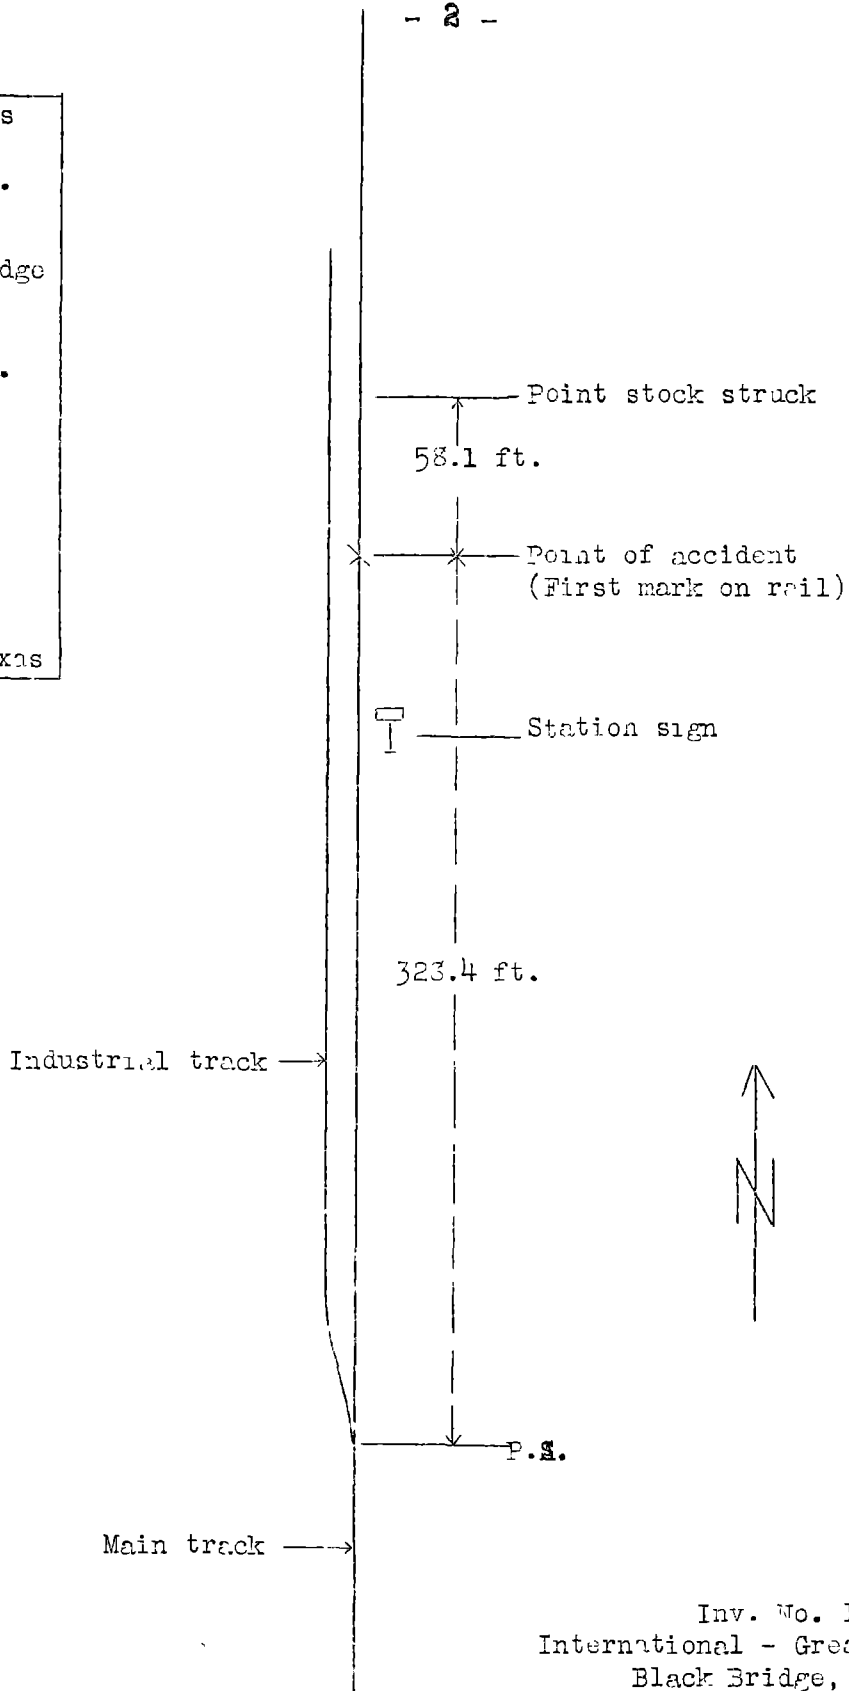
The engine and tender became entirely derailed after passing the frog of the switch, and then overturned and stopped on their right sides with the engine to the left of the track and its forward end 521.9 feet south of the point of accident, while the tender stopped diagonally across the track. The first 17 cars

and the forward truck of the eighteenth car were also derailed and stopped in various positions across and adjacent to the track within a space of 300 feet. The engine was considerably damaged, four of the cars were destroyed and the remainder of the derailed cars, except the eighteenth car, was more or less damaged. The employees killed were the engineman, fireman and head brakeman.
