INTERSTATE COMMERCE COMMISSION

REPORT OF THE DIRECTOR OF THE BUREAU OF SAFETY CONCERNING
 INVESTIGATION OF AN ACCIDENT WHICH OCCURRED ON THE
 INTERNATIONAL-GREAT NORTHERN RAILROAD, MISSOURI
 PACIFIC LINES, NEAR PALESTINE, TEX., ON MARCH
 3, 1932.

INV. NO. 1754
INTERNATIONAL - GREAT NORTHERN RR
PALESTINE, TEXAS
MARCH 2, 1932.

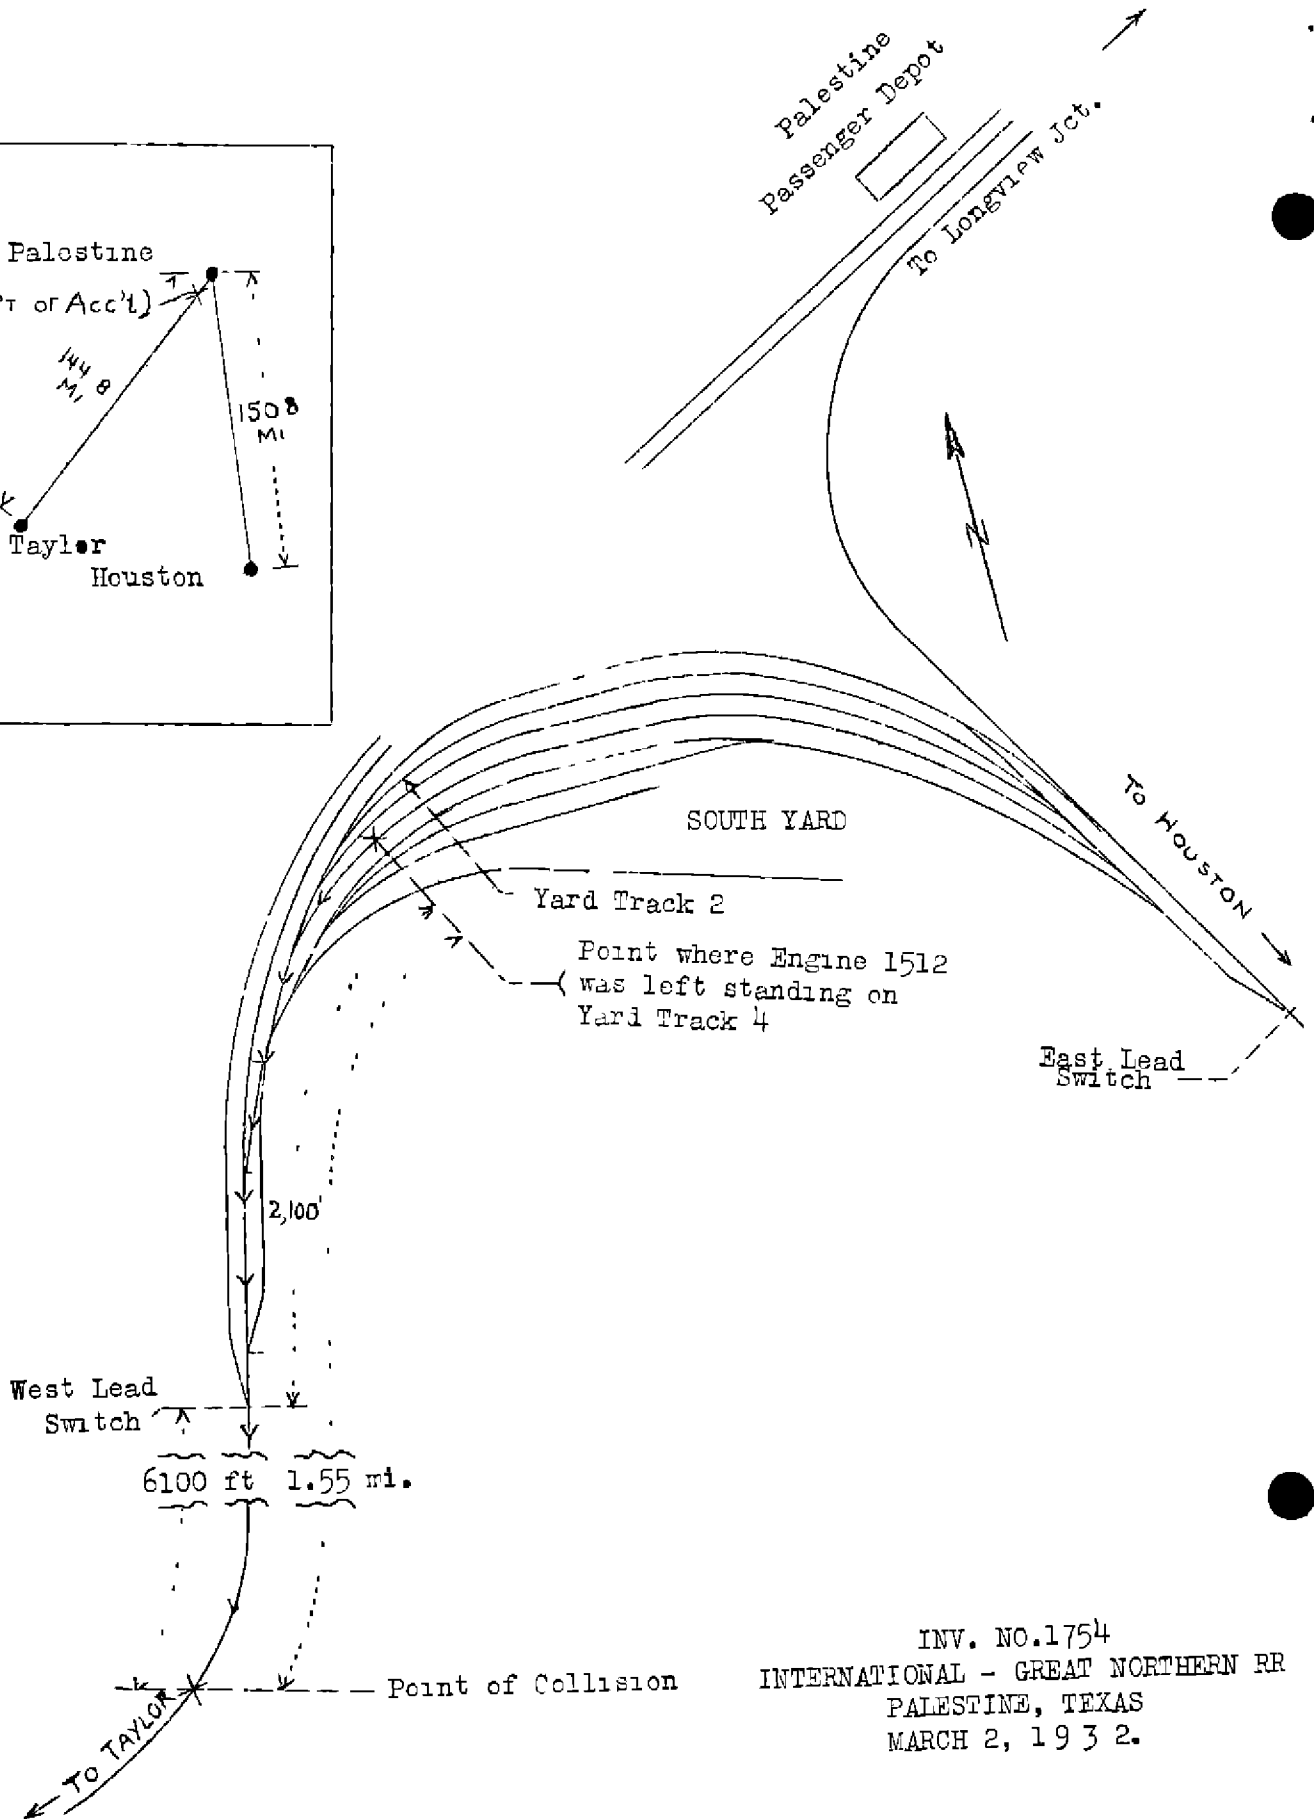
west lead switch and beyond to the point of accident, the maximum descending grade on the main track is 1.10 per cent, while the grade at the point of accident is 0.30 per cent. Approaching the point of accident from the north, beginning at the west lead switch, the track is tangent for a distance of 1,463 feet and then there is a 3° curve to the right 867 feet in length and 2,950 feet of tangent, followed by a 1° curve to the right 1,300 feet in length, the accident occurring on this curve at a point 819 feet from its northern end. Approaching from the south the track is tangent for a distance of 2,500 feet, followed by the curve on which the accident occurred.
