REPORT OF THE DIRECTOR
BUREAU OF SAFETY

ACCIDENT ON THE
INTERNATIONAL-GREAT NORTHERN RAILROAD

-----+
COLORADO BRIDGE, (AUSTIN) TEXAS

-----+
JANUARY 5, 1937

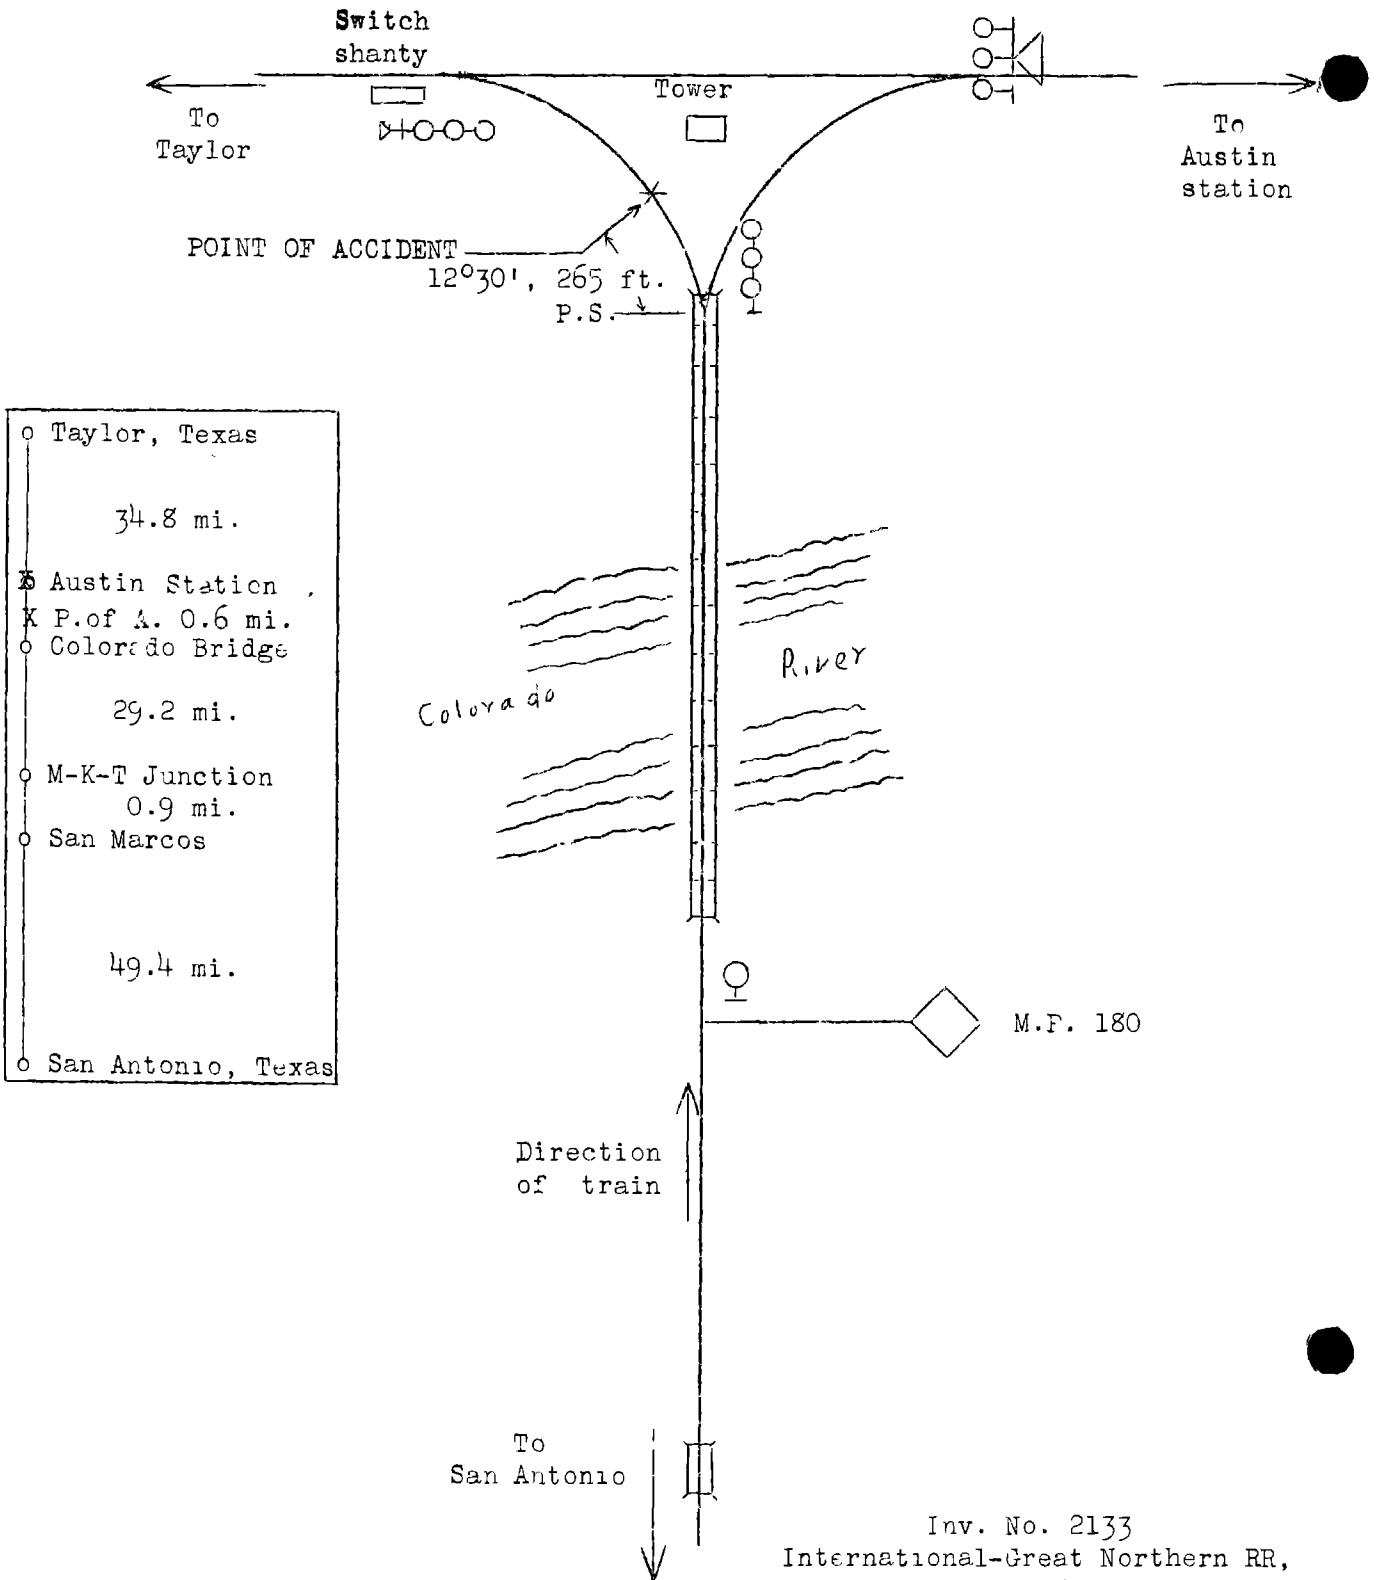
Inv. No. 2133
International-Great Northern RR,
Austin, Texas
Jan. 5, 1937

Time table directions are used throughout this report. Approaching the point of accident from the south, the track is tangent for more than a mile, extending to the north end of Colorado River bridge; there is then a 12° 30' curve to the left, 794 feet in length. At the south end of this curve a track leading to Austin passenger station diverges to the right on a similar curve; the normal position of the switch at this point is for a main track movement. These two curves form the west and east legs, respectively, of a wye and a track connecting the north ends of the curves forms the north leg of the wye. The wye switches are operated from an interlocking tower located approximately in the center of the wye; wayside signals indicate the position of the wye switches. Passenger trains entering Austin from the south, proceed over the west leg of the wye and back through the north leg to the station. The accident occurred on the curve forming the west leg of the wye, 265 feet from the receiving or south end. The grade is 1.25 per cent descending northward for approximately 3½ miles, to a point 3,150 feet south of the point of accident, followed by 755 feet of level track, 610 feet of 0.83 per cent ascending grade, 1,520 feet of level track across the bridge, and then 794 feet of 0.94 per cent descending grade to the end of the curve.

Inspection of the track by the Commission's inspectors showed that the first indication of derailment was a flange mark on a tie, 265 feet north of the south wye-switch and 17 inches outside the gauge of the high rail. Flange marks continued on the ends of the ties, parallel to the outside rail, for a distance of approximately 100 feet from that point, and then apparently the wheels left the ties. The first wheel mark inside the low rail appeared on a spike head 320 feet north of the south switch, and these marks continued to the point where the opposite flange mark disappeared. Continuing for a distance of 280 feet from this point there were a number of flange marks which appeared to have been made by the front truck of the second baggage car, MP 4248. At no place was there any indication of dragging equipment or of a wheel having climbed the high rail. The track was but slightly damaged; one rail on the high side of the curve was kinked downward about 1 inch and inward slightly toward the center of the track, at points 2 feet from its north end and 3 feet from its south end; this latter point was 92 feet north of the first marks of derailment and nearly opposite the point where the rear of the derailed locomotive stopped.

The investigation indicates that the derailment was started by the careening toward the right of the tender of engine 6425 as it entered upon the $12^{\circ} 30'$ curve of the west leg of the wye; this is evident by the twists in the shanks of the couplers on the rear end of the tender and the head end of the first car, and as a result of this force the engine and tender were overturned toward the outside of the curve. The baggage car became separated from the tender and was derailed on the outside of the curve but did not overturn.

This accident was caused by excessive speed on a sharp curve.

It is recommended that measures be taken to enforce a definite, maximum speed limit which will provide an adequate margin of safety for trains on this curve.
