INTERSTATE COMMERCE COMMISSION

REPORT OF THE DIRECTOR OF THE BUREAU OF SAFETY CONCERNING AN
ACCIDENT WHICH OCCURRED ON THE INTERSTATE RAILROAD NEAR
JOSEPHINE, VA., ON DECEMBER 1, 1932.

January 6, 1933.

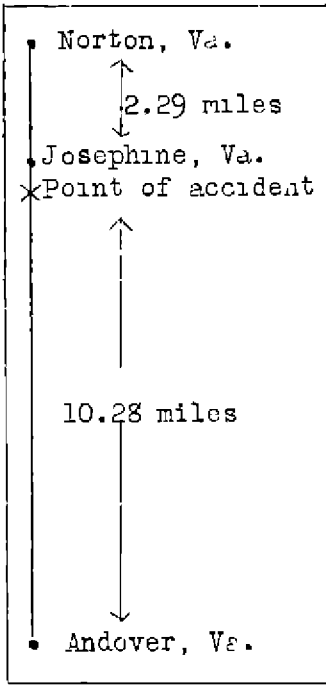
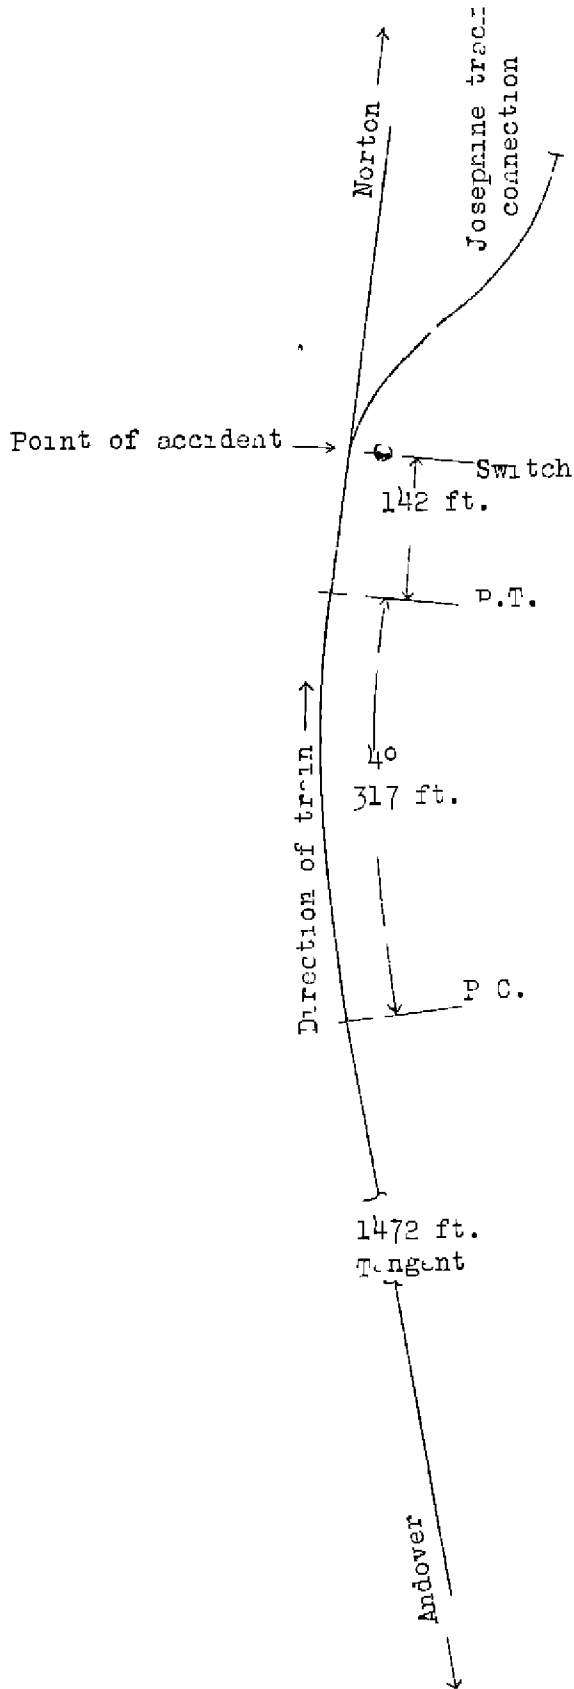
Inv. No. 1795
 Interstate Railroad
 Josephine, Va.
 Dec. 1, 1932

This accident was caused by a cocked or partly-opened switch, due to tampering.
