# NATIONAL TRANSPORTATION SAFETY BOARD

## RAILROAD ACCIDENT REPORT

**HEAD-ON COLLISION BETWEEN  
IOWA INTERSTATE RAILROAD EXTRA 470 WEST  
AND EXTRA 406 EAST WITH RELEASE OF  
HAZARDOUS MATERIALS  
NEAR ALTOONA, IOWA  
JULY 30, 1988**

NTSB/RAR-89/04

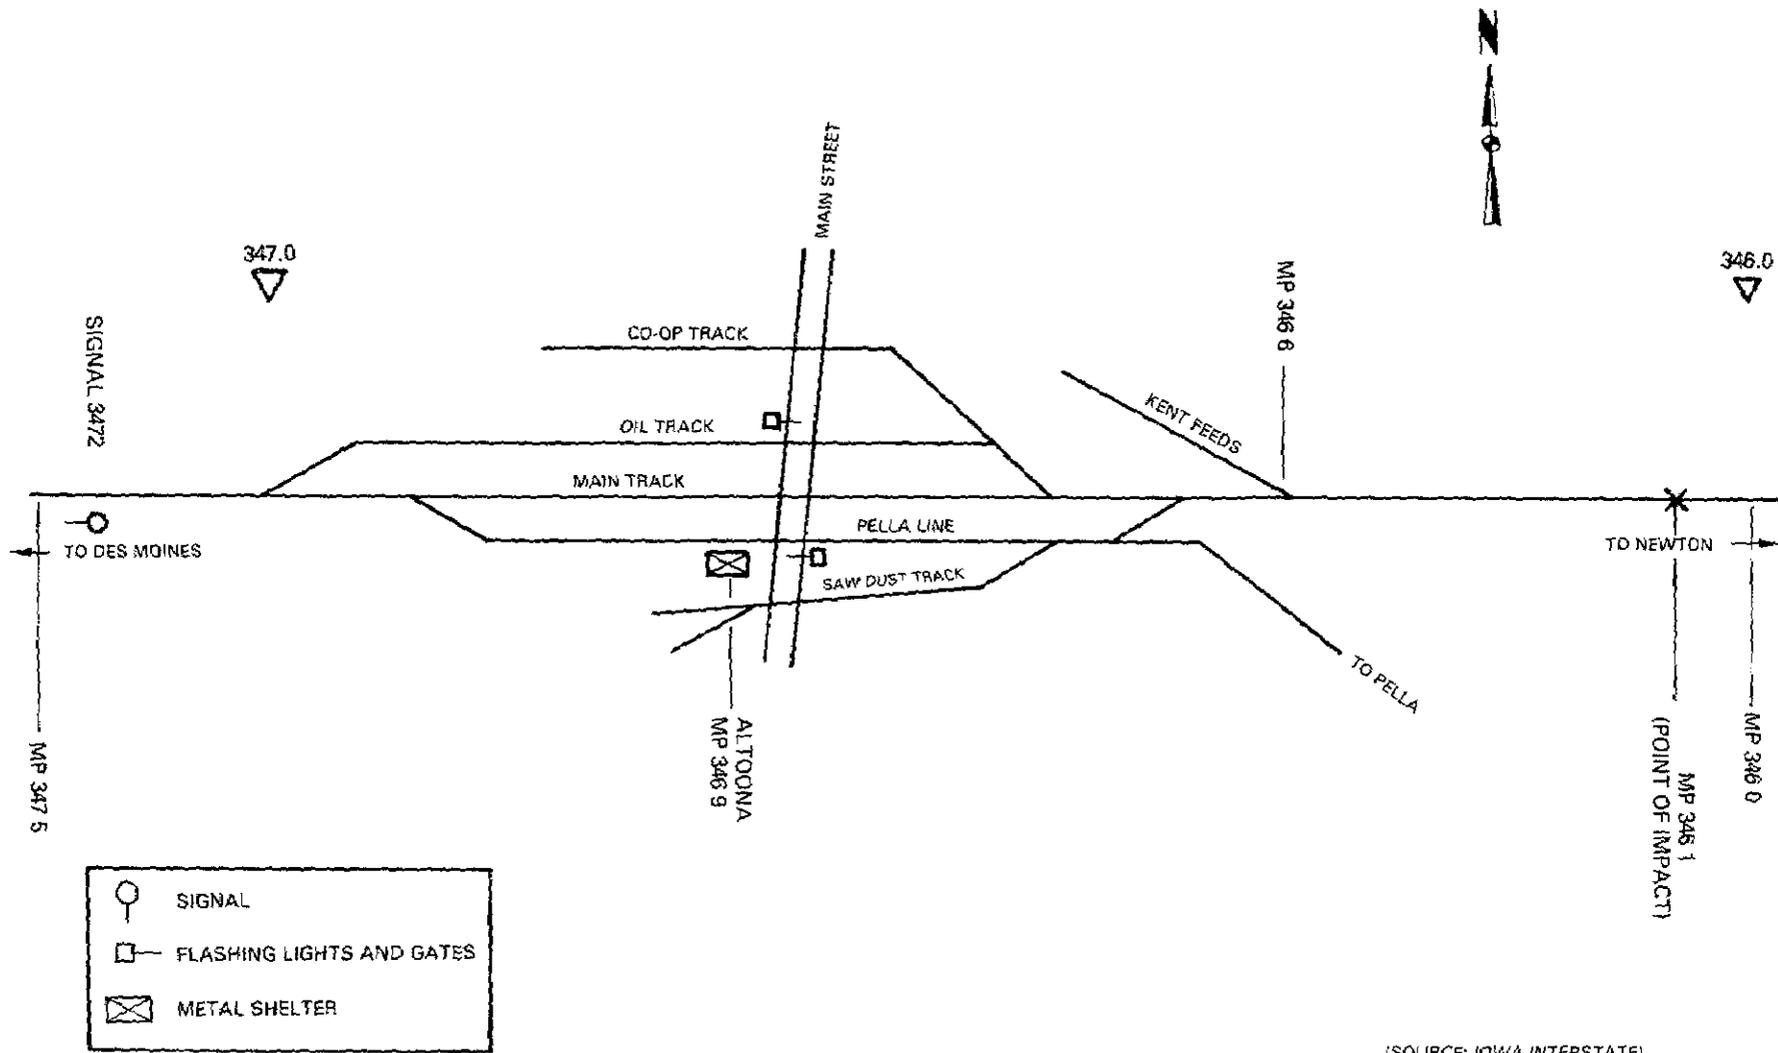
Figure 2.--Layout of Altoona Yard Track.

Safety Board investigators observed that signal No. 3472, located approximately 0.3 mile west of the Altoona station (see figure 2), had not been removed, covered, or turned away from the track.

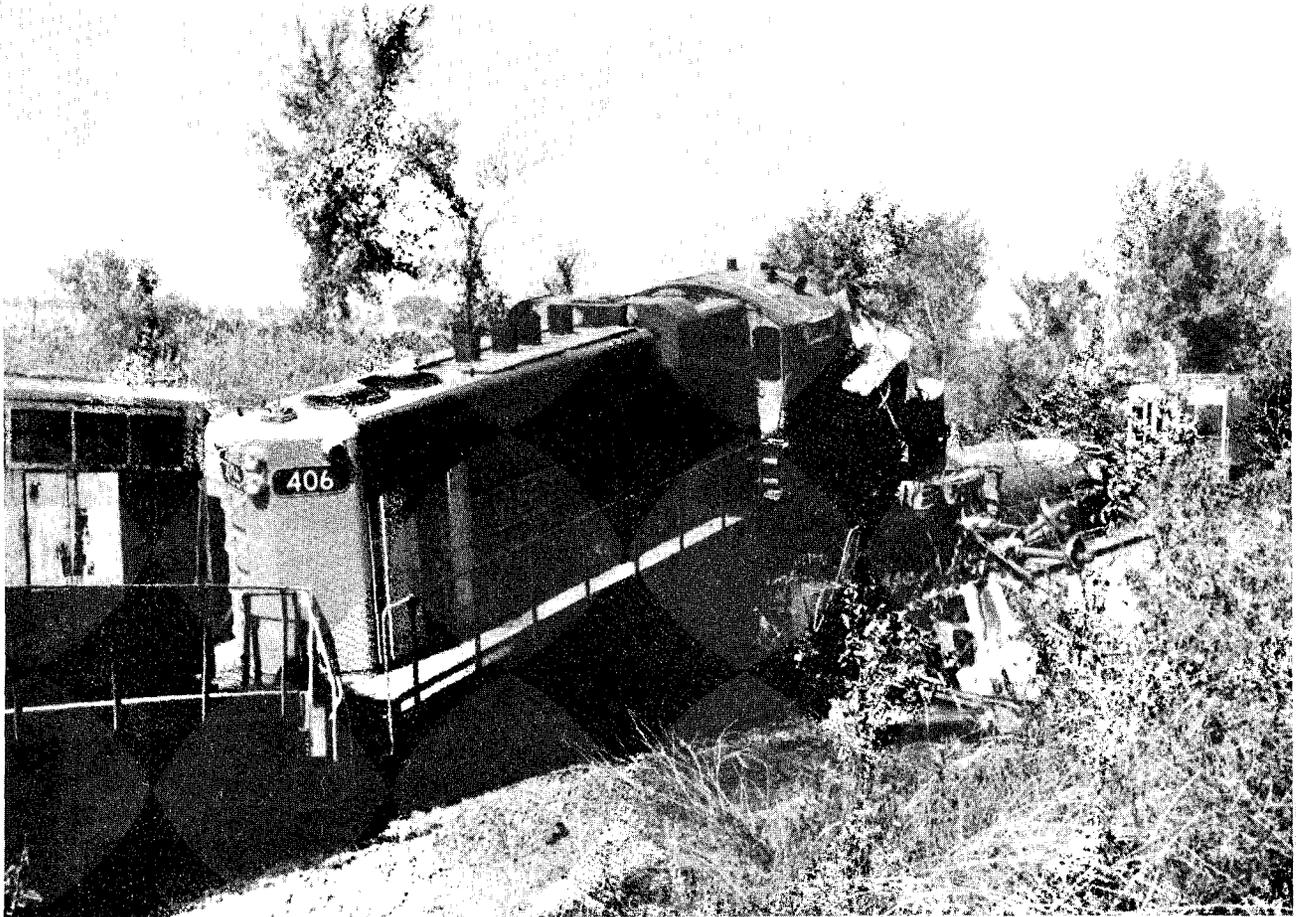
**Figure 4.--Unit 406 Overriding Unit of 470 West.**

Extra 406 East.--The lead unit of Extra 406 East received major crush damage to the front with sheet metal displacement that extended 2.5 feet to the rear. The interior of the cab of this unit was destroyed by the post-accident fire. The remaining units received light to moderate damage. The trailing unit received damage when it was struck and overridden by the first car of the consist. Three of the 11 cars that derailed were destroyed.

was operating westbound with its long hood forward. As a result, the fuel tank on unit 406 was damaged. With the exception of slight deformation to the rear cab door, the cab compartment structure remained intact. The postcollision fire, however, destroyed the interior of the cab compartment.

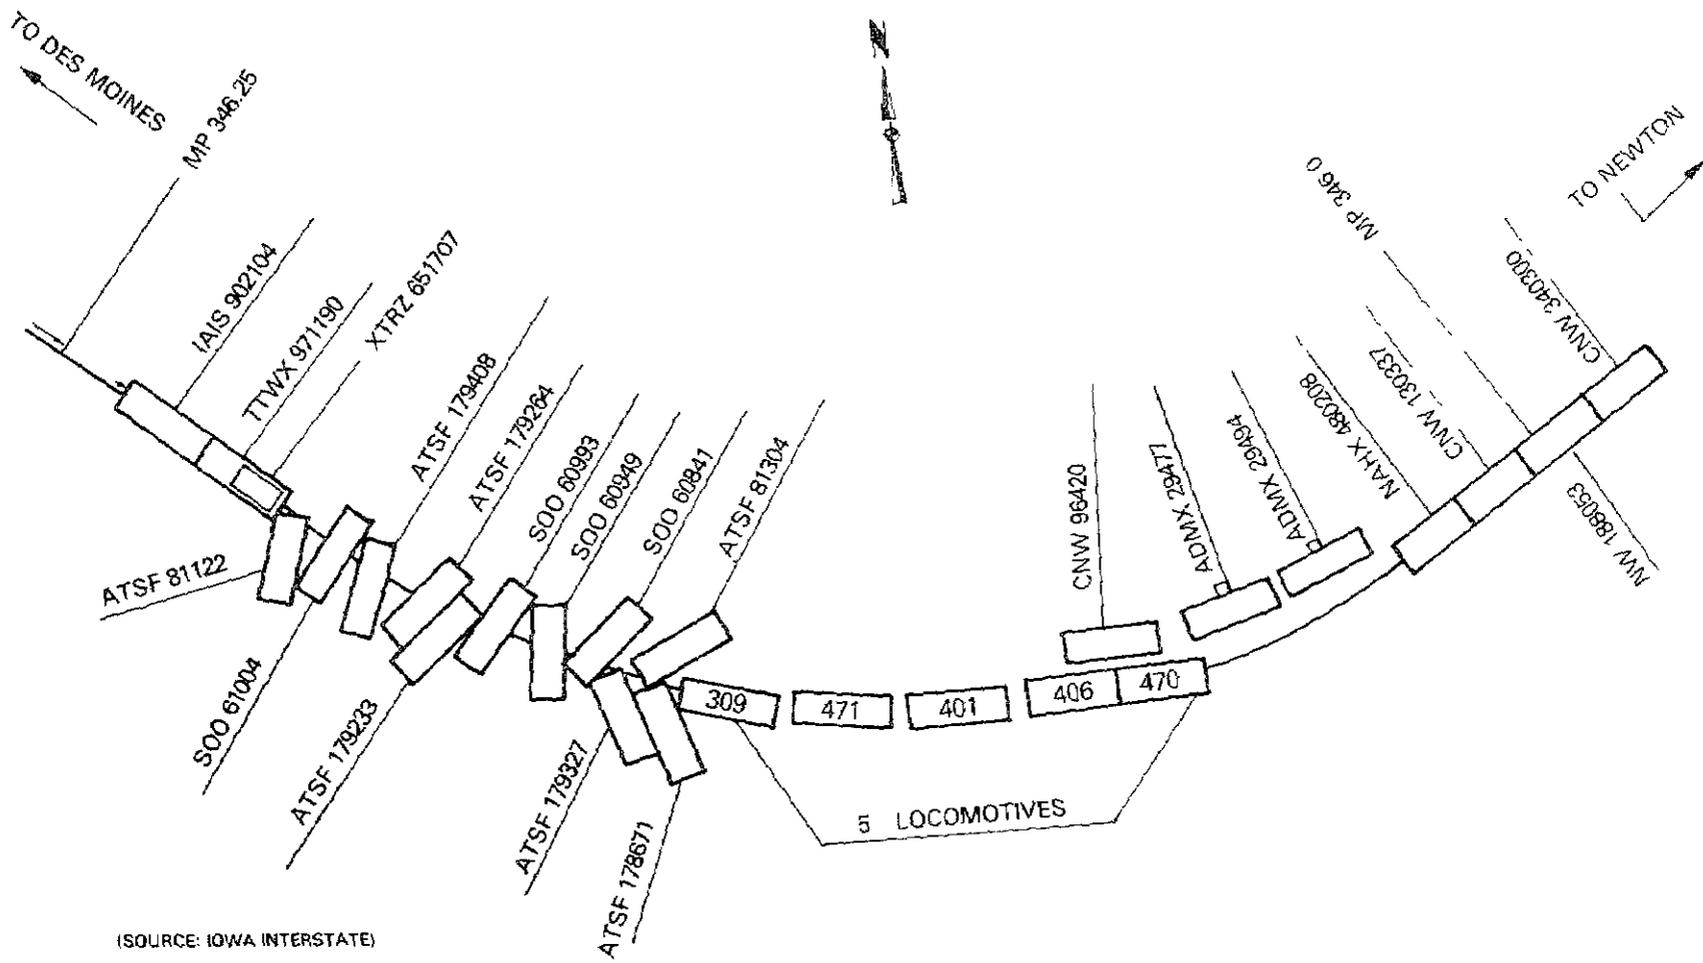
Figure 5.--Sketch of Derailment.

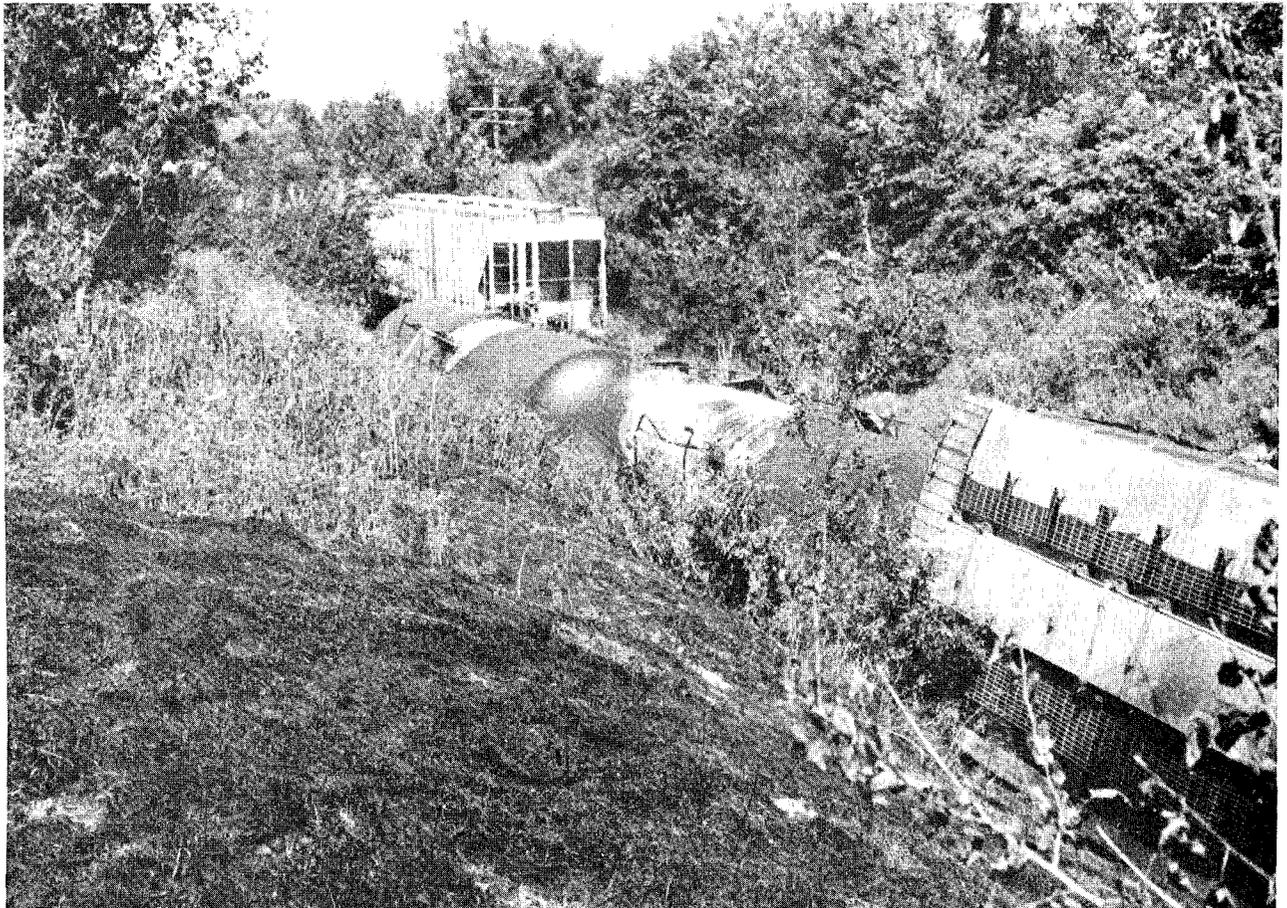
The postaccident visual inspection of the two tank cars on the afternoon of August 2 revealed a dent in the tank shell head at the B-end, or leading end, of ADMX 29477, the lead tank car (second car from the head end) in the train. When facing the B-end, there was a crease on the left side of the tank shell just forward of the first circumferential weld seam in the side shell. The tank shell was scorched and burned around the manway and the pressure relief valve toward the A-end. The scorched and burned area extended about 2/3 the tank length from the manway toward the A-end and on the side of the tank that faced up on the overturned tank. The paint around the manway had been burned away, or was blistered. There was no visible

**Figure 7.--Burning at Manway Cover of ADMX 29477 (foreground) and ADMX 29494.**

warping, buckling, or other obvious indications of structural damage to the tank shell observed. The bottom outlet valve extension and cap did not have any obvious damage. The manway cover and nozzle were not visibly warped. The area where the gasket contacted the manway cover had some unknown residue that had burned, but had no visible scars or marks.

The A-end of ADMX 29494, which had been the leading end of the car, had no visible damage. A small crease was found in the tank shell on the side that had been on the ground toward the B-end of the tank car. The tank shell was scorched around the manway opening and the pressure relief valve toward the A-end of the car. The scorched area extended around the side of the overturned tank that faced up, but it did not extend toward either end of

the tank. The paint in areas adjacent to the scorching was blistered. The bottom outlet valve extension and cap showed no visible damage. The manway nozzle and lid were not visibly warped or deformed.
