RAILROAD ACCIDENT INVESTIGATION

REPORT NO 4172,

KANSAS CITY SOUTHERN LINES

SEPTEMBER 23, 1970

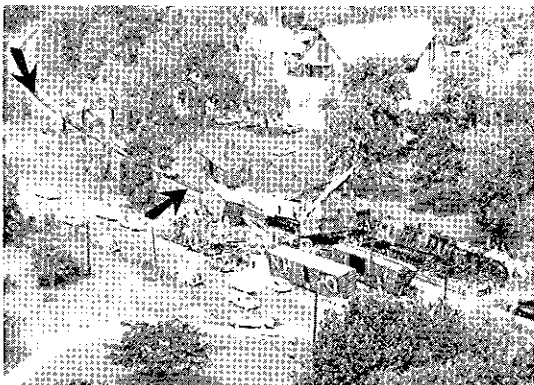
Because of track curvature, trees bordering the track structure, and supports for the pedestrian bridge, the maximum range of vision between a caboose standing at the collision point and an approaching southbound train is restricted to approximately 350 feet (see photo below).

Arrows shown direction of trains involved and the approximate point of collision. Photo taken during wreck clearing operations.

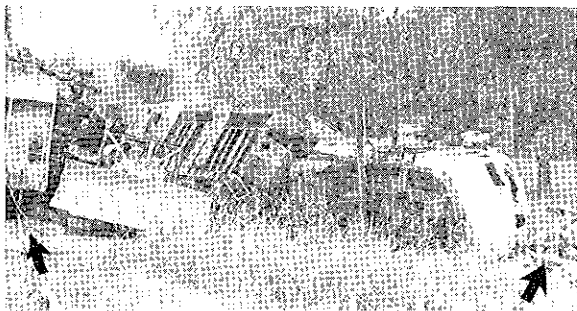
The last car and the caboose of this train were derailed. The car remained upright on and in line with the track structure. It was damaged considerably. The caboose was destroyed. Its wreckage stopped about 160 feet south and 40 feet east of the collision point, immediately in front of the derailed locomotive of Extra 50 South. Its fuel tank ruptured, resulting in escaping propane catching fire.

Arrows point to last car and wreckage of caboose of Extra 1 South. First locomotive unit of Extra 50 South shown with front end against caboose wreckage.
