INTERSTATE COMMERCE COMMISSION

REPORT OF THE DIRECTOR OF THE BUREAU OF SAFETY CONCERNING
AN ACCIDENT ON THE LAKE SHORE ELECTRIC RAILWAY AT CLYDE,
OHIO, ON MAY 6, 1934.

July 9, 1934.

Inv. No. 1911
Lake Shore Electric Ry.
Clyde, Ohio
May 6, 1934

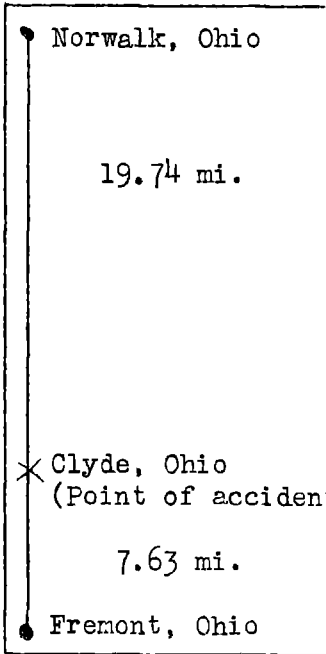
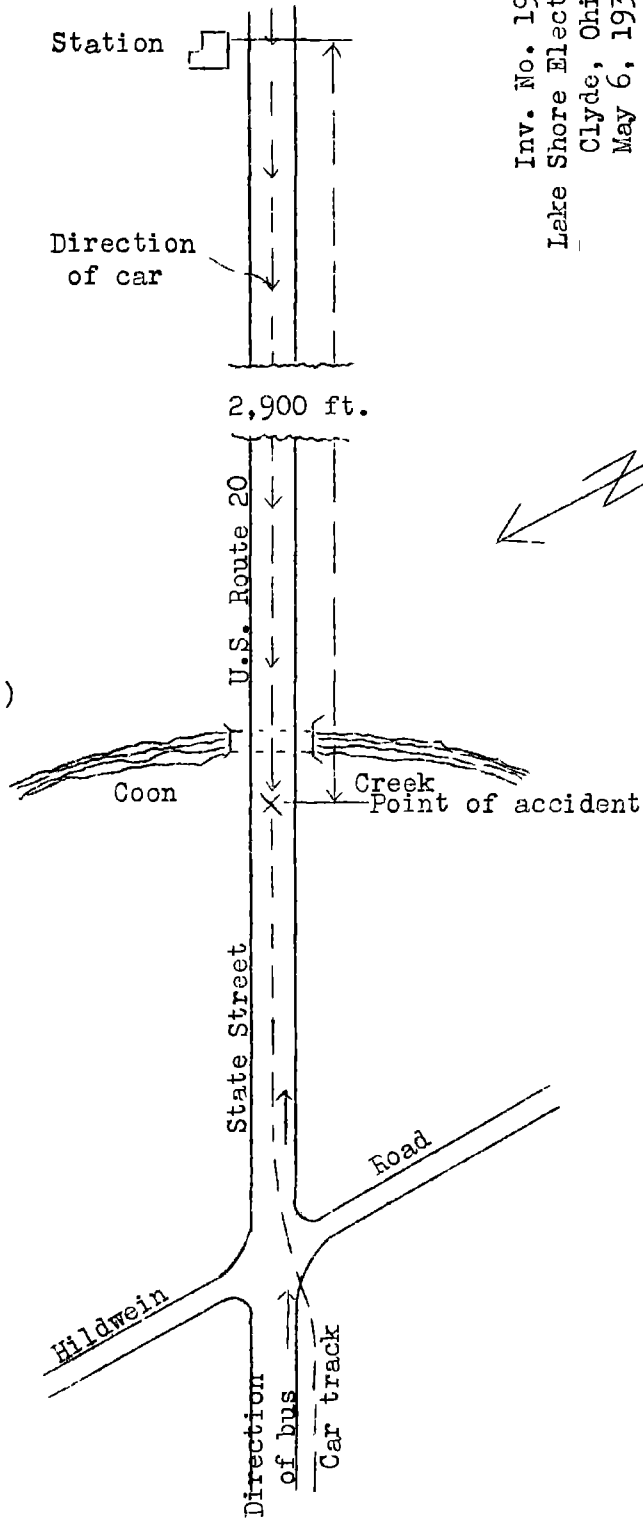
This accident occurred on that part of the railroad extending between Norwalk and Fremont, Ohio, a distance of 27.37 miles; in the vicinity of the point of accident this is a single-track electric line over which trains are operated by time table and train orders, no block-signal system being in use. The accident occurred within the corporate limits of Clyde, on State Street, 2,900 feet west of the station and 530 feet west of a regular stopping point for the bus involved in this accident; approaching this point from either direction the track is tangent for a considerable distance, and the grade is 0.3 percent descending for west-bound trains.

State Street extends east and west and the railway track is laid in the center of the street, with the improved highway, which is known as U.S. Route 20, paralleling the track on either side at the point where the accident occurred. The highway proper is composed of macadam about 10 feet in width on each side of the track, outside of which there are well-settled shoulders from 7 to 10 feet wide, dressed with medium crushed stone and slag; the center strip upon which the car track is laid is about 10 feet in width and filled in between and along the outside of the rails with medium crushed rock and stone to the tops of the rails and is approximately level with the adjoining macadam surface of the highway.
