## INTERSTATE COMMERCE COMMISSION

REPORT OF THE DIRECTOR OF THE BUREAU OF SAFETY CONCERNING AN  
ACCIDENT ON THE LEHIGH VALLEY RAILROAD AT BOWMANSTOWN,  
PA., ON APRIL 24, 1934.

Inv. No. 1910  
Lehigh Valley Railroad  
Bowmanstown, Pa.  
April 24, 1934.

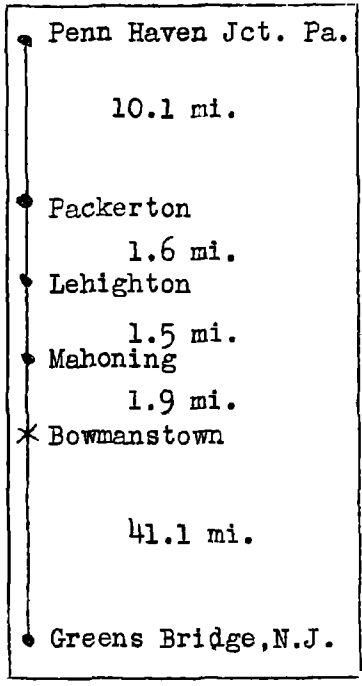
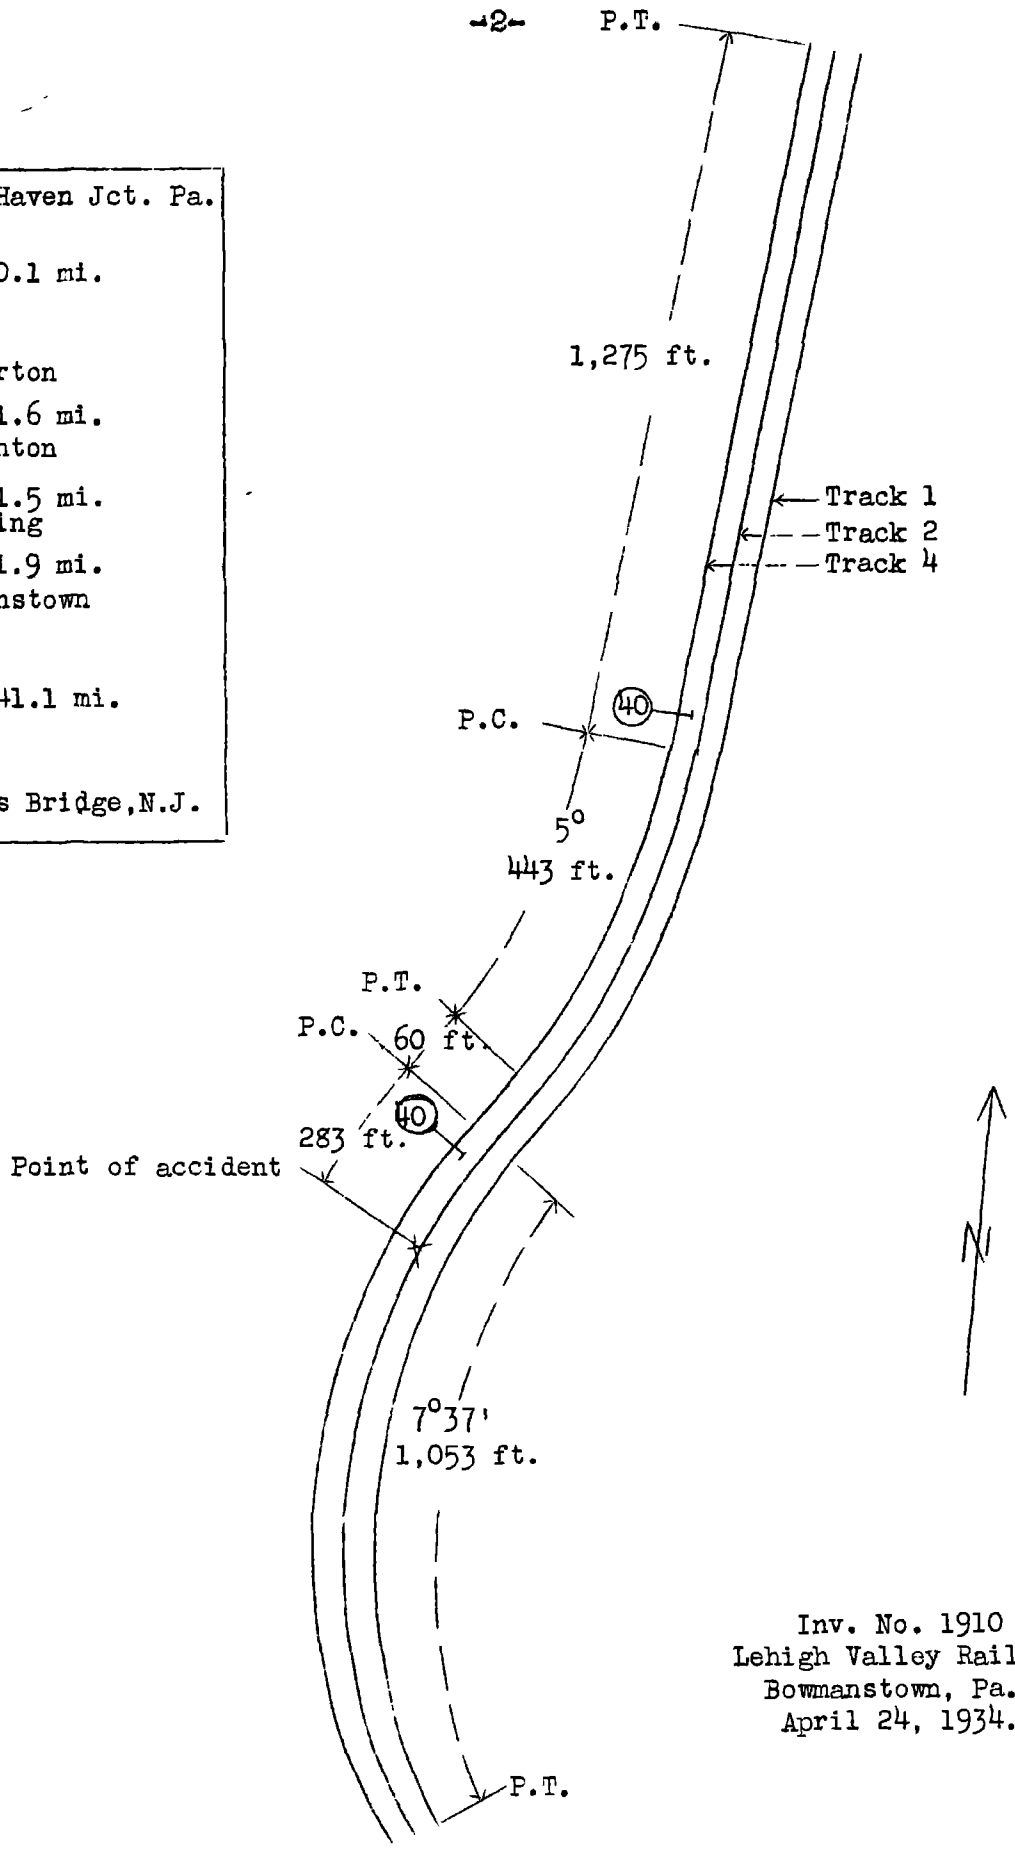
This accident was caused by excessive speed on a sharp curve.
