-----  
ACCIDENT ON THE  
LEHIGH VALLEY RAILROAD

-----  
ROCHESTER, N. Y.

-----  
JANUARY 27, 1940

-----  
INVESTIGATION NO. 2411

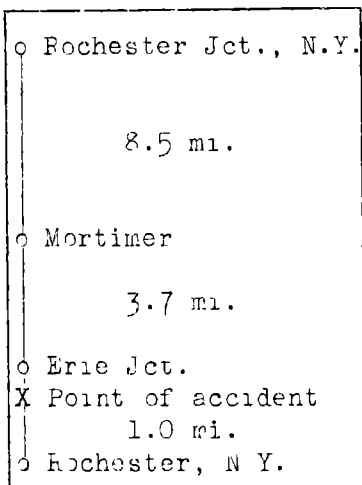
Inv. No. 2411  
Lehigh Valley R.R.  
Rochester, N.Y.  
January 27, 1940

This accident occurred on that part of the Buffalo Division designated as the Rochester Branch which extends between Hemlock and Rochester, N.Y., a distance of 28.4 miles. In the vicinity of the point of accident this is a single-track line over which trains are operated by timetable, train orders and a manual block system. The accident occurred within yard limits on the main track at a point 7,503 feet west of the east yard-limit board. Approaching from the east there are, in succession, a tangent 1,337 feet in length, a 3°45' curve to the right 461 feet in length, and a tangent 621 feet to the point of accident and 1,089 feet beyond. The grade for west-bound trains varies between 0.6 and 0.75 percent descending a distance of 2,011 feet to the point of accident and is 0.75 percent at the point of accident. Approaching from the west there are, in succession, a tangent 1,505 feet in length, a 4°30' curve to the right 540 feet in length, and the tangent on which the accident occurred. The grade for east-bound trains is, successively, 1.34 percent ascending a distance of 500 feet, 0.81 percent ascending 300 feet, and 0.75 percent ascending 689 feet to the point of accident.

From the engineman's side of a motor-car of the type involved, approaching from the east, the point of accident can be first seen from a distance of 792 feet; from the cab of a Diesel switch-engine approaching from the west it can be first seen from a distance of 1,155 feet.

Point of accident
