REPORT OF THE DIRECTOR
BUREAU OF SAFETY

ACCIDENT ON THE
LEHIGH VALLEY RAILROAD

TANNERY, PA.

INVESTIGATION NO. 2067

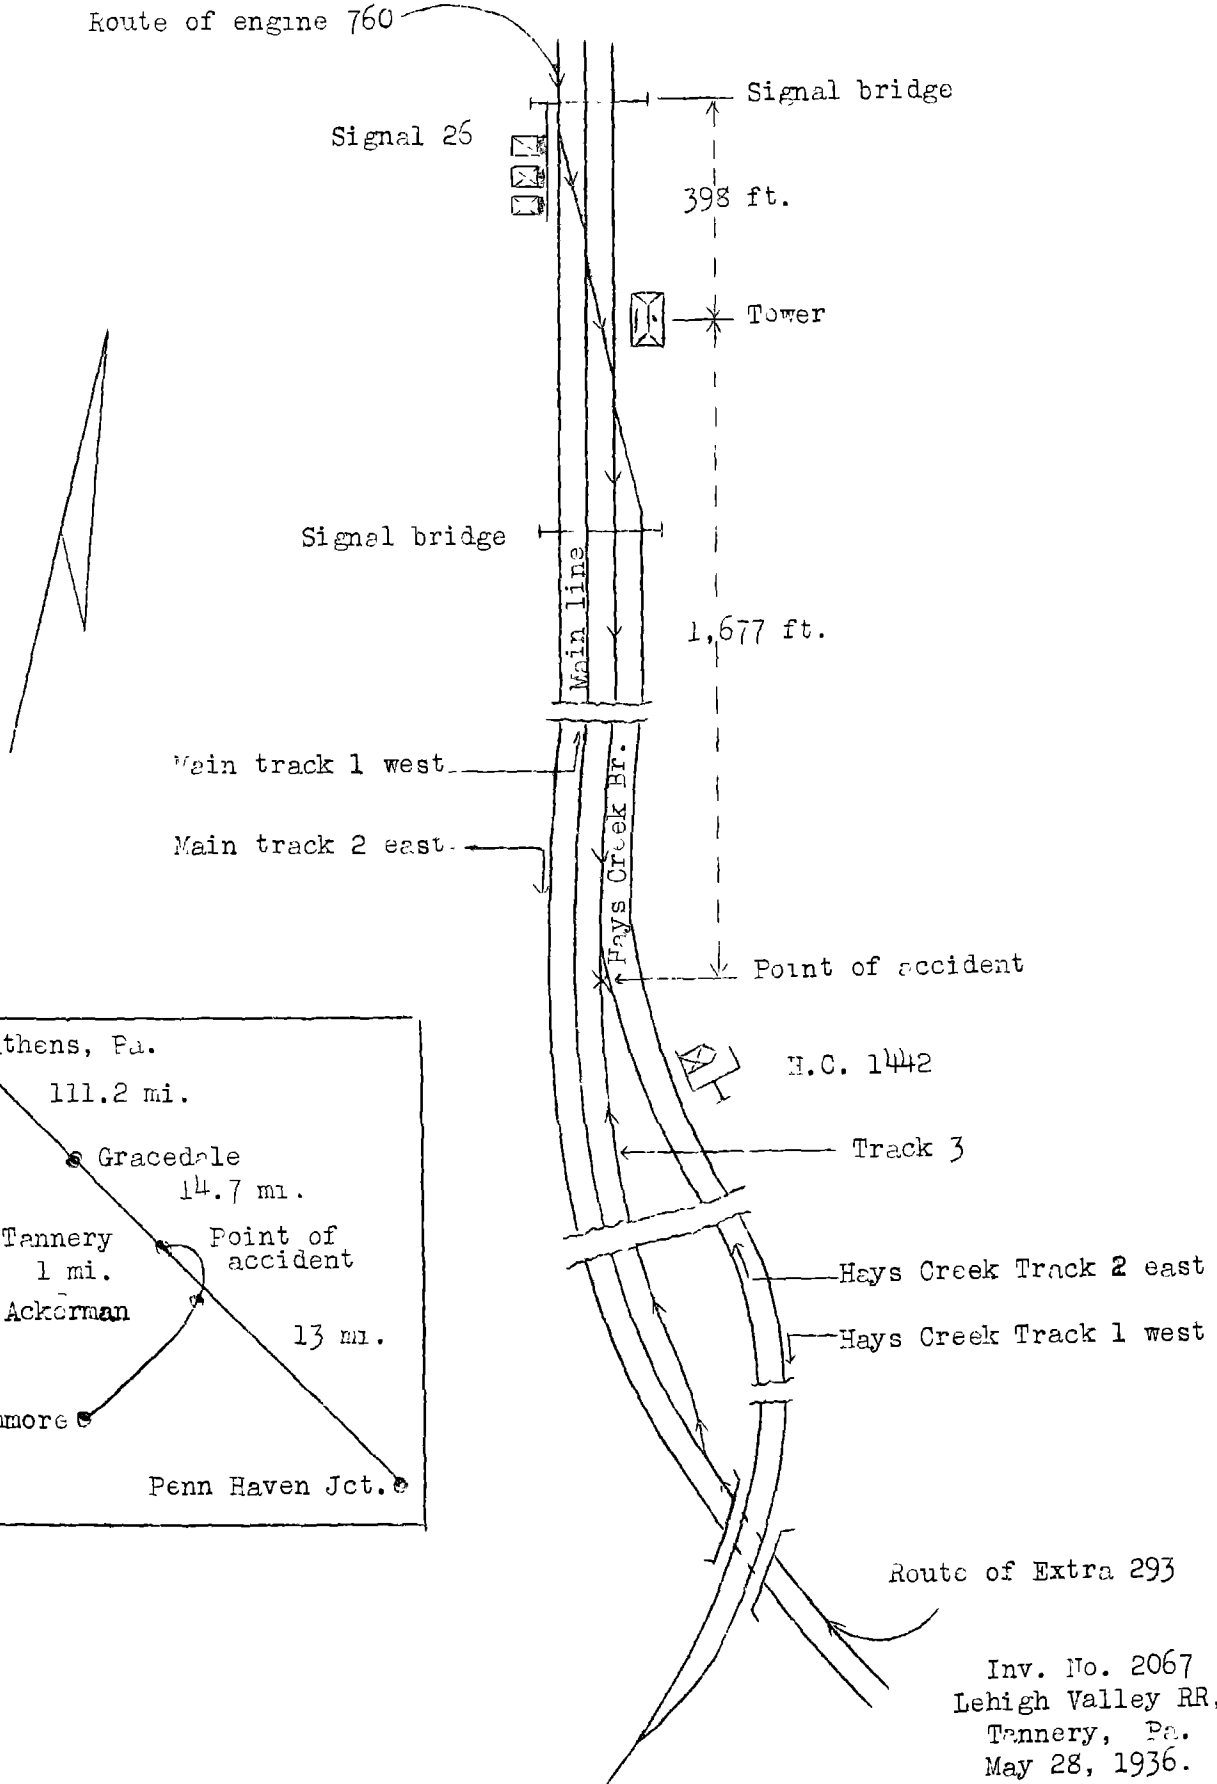
Inv. No. 2067
 Lehigh Valley RR,
 Tannery, Pa.
 May 28, 1936.

At a point 1,580 feet east of the tower there is a switch leading to track 3, this track lying between the branch line and the main tracks. Track 3 in turn leads to stub tracks 5 and 7. The accident occurred at the frog of the branch track switch leading to track 3. Approaching this point from the west the track is tangent for 1,144 feet, followed by a $1^{\circ} 40'$ curve to the right 362 feet in length, tangent track for 245 feet and then a $5^{\circ} 04'$ curve to the left 1,309 feet in length, the accident occurring on this latter curve at a point 324 feet from its western end. The grade on the branch line eastward is 0.41 percent descending. Due to a high cliff on the inside of the curve, the view to be had of the point of accident, approaching from the west, is limited to about 500 feet.

Route of engine 760

branch track 2 against the current of traffic, entered the open switch leading to track 3, and collided with Extra 293 while traveling at a speed estimated to have been about 20 miles per hour.

It is recommended that the operating officials of this railroad take such steps as may be necessary to secure proper enforcement and observance of the rules.
